## Conservation Management Strategy

FMR COOPER'S MILL  
COOLEENUP ISLAND, SOUTH YUNDERUP

**WATER TECHNOLOGY**

February 2026

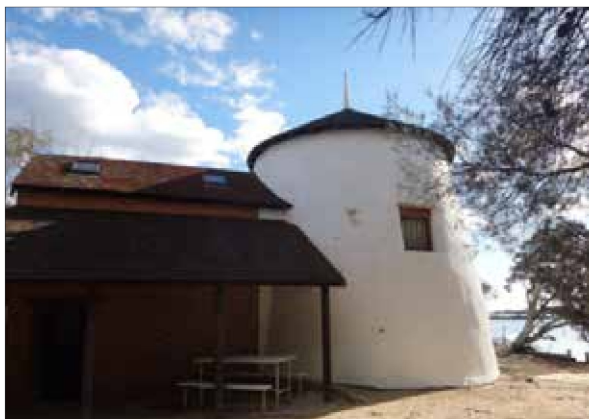
Image 13: East facing view of mill - note minimal fall and setback to river, July 2011. Photos Cooper's Mill damage.

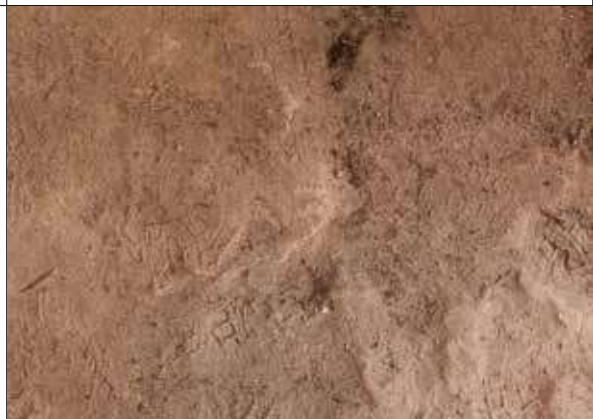
Image 44: Silt build-up internally

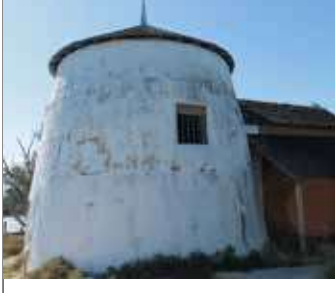
| ITEM/<br>LOCATION | CONDITION<br>RATING | DEFECT | PROPOSED<br>WORKS | PRIORITY | PHOTOS |
|---|---|---|---|---|---|
| Rendered Wall<br>- Hard Render<br>(3m high) +<br>Render Band<br>Top (3m to<br>4.5m high) | D | <ul style="list-style-type: none"> <li>Signs of damp and weathering.</li> <li>Evidence of deterioration and flaking to render and paint.</li> <li>Visible cracking and erosion to masonry.</li> </ul> | <ul style="list-style-type: none"> <li>Remove hard cement.</li> <li>Treat damp.</li> <li>Repair, repoint or re-render wall surface.</li> <li>Improve drainage and ventilation.</li> <li>Reassess following investigation works.</li> </ul> | 2 | |

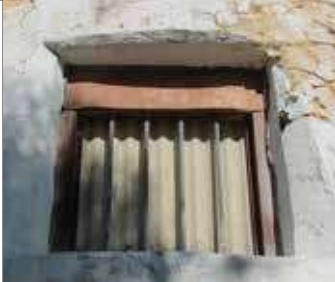
| ITEM/<br>LOCATION | CONDITION<br>RATING | DEFECT | PROPOSED<br>WORKS | PRIORITY | PHOTOS |
|---|---|---|---|---|---|
| Windows -<br>1No. East +<br>1No. West | C | <ul style="list-style-type: none"> <li>Signs of weathering to metal and timber frame.</li> </ul> | <ul style="list-style-type: none"> <li>Treat rust to metal bars.</li> <li>Paint or replace metal and timber as required.</li> <li>Remove infill as required.</li> <li>Review window detailing when overall conservation works are proposed.</li> </ul> | 3 | |

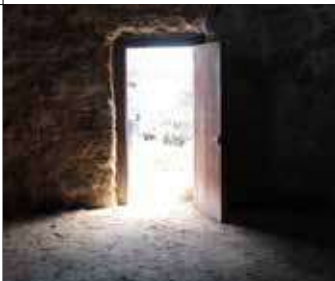
| ITEM/<br>LOCATION | CONDITION<br>RATING | DEFECT | PROPOSED<br>WORKS | PRIORITY | PHOTOS |
|---|---|---|---|---|---|
| Entry Door | C | <ul style="list-style-type: none"> <li>Signs of weathering to door leaf and timber frame.</li> <li>Evidence of water inundation.</li> <li>Door cannot be fully closed.</li> </ul> | <ul style="list-style-type: none"> <li>Repaint or replace as required.</li> <li>Repair and maintain hardware.</li> </ul> | 2 | |
