Conservation Management Strategy

FMR COOPER'S MILL
COOLEENUP ISLAND, SOUTH YUNDERUP

PREPARED FOR

WATER TECHNOLOGY

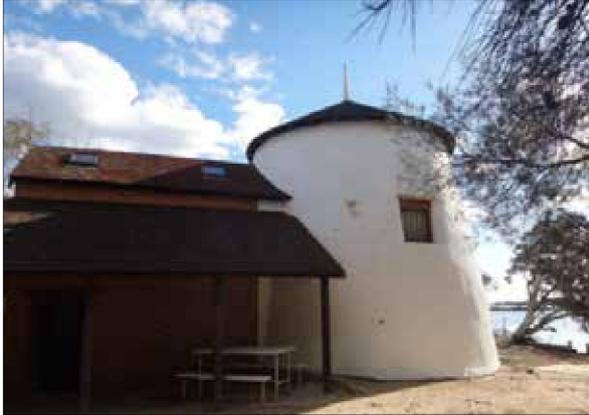
Image 13: East facing view of mill - note minimal fall and setback to river, July 2011. Photos Cooper's Mill damage.

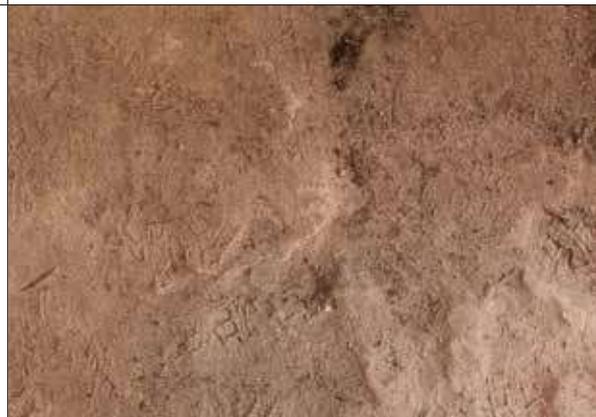
- The limestone wall is in fair to poor condition, with evidence of rising damp, discolouration and silt build up externally and internally from the inundation of the place.

Image 44: Silt build-up internally

- Remove sand and silt to the floor of the stone mill and Engine Room and investigate the condition of the stone flooring. Repair and replace stone and lime mortar as required.

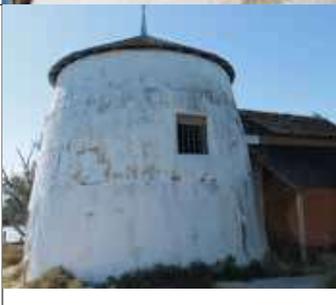
Rendered Wall - Layers (base of wall)	D	<ul style="list-style-type: none"> Evidence of erosion. At least 4 separate layers of render are evident. 	<ul style="list-style-type: none"> Remove render layers. Investigate re-rendering with structural consideration. 	2

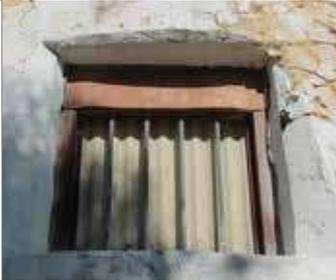
ITEM/ LOCATION	CONDITION RATING	DEFECT	PROPOSED WORKS	PRIORITY	PHOTOS
Windows - 1No. East + 1No. West	C	<ul style="list-style-type: none"> Signs of weathering to metal and timber frame. 	<ul style="list-style-type: none"> Treat rust to metal bars. Paint or replace metal and timber as required. Remove infill as required. Review window detailing when overall conservation works are proposed. 	3

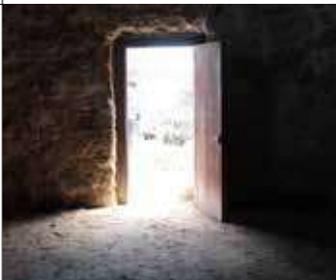
Entry Door	C	<ul style="list-style-type: none"> Signs of weathering to door leaf and timber frame. Evidence of water inundation. Door cannot be fully closed. 	<ul style="list-style-type: none"> Repaint or replace as required. Repair and maintain hardware. 	2
