# Report

## Cooper's Mill Reserve 23015 Foreshore Management Plan

Shire of Murray

13 February 2026

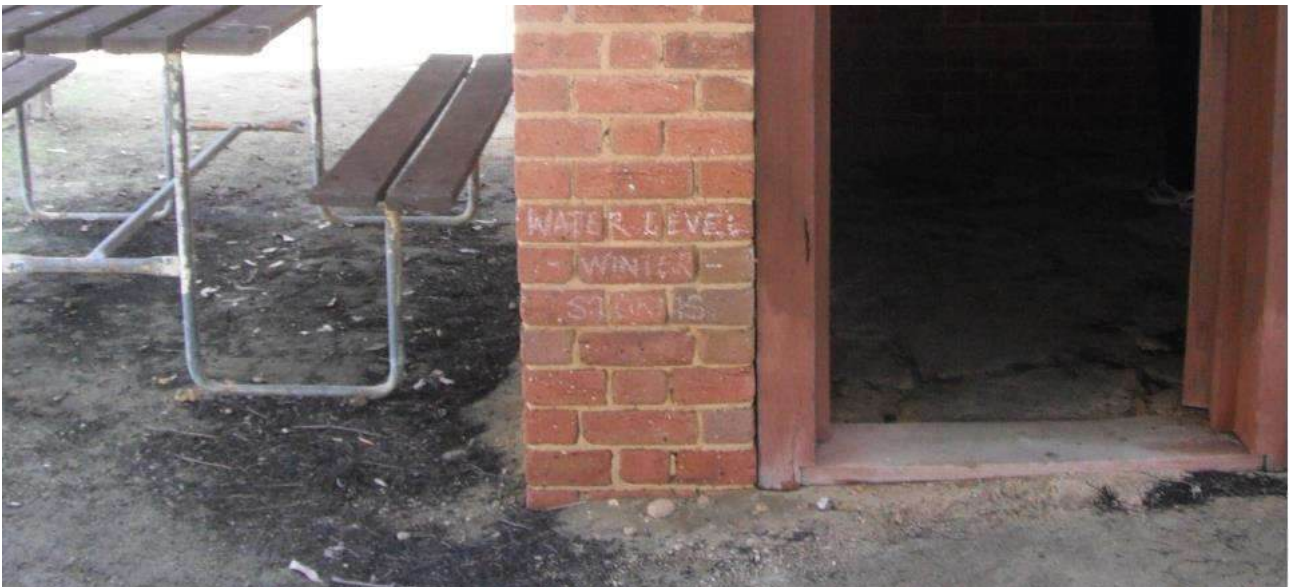
**Figure 2-1 2010 winter water levels mark on Mill building. Supplied by Shire. Estimated water depth at ~0.5m above land surface assuming ~8cm per course of bricks.**

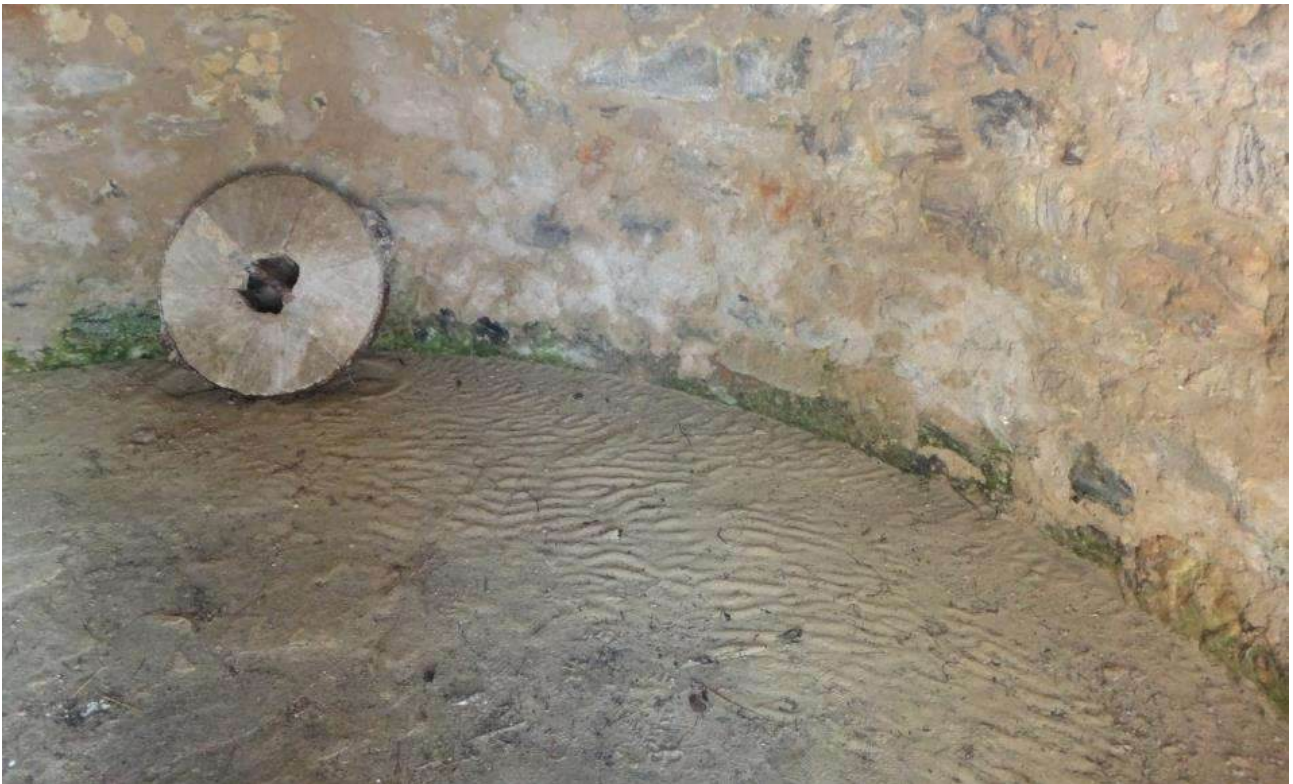
**Figure 2-2 Winter 2011 – Evidence of water flow leaving sand ripples inside Mill engine building. Supplied by Shire.**

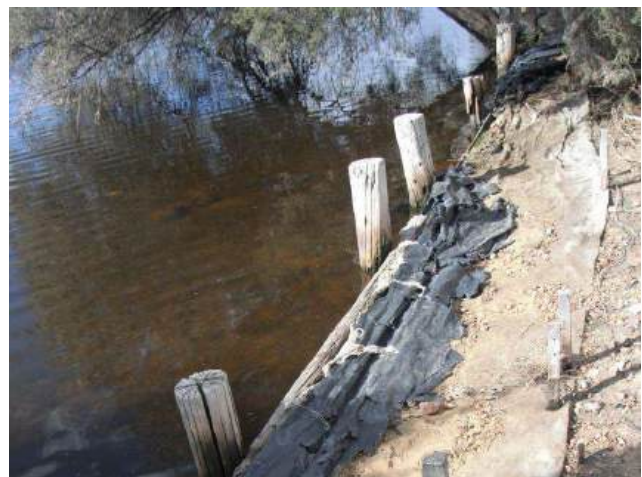
**Figure 2-4 Winter 2011 – Northern revetment. Overtopping evident. Supplied by Shire.**

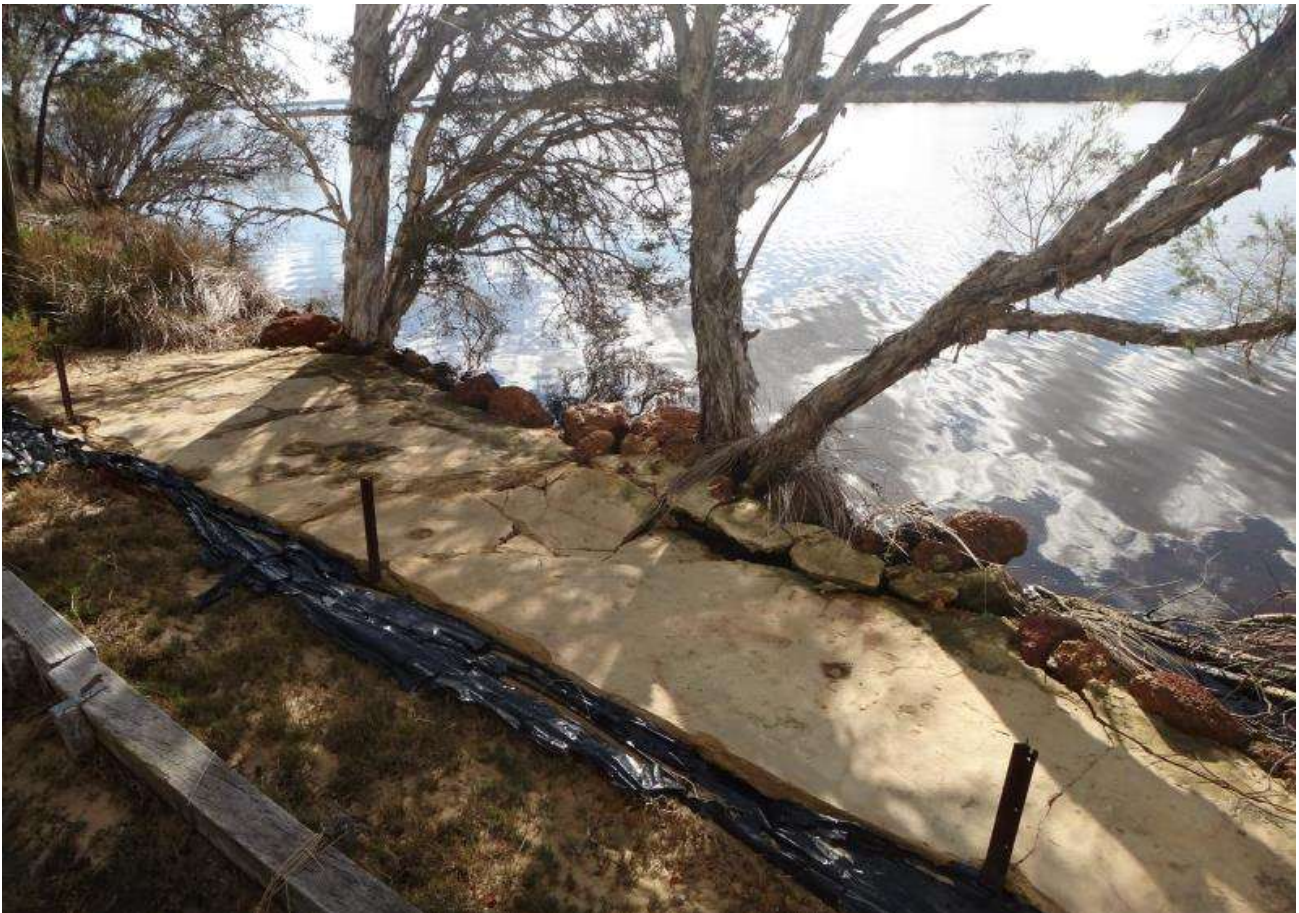
**Figure 2-5 Winter 2011 – Northern revetment. New concrete capping installed. Supplied by Shire.**

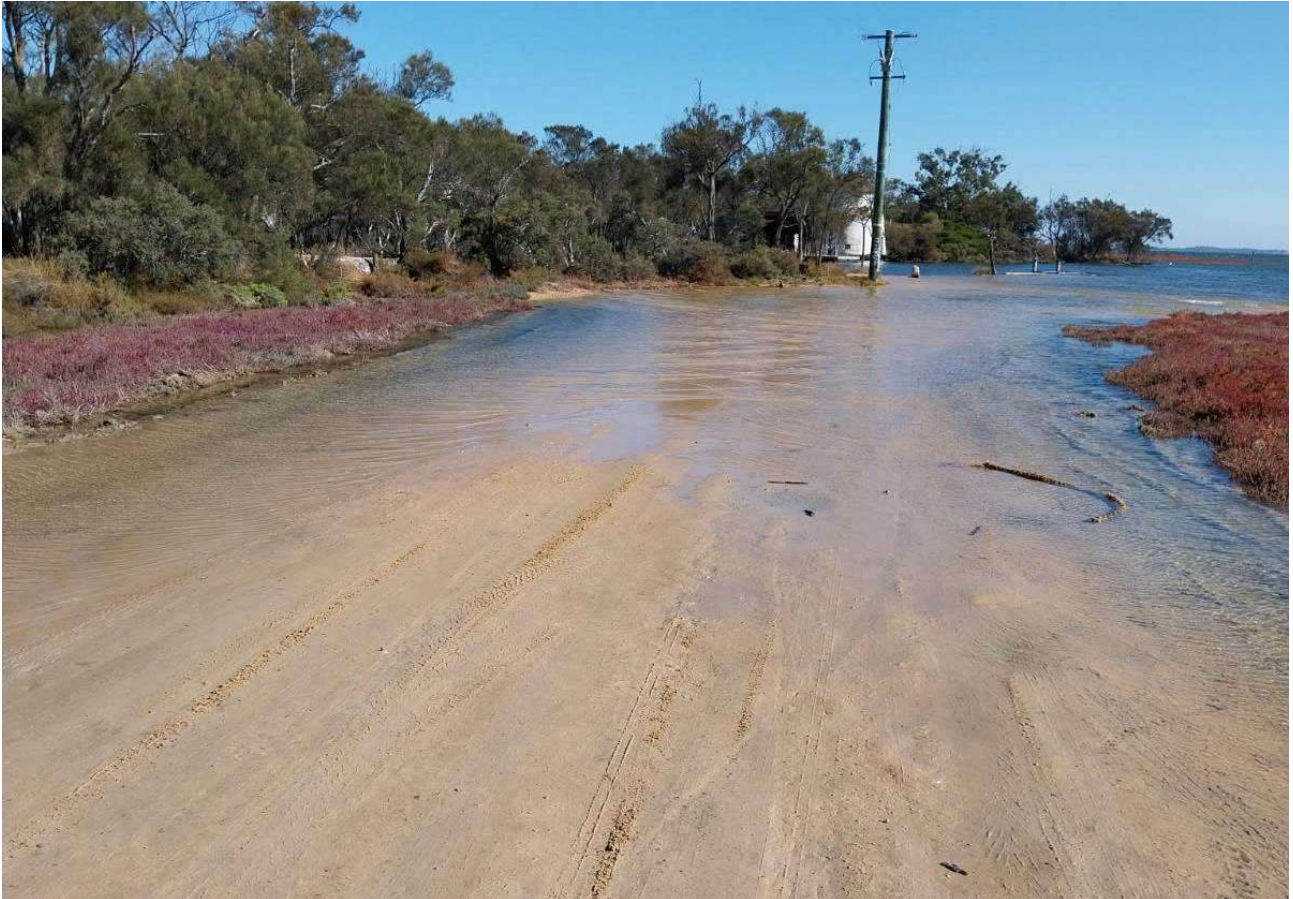
**Figure 2-15 End of Tonkin Drive looking towards Cooper's Mill; Monday 12/5/2025 (Supplied by community member)**

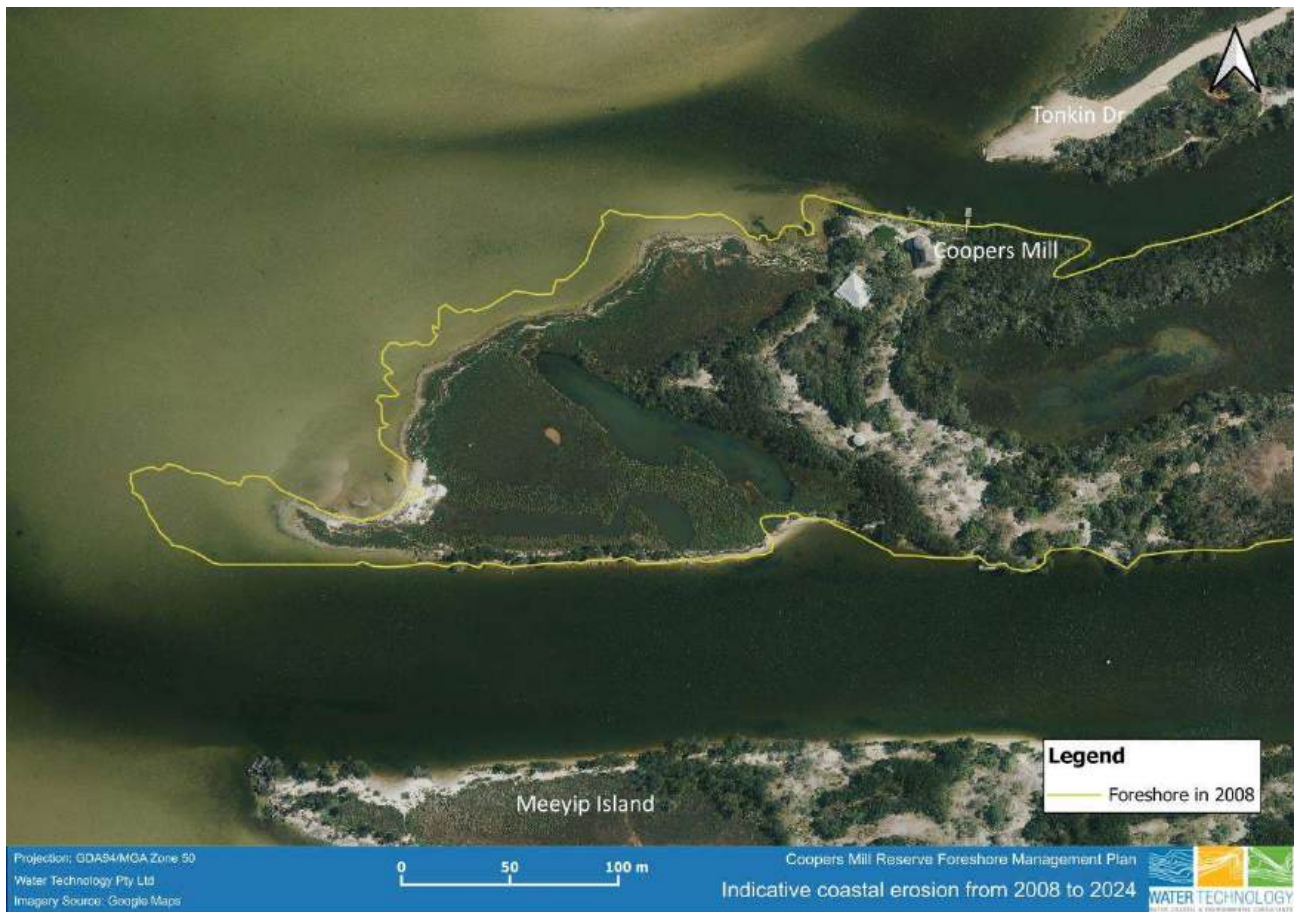
**Figure 2-16** Indicative coastal erosion between 2008 and 2024. The yellow outline shows where the foreshore was in 2008 in comparison with the satellite image taken in November 2024 (Metromap). This is indicative and water level comparisons and adjustments have not been made.

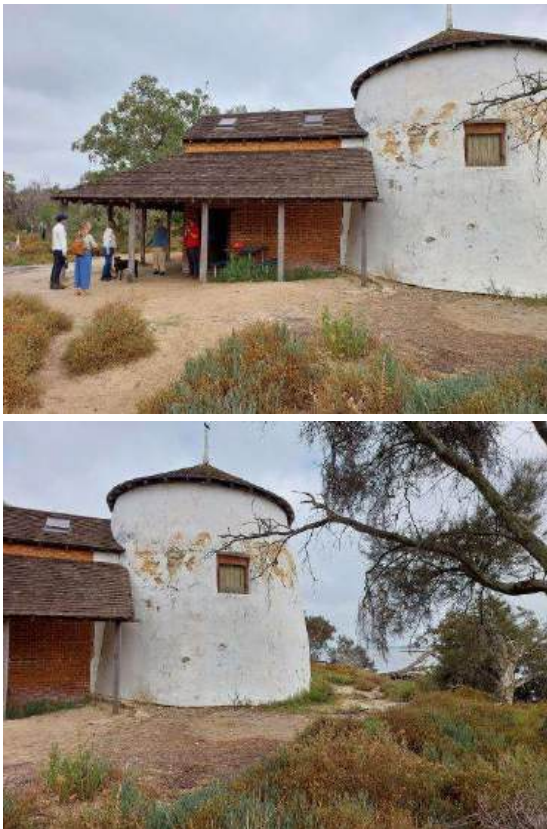
| Location | Photos | Comments |
|---|---|---|
| Cooper's Mill | | <ul style="list-style-type: none"> <li>Water from estuary comes inside Mill building often – approximately 5 to 10 times most winters (John L). Up to ~1.0m deep (2007 marked on bricks) and can linger days to a week or so.</li> <li>Need to remove seaweed / wrack and sand from Mill after flooding / overtopping events</li> <li>The round Mill engine room is approximately 6m back from the old timber wall – erosion management here is likely to be key.</li> <li>Overtopping at this location seems to be the primary pathway for estuary water and energy to reach and enter the Mill. Management of this area will be key to reducing flooding or energy of inundation reaching structure.</li> </ul> |

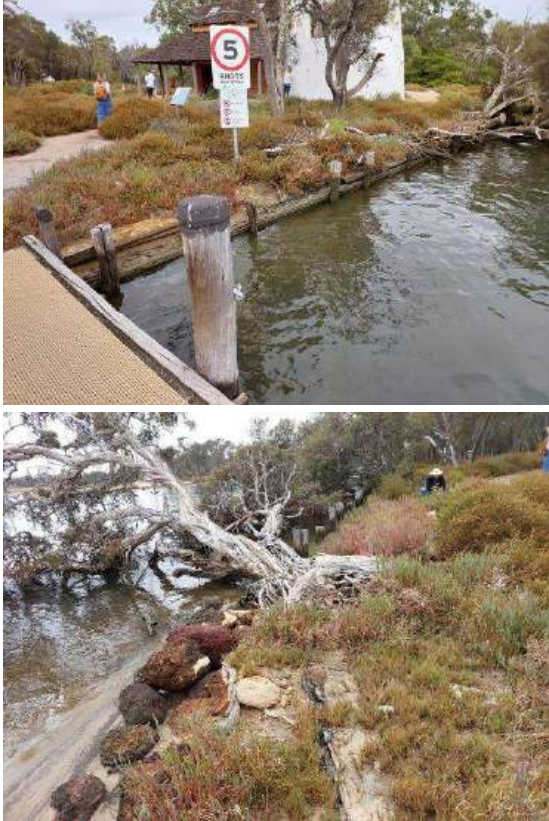
| Location | Photos | Comments |
|---|---|---|
| Northern foreshore and seawall | | <ul style="list-style-type: none"> <li>▪ Approximately 5m long rock retaining wall east of barge jetty</li> <li>▪ Approximately 10m long rock retaining wall west of barge jetty</li> <li>▪ Approximately 25m long wooden wall west of the rock wall.</li> <li>▪ All in poor or failed condition. Other than fallen trees and tree branches there is little vegetation connecting estuary and saltmarsh across wooden retaining wall.</li> <li>▪ Some old, ragged geofabric cloth is present behind walls.</li> </ul> |

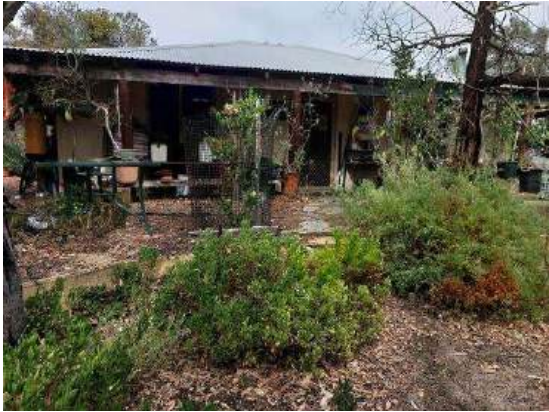
| Location | Photos | Comments |
|---|---|---|
| Caretaker's House | | <ul style="list-style-type: none"> <li>▪ Water laps at raised house pad (~0.3m) and slightly overtops retaining wall but hasn't got inside house in John's time.</li> </ul> |

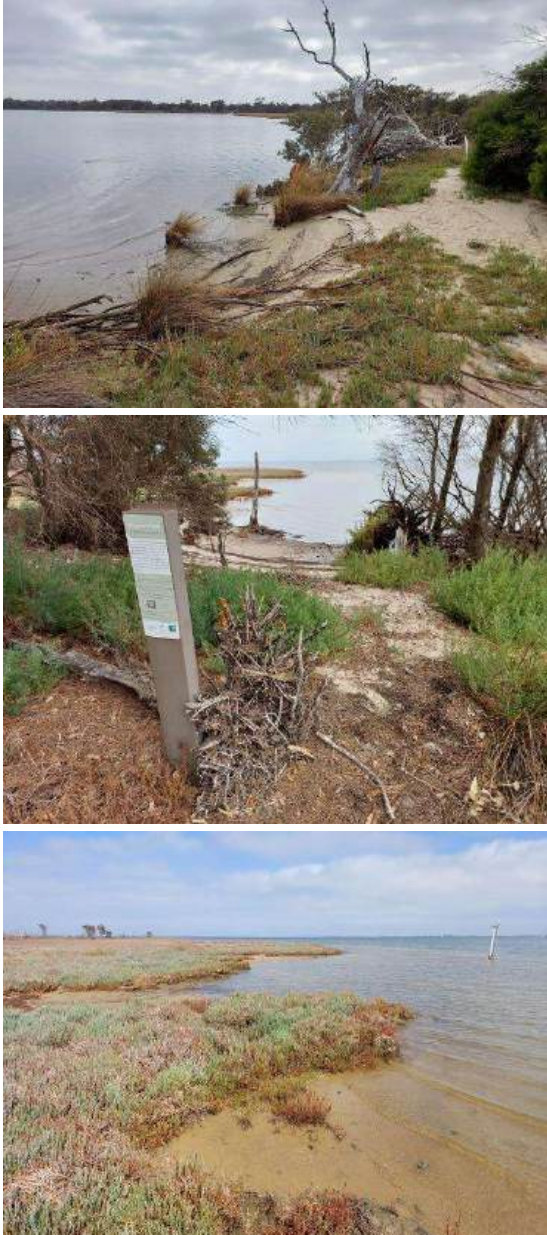
| Location | Photos | Comments |
|---|---|---|
| Western foreshore | | <ul style="list-style-type: none"> <li>▪ Largely a natural setting comprising tidal estuary samphire marsh backed by some woodland including tree species such as <i>Causarina obesa</i> and <i>Melaleuca raphiophylla</i>.</li> <li>▪ Evidence of tree roots being undermined from gradual sediment erosion, resulting in trees falling into estuary.</li> </ul> |

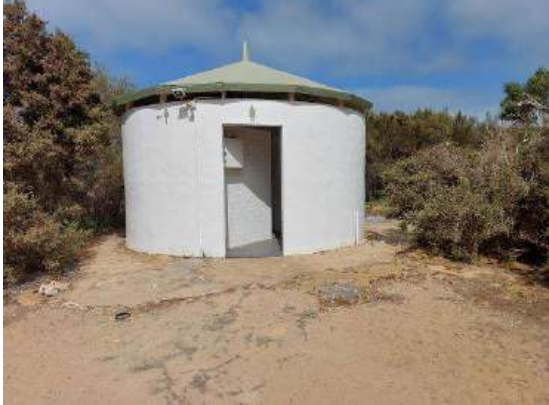
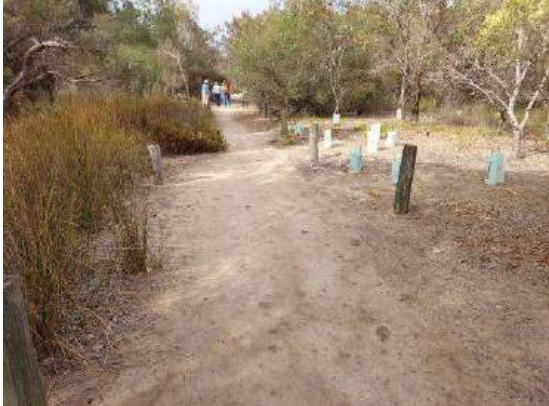
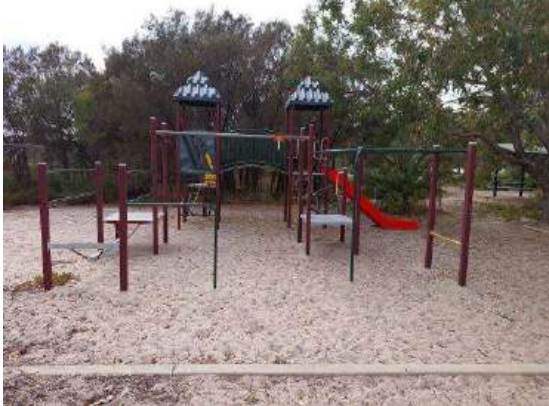
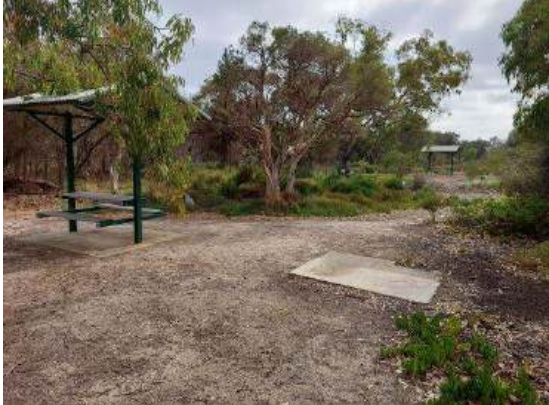
| Location | Photos | Comments |
|---|---|---|
| <p>Foreshore amenities including bathrooms, playground, BBQ's pathway, picnic area and associated infrastructure</p> | | <ul style="list-style-type: none"> <li>▪ Generally popular with family picknickers, boaters and people who want to visit Mill.</li> <li>▪ Playground, picnic area and toilets provided with associated pathway and revegetation.</li> <li>▪ No public bins (old ones vandalised by fire).</li> <li>▪ Recurring nuisance behaviour in general – including theft and vandalism.</li> </ul> |

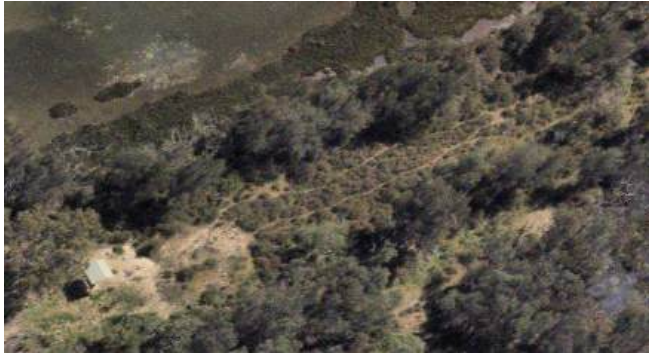
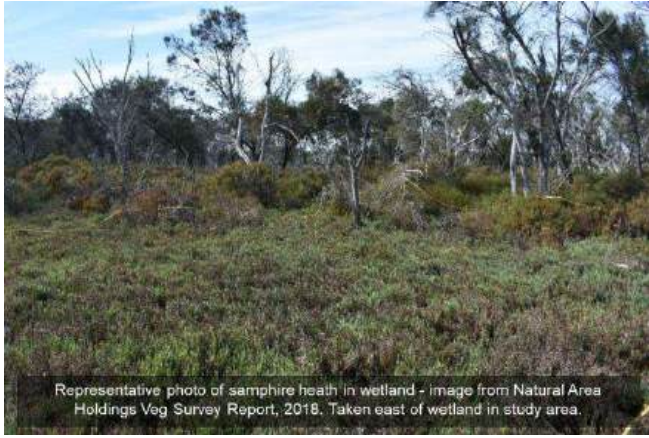
| Location | Photos | Comments |
|---|---|---|
| Eastern vegetation and wetland | <br> | <ul style="list-style-type: none"> <li>Good saltmarsh vegetation (samphire, marine couch, Austral sea-blite and sea heath) except where there's been ground compaction from walking.</li> </ul> |

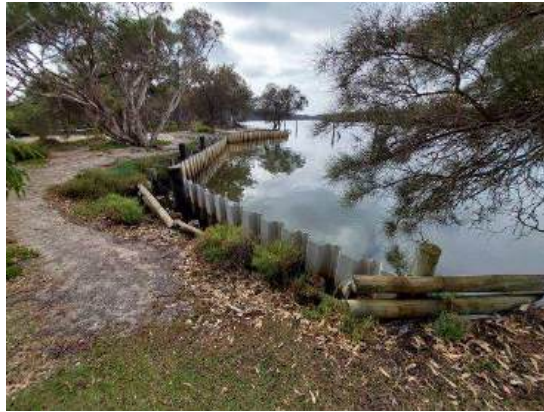
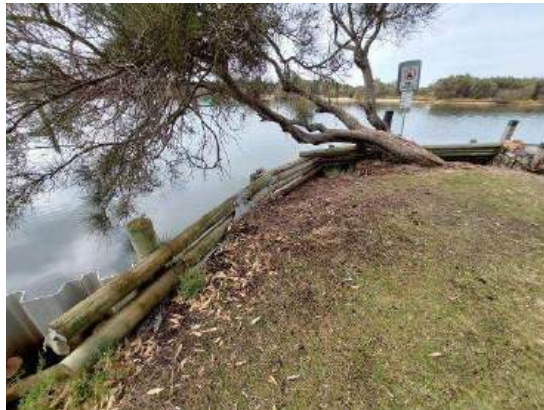
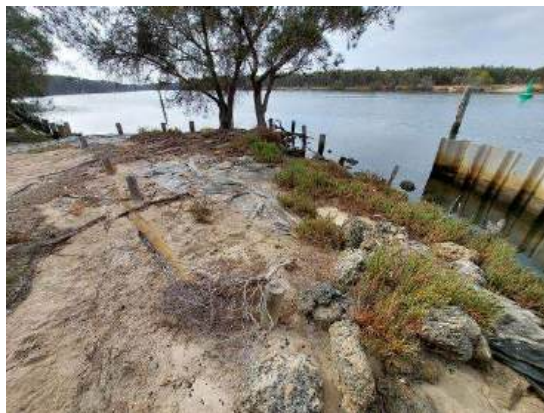
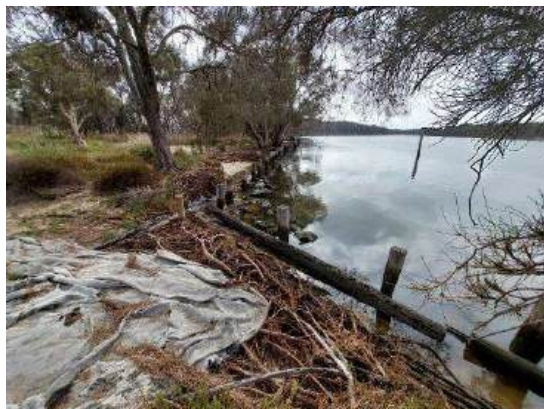
Southern  
foreshore  
seawalls

- At east end there is ~35m PVC sheet pile wall (SPW - some damaged, not backfilled properly) crest height estimated at ~1.4mCD. This wall installed in last 20 years – other all built before ~2005.

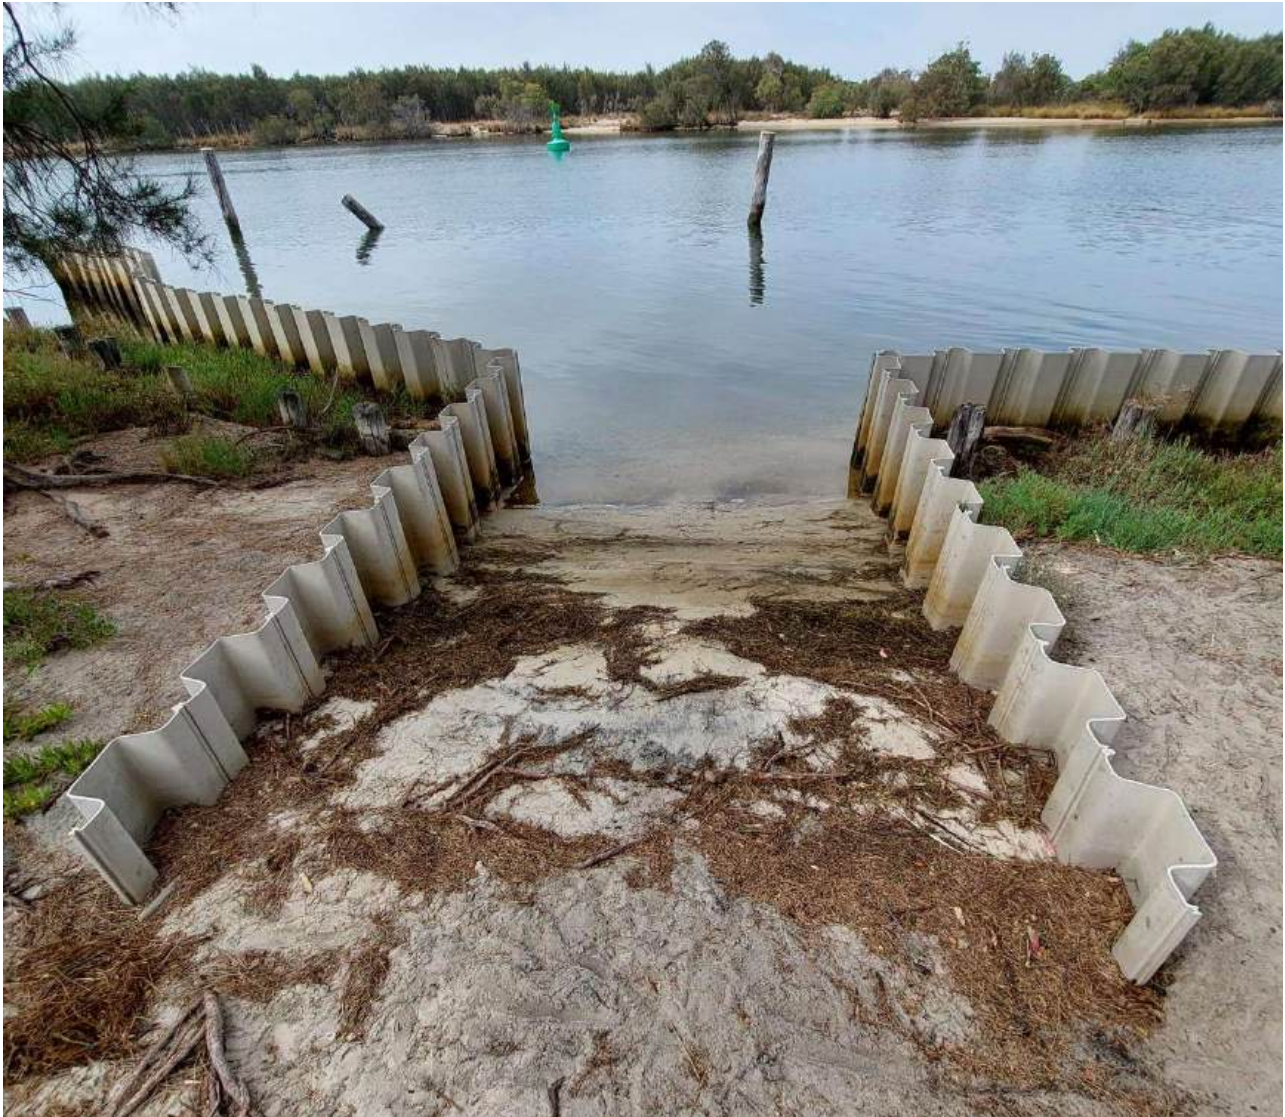
**Figure 9-4** PVC sheet piled wall in place on the southern foreshore of the study area since ~2013.
