Report

Cooper's Mill Reserve 23015 Foreshore Management Plan

Shire of Murray

13 February 2026

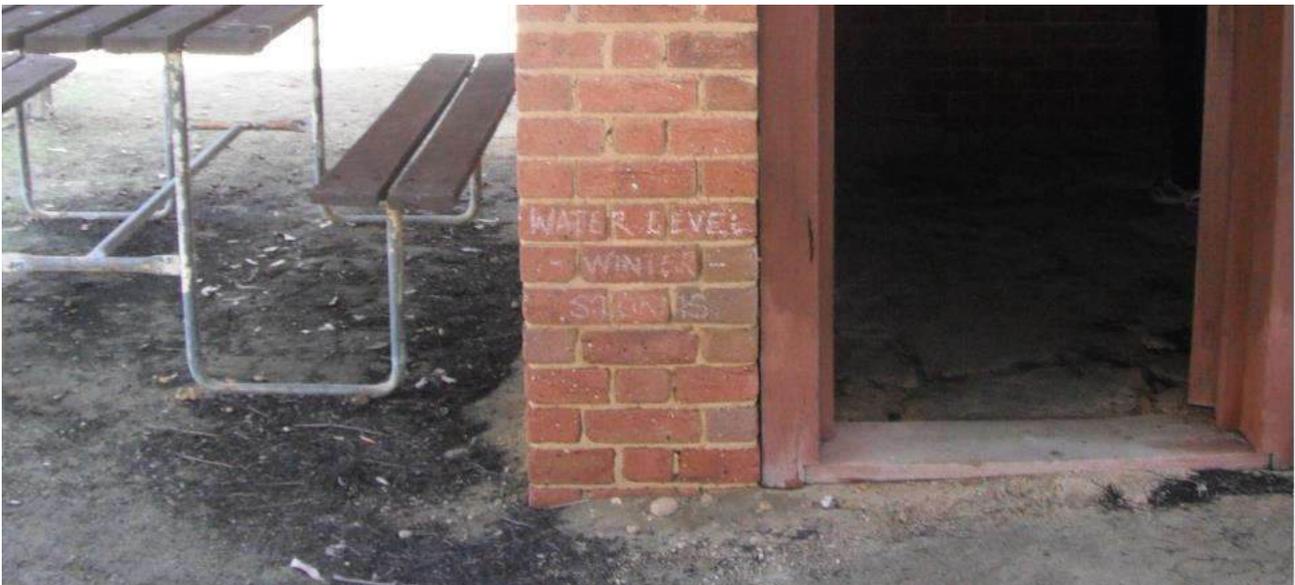
Figure 2-1 2010 winter water levels mark on Mill building. Supplied by Shire. Estimated water depth at ~0.5m above land surface assuming ~8cm per course of bricks.

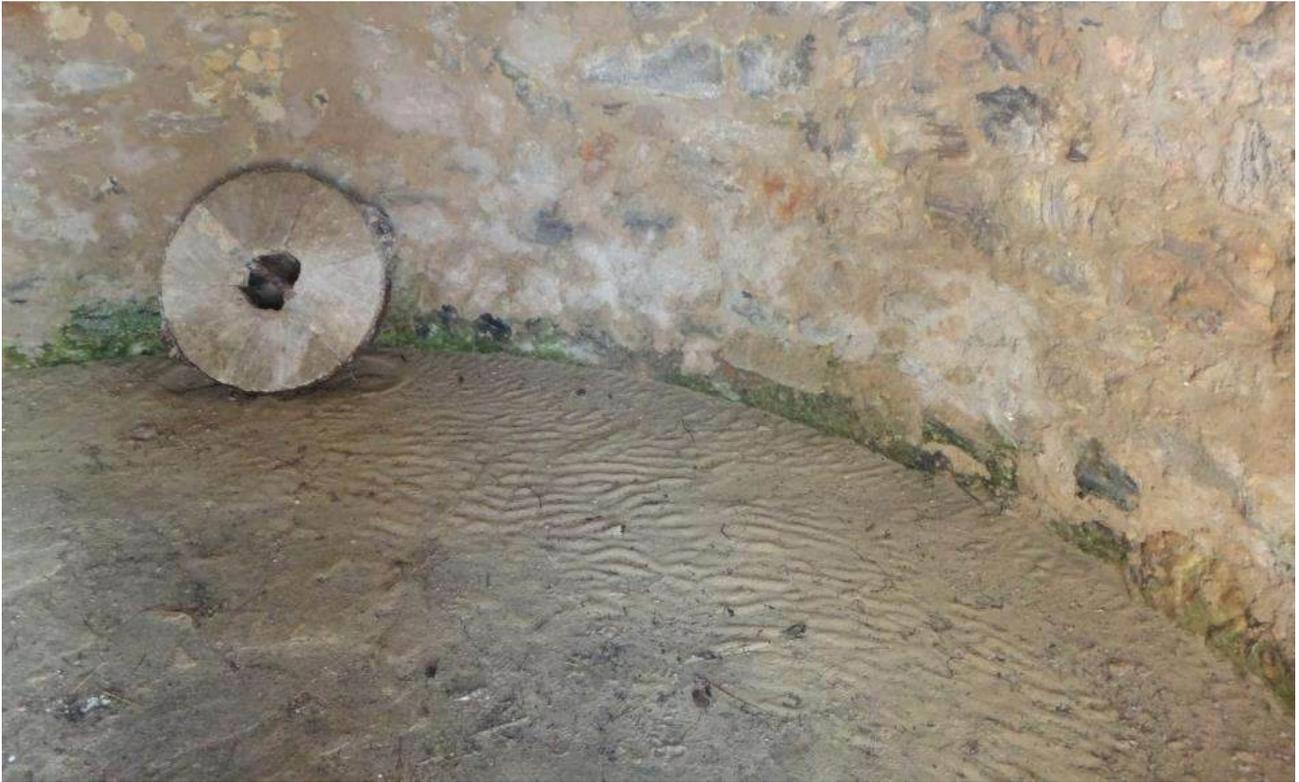
Figure 2-2 Winter 2011 – Evidence of water flow leaving sand ripples inside Mill engine building. Supplied by Shire.

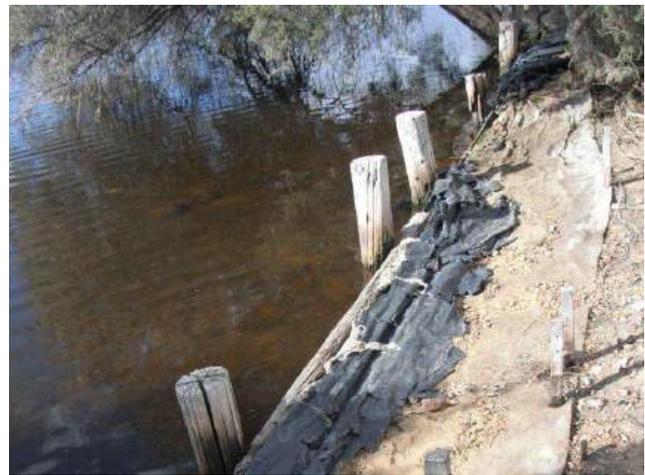
Figure 2-4 Winter 2011 – Northern revetment. Overtopping evident. Supplied by Shire.

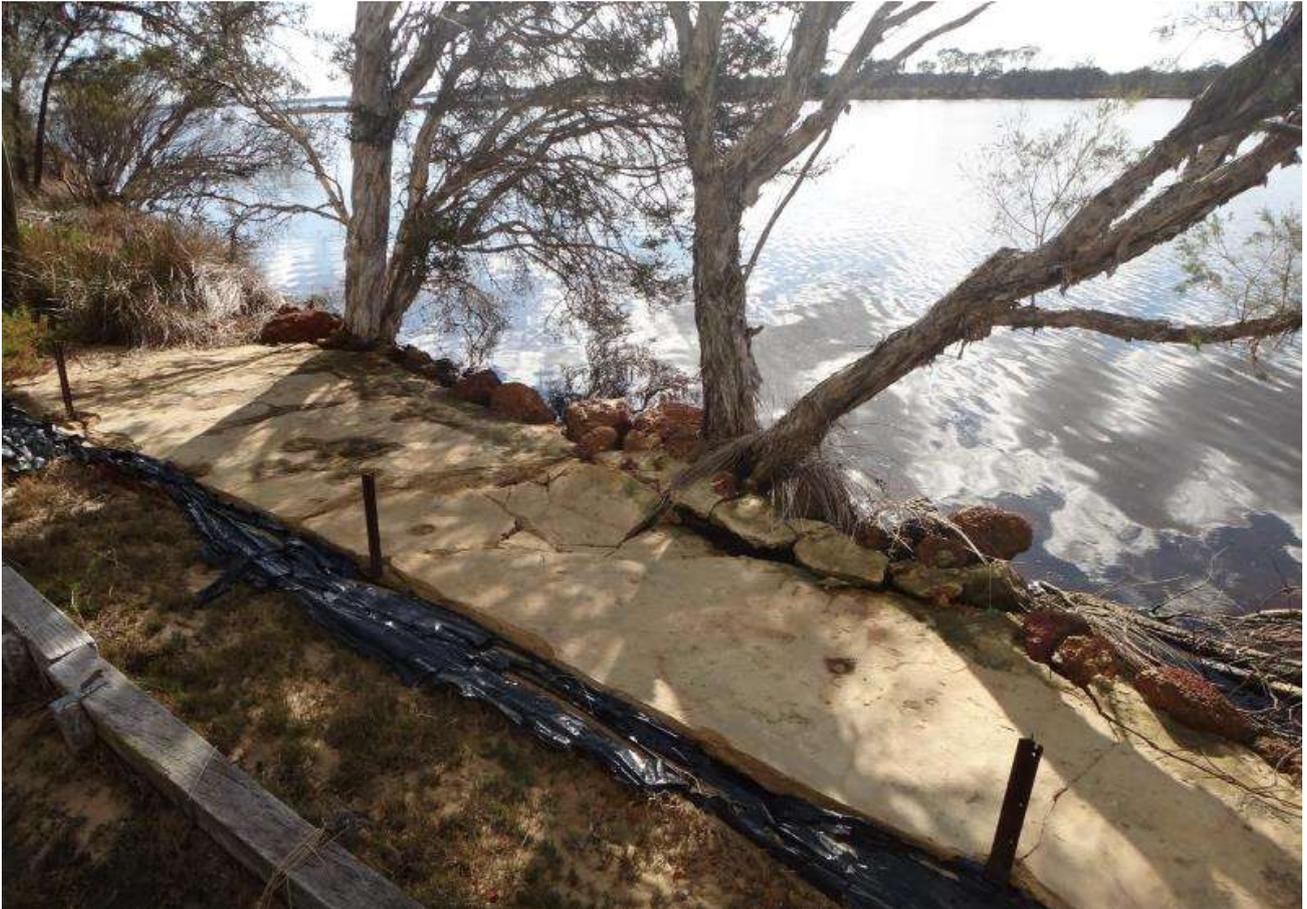
Figure 2-5 Winter 2011 – Northern revetment. New concrete capping installed. Supplied by Shire.

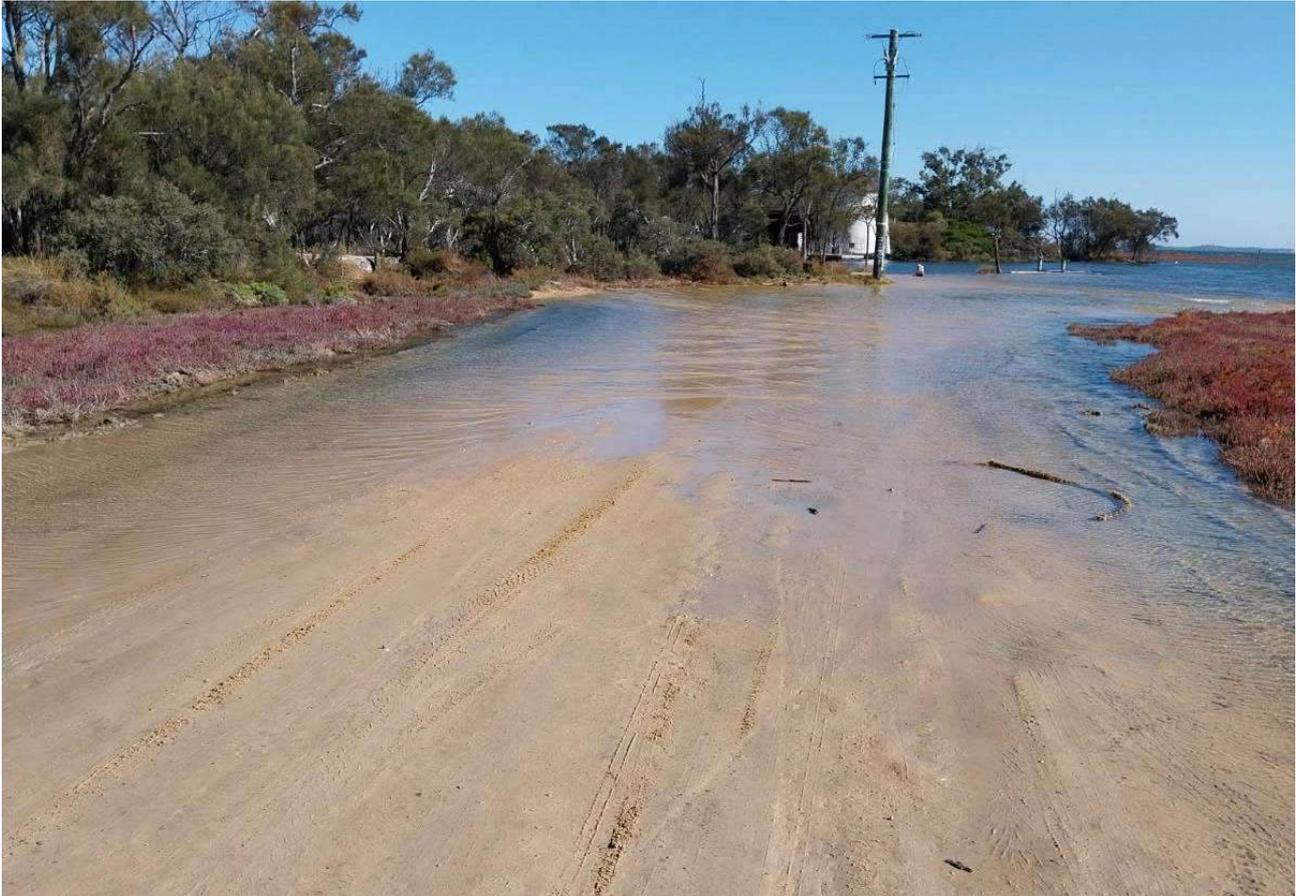
Figure 2-15 End of Tonkin Drive looking towards Cooper's Mill; Monday 12/5/2025 (Supplied by community member)

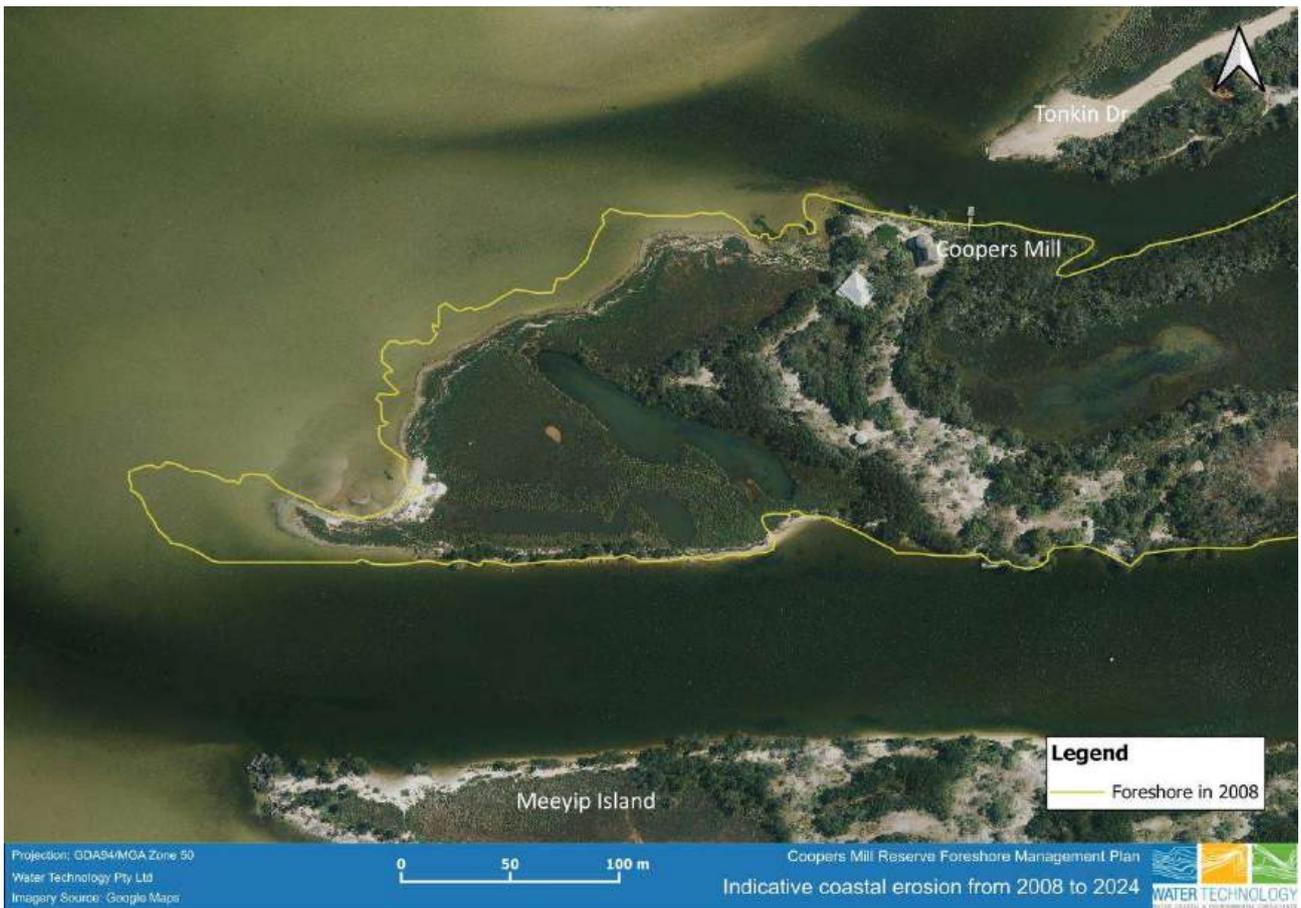
Figure 2-16 Indicative coastal erosion between 2008 and 2024. The yellow outline shows where the foreshore was in 2008 in comparison with the satellite image taken in November 2024 (Metromap). This is indicative and water level comparisons and adjustments have not been made.

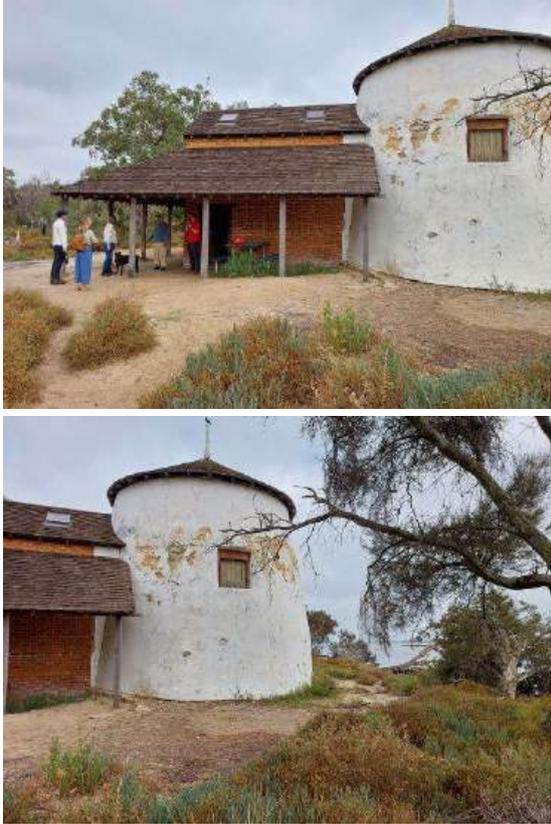
Location	Photos	Comments
Cooper's Mill

<ul style="list-style-type: none"> ▪ Water from estuary comes inside Mill building often – approximately 5 to 10 times most winters (John L). Up to ~1.0m deep (2007 marked on bricks) and can linger days to a week or so. ▪ Need to remove seaweed / wrack and sand from Mill after flooding / overtopping events ▪ The round Mill engine room is approximately 6m back from the old timber wall – erosion management here is likely to be key. ▪ Overtopping at this location seems to be the primary pathway for estuary water and energy to reach and enter the Mill. Management of this area will be key to reducing flooding or energy of inundation reaching structure.

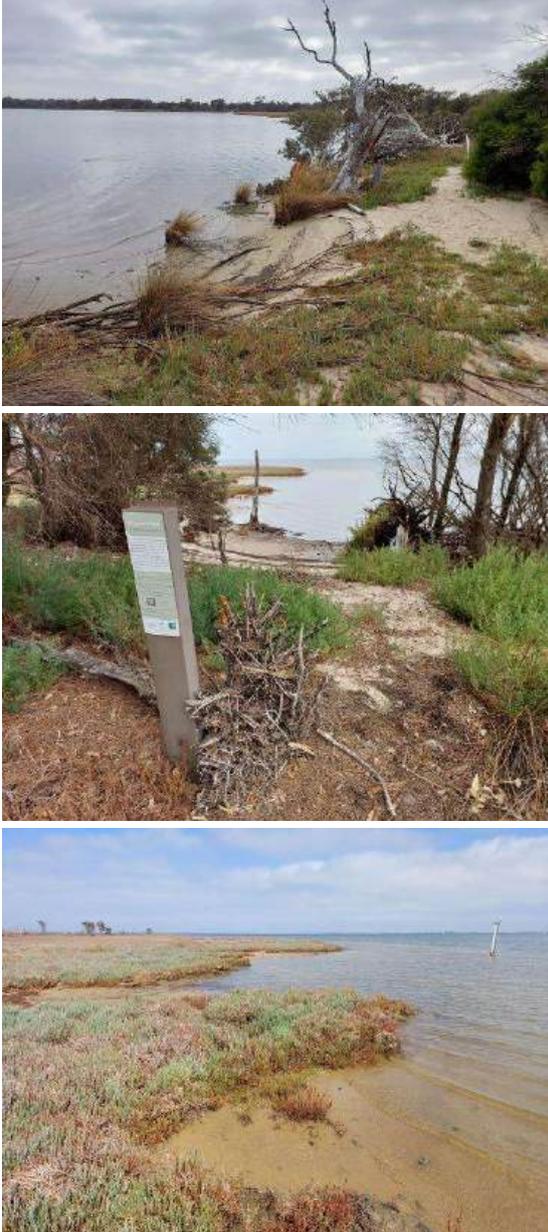
Location	Photos	Comments
Western foreshore

<p>The top photo shows a sandy beach with a dead tree trunk and some greenery. The middle photo shows a dirt path leading to a body of water with a signpost. The bottom photo shows a wide view of a tidal estuary with marshland and a boat in the distance.</p>	<ul style="list-style-type: none">▪ Largely a natural setting comprising tidal estuary samphire marsh backed by some woodland including tree species such as <i>Causarina obesa</i> and <i>Melaleuca raphiophylla</i>.▪ Evidence of tree roots being undermined from gradual sediment erosion, resulting in trees falling into estuary.

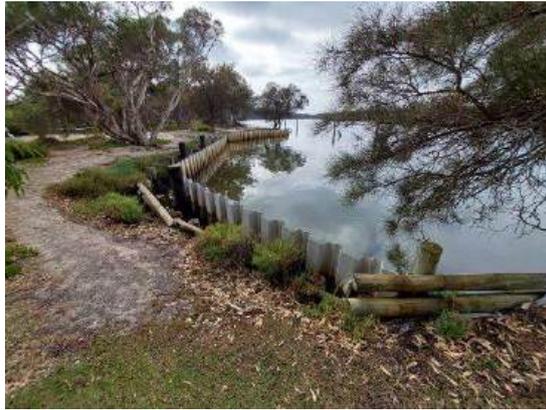
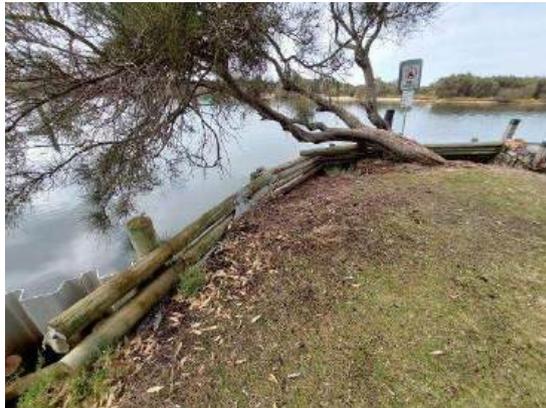
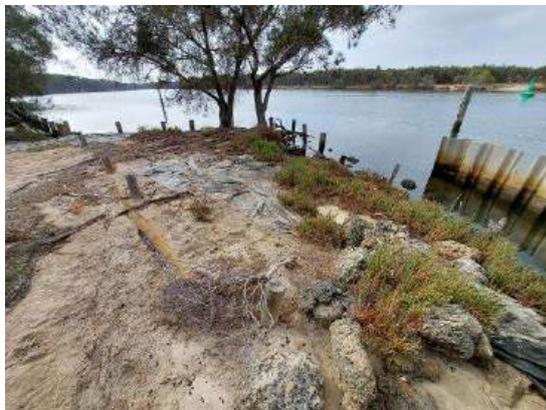
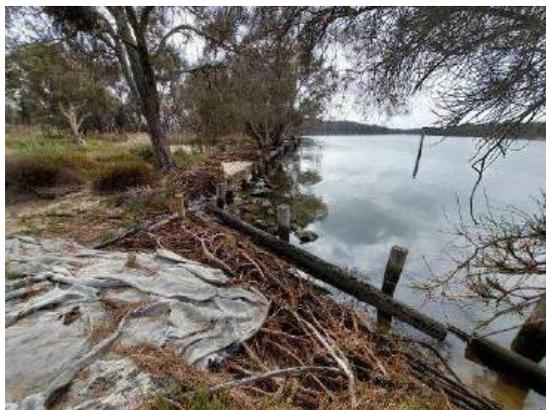
Southern foreshore seawalls

- At east end there is ~35m PVC sheet pile wall (SPW - some damaged, not backfilled properly) crest height estimated at ~1.4mCD. This wall installed in last 20 years – other all built before ~2005.
