Report on
Site Soil Evaluation
11 Moores Road, Pinjarra WA

Project:
LGK0372024SSE
Rev_0

Client:
Method Planning

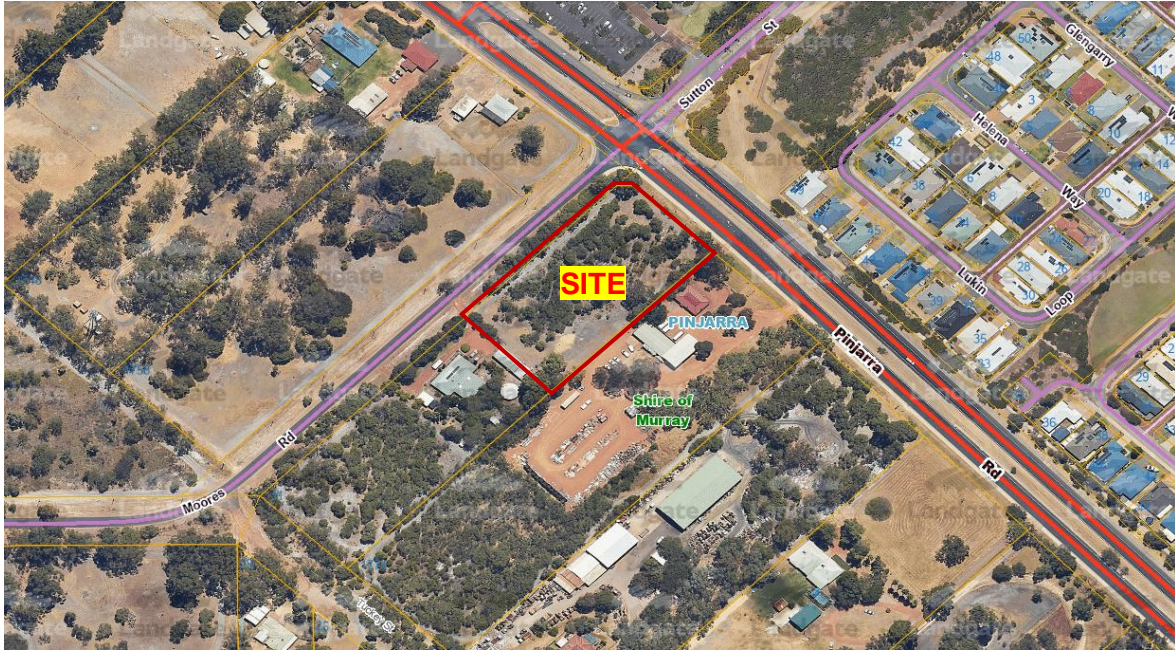
Figure 1. Aerial View of the Site Location (Source: Landgate Map)

Method Planning commissioned Local Geotechnics (LG) to prepare a Site Soil Evaluation report for 11 Moores Road, Pinjarra WA (the project). The site location is shown in Figure 1. The proposed construction will be the Pinjarra Veterinary Hospital, the site plan is attached in Appendix A.

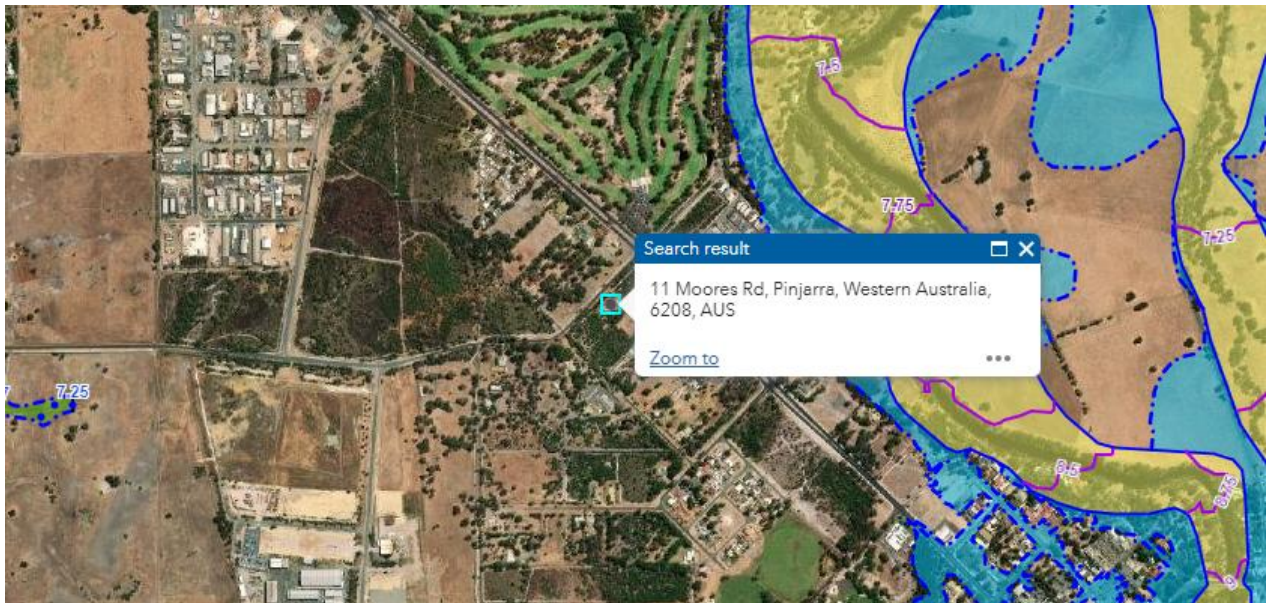
The site is not located within a floodplain according to the Western Australia Flood Plain Mapping database. The Flood Plain Mapping are shown in Figure 5.

Figure 5. Flood Plain Mapping (Source: Department of Water and Environmental Regulation)

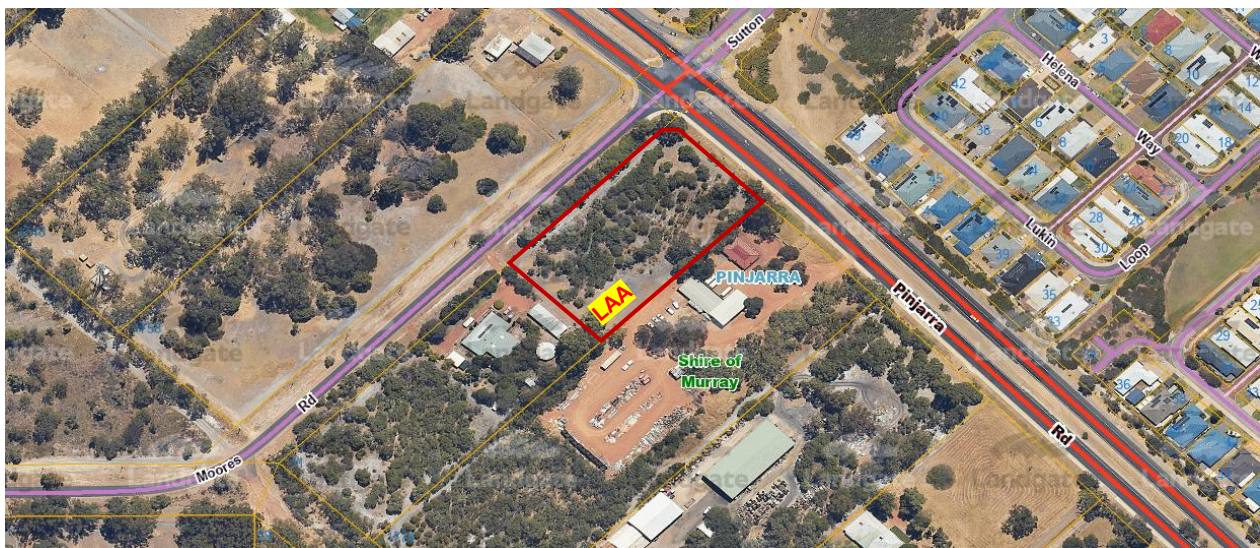
Figure 8. Proposed Land Application Area (LAA)

LAA for this site is **140 m²**. The proposed location of LAA is shown in Figure 8. **The proposed location in Figure 8 is indicative. Location of effluent system remains at the discretion of the future landowner and effluent system designer.**

Location of ATU system at the discretion of the future landowner as long as the setback distance from environmental and structural landmarks should be assessed in accordance with the Government Sewerage Policy (GSP) 2019. Which states that any on-site sewerage system is not to be located within:

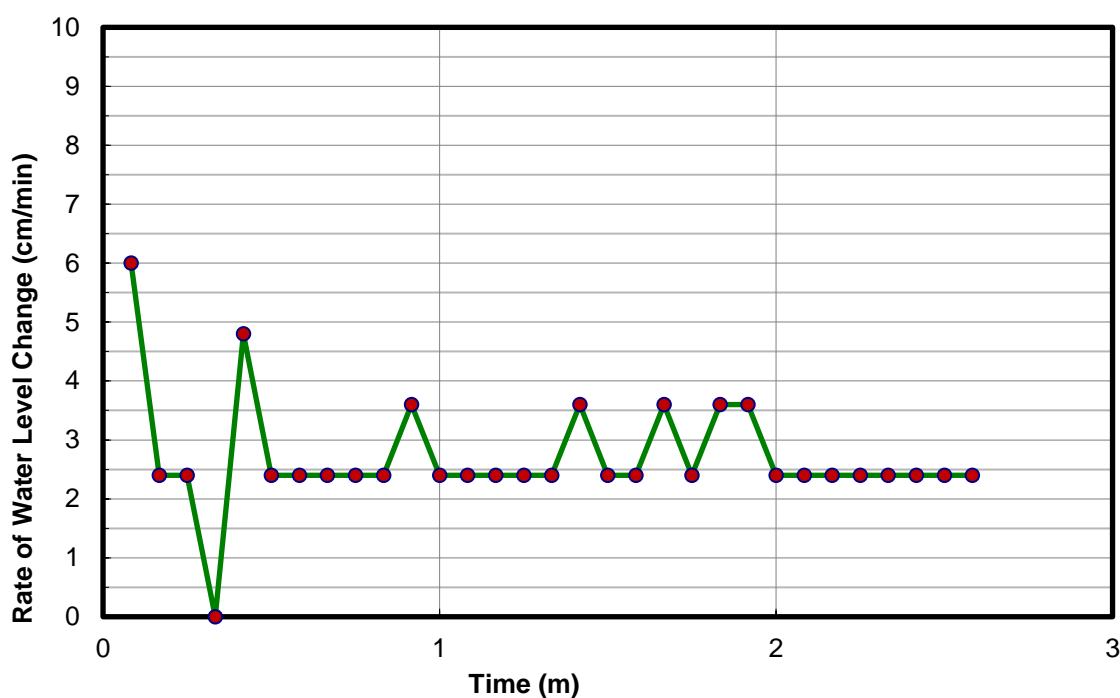
Notes: Test was conducted at a depth of 0.3 m from the existing surface level

Water Hydraulic conductivity K_{fs} : **7.1E-05** m/sec
6.2E+00 m/day

It is assumed that site soil was fully saturated during the field permeability test. Permeability test result is summarised in Table 2 and the test certificate is presented in Appendix B.

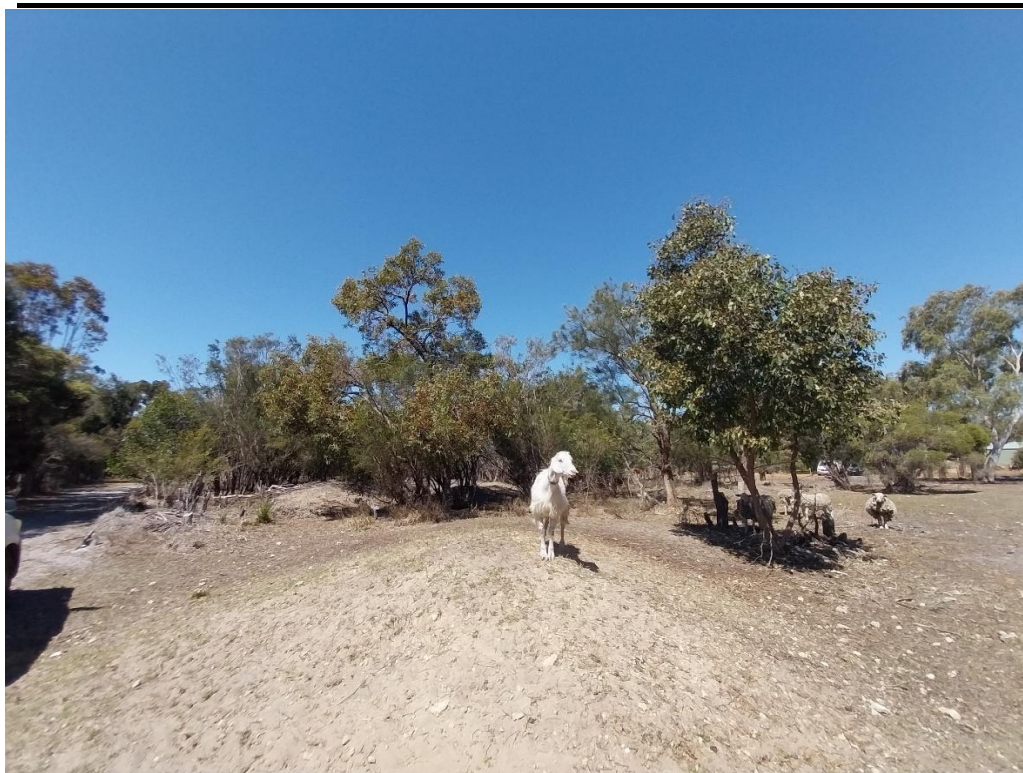
Photo 2. General Site Condition

The surface condition and the overall topography of the site are generally flat. There are medium to large sizes trees can be observed at the time of investigation. The site boundaries are enclosed with fences. There are surrounding houses adjacent to the property.

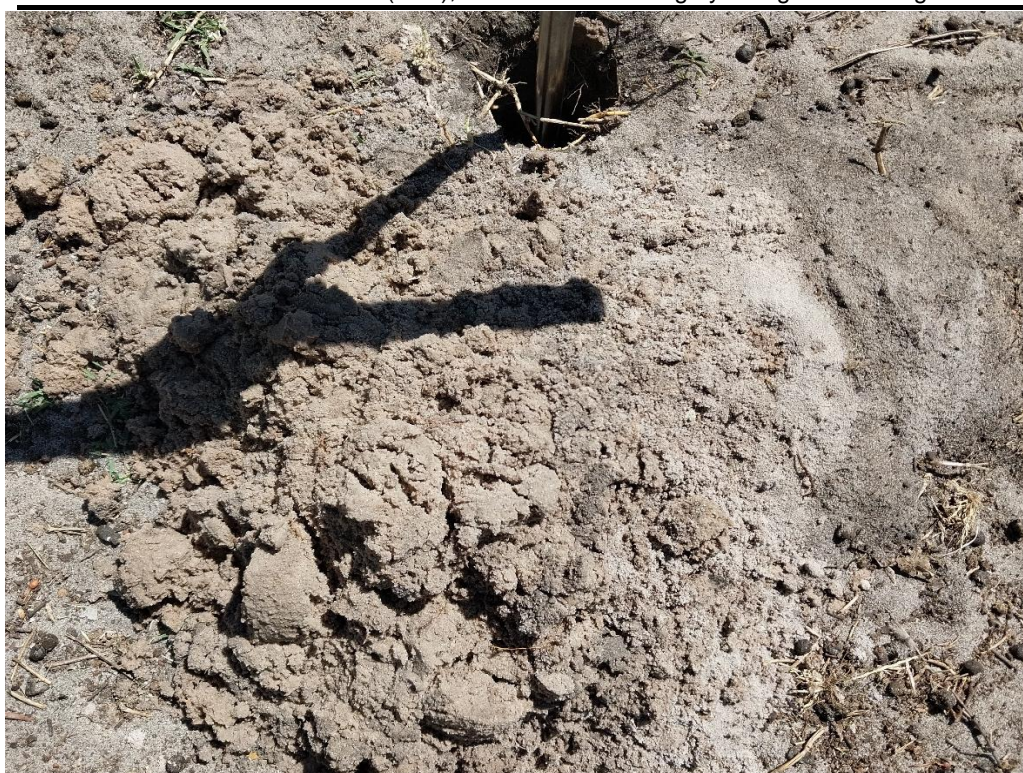
Photo 4. Soil from Test Location 02 (TH2)

- **Topsoil, Silty SAND (SM)** – fine to medium grained, grey, with low plasticity silt, grass and roots, slightly moist, loose to dense, up to a depth of 0.1 m; followed by
- **Silty SAND (SM)** – fine to medium grained, grey, with low plasticity silt, slightly moist, loose to dense, up to a depth of 0.5 m; followed by
- **SAND (SP)** – fine to medium grained, pale grey to pale brown, slightly moist to wet, loose to dense, up to the maximum investigated depth.
