Metro Outer Development Assessment Panel Agenda

Part B – Item 3.1 – LOT NO. 89 (NO. 11) MOORES ROAD, PINJARRA – PROPOSED VETERINARY CENTRE

Form 1 – Responsible Authority Report (Regulation 12)

PINJARRA VETERINARY HOSPITAL
@
11 MOORES ROAD, PINJARRA

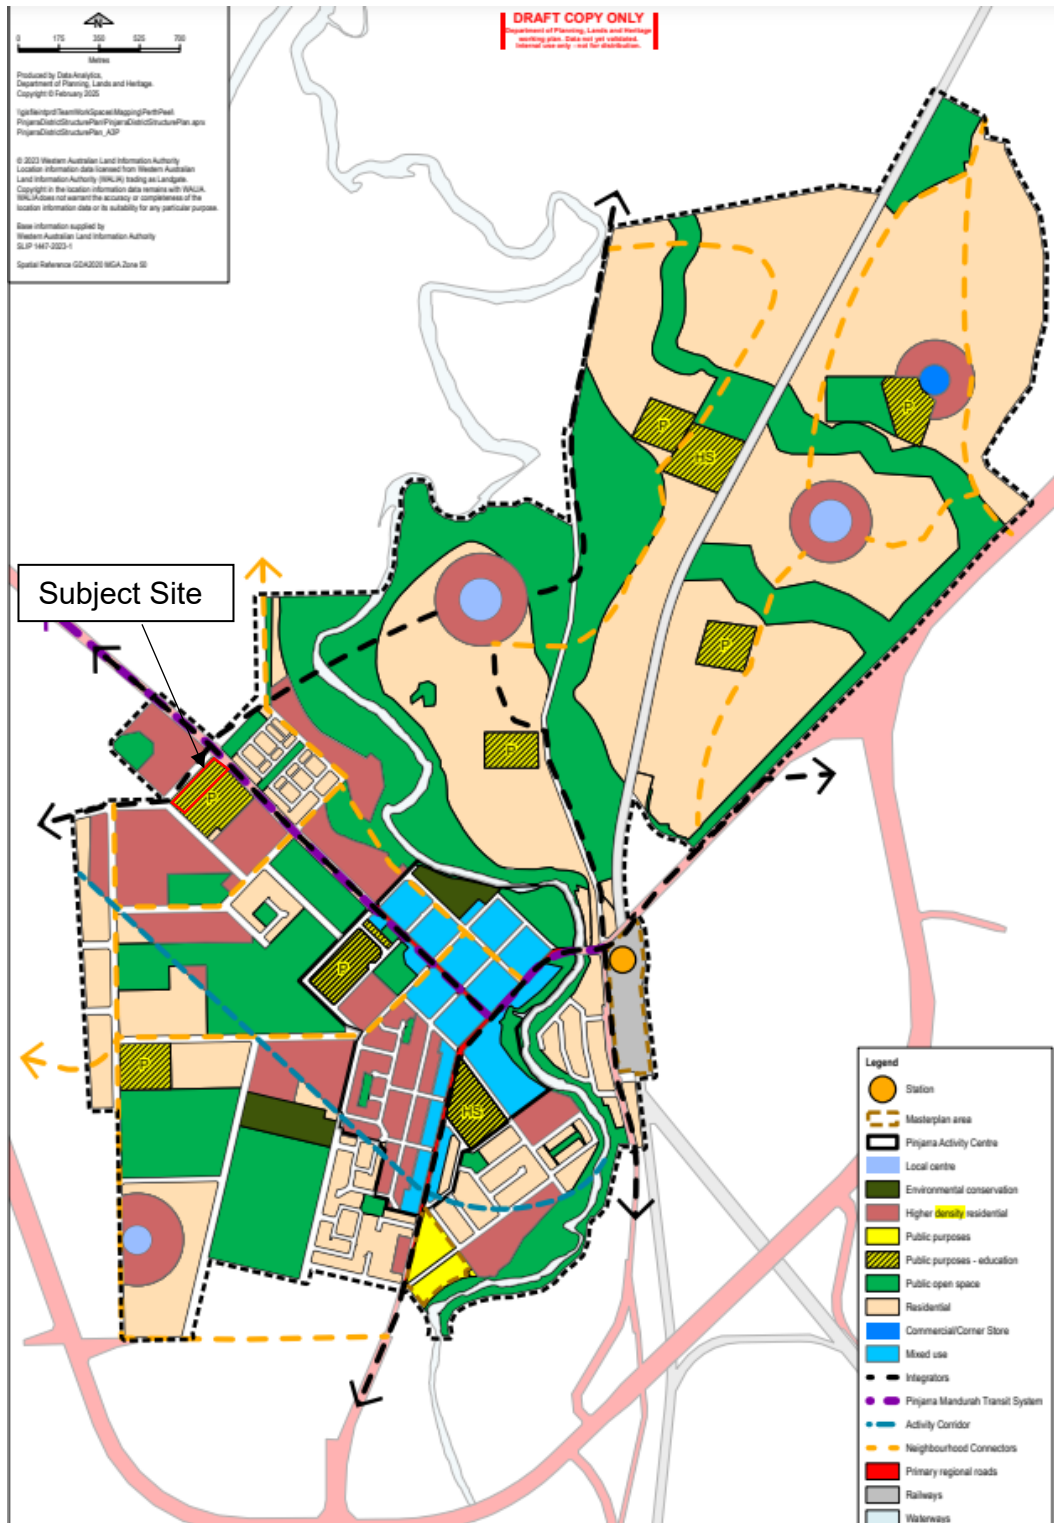
4. Draft District Structure Plan Map under Draft PDSP.

The subject site has been identified within the draft PDSP as a future Primary School site (**Figures 4, 5 & 6**). The Department of Education (DoE) originally raised concerns with the proposed location as Pinjarra Road is a Primary Regional Road and *operational Policy 2.4 Planning for School Sites* and *Liveable Neighbourhoods* do not recommend schools in such locations due to traffic safety. After receiving the advice, the Shire undertook further investigations which concluded that:

The Shire, however, notes that the acoustic report fails to consider the sites location within a future higher density residential precinct under the PDSP (**Figure 4**). If the adjoining site at Lot 88 (1774) Pinjarra Road, Pinjarra was to be developed to a R40 standard this would introduce additional dwellings directly adjacent to the site. This represents the potential for significant future land use conflicts that may fetter the ability to deliver urban land and will impact the amenity of future residents.

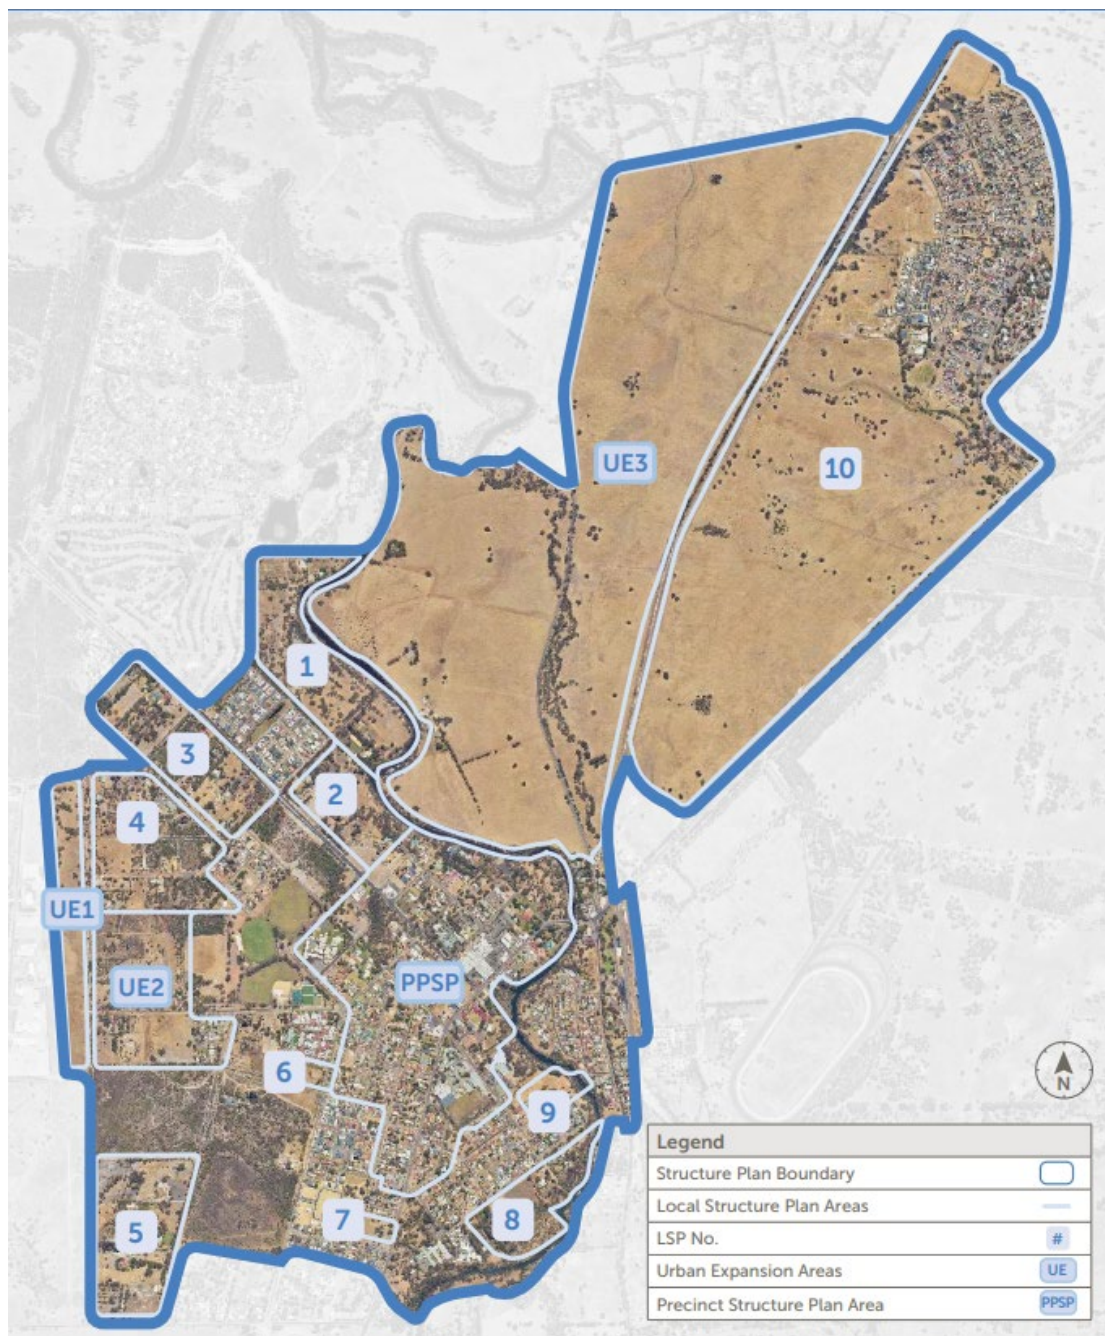
7. Structure Plans Areas under Draft PDSP

- There is not enough unconstrained land within draft PDSP Precincts LPS1 and LPS2 (**Figure 7**) to accommodate a Primary School.
- LPS precincts 4 and 5 under the draft PDSP both have valid Structure Plans that currently do not contain a primary school and can currently be implemented. It is therefore impractical and unreasonable to retroactively designate a new primary school within these precincts.
- If the proposed school in LPS3 was moved to LPS4 (despite not being provided in the approved structure plan) it would cause the school in urban expansion area 2 to move to LPS5 (also no approved school) which is on the urban periphery.
- If the proposed school is removed there will be an undersupply of Primary Schools.

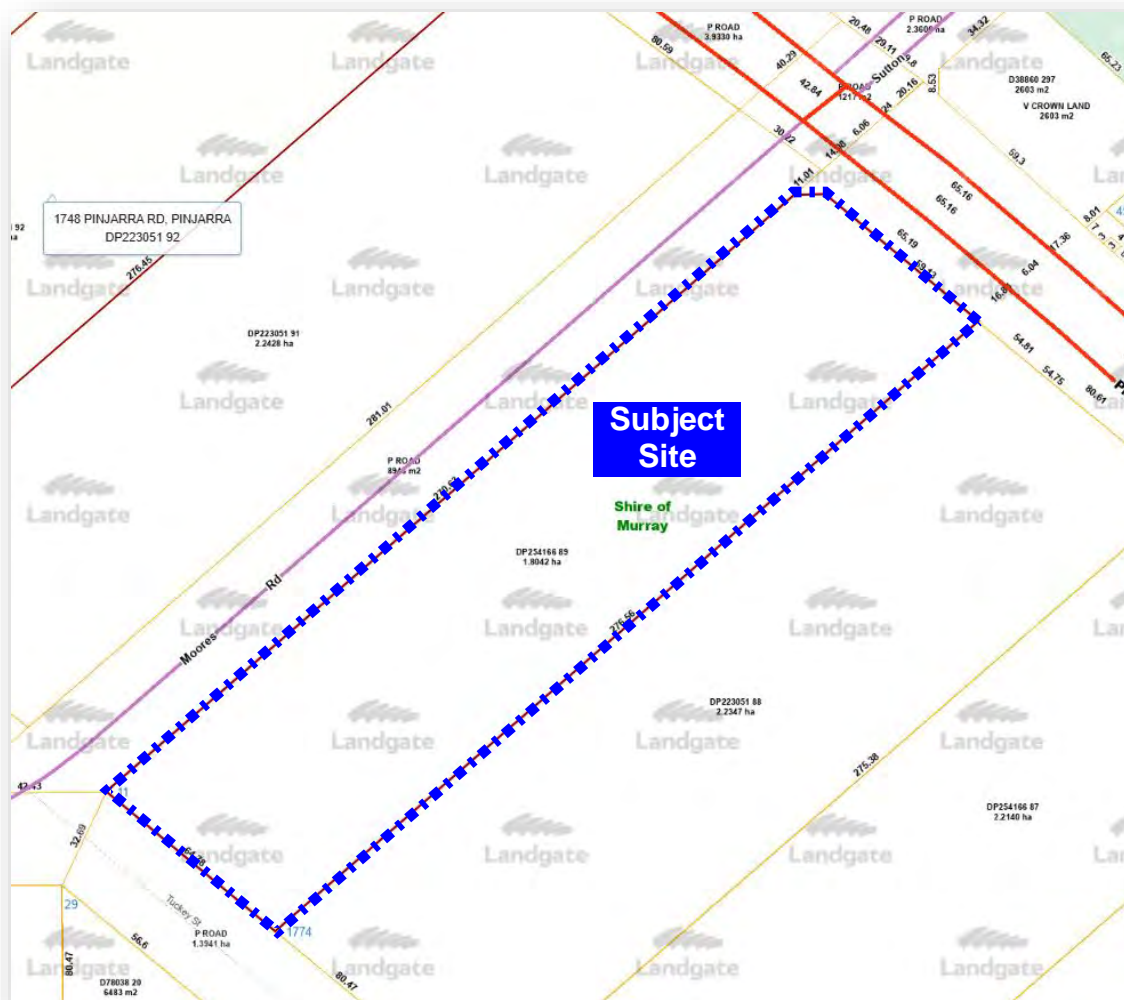
Figure 1 – Cadastral Boundaries

Please refer to **Appendix B – Certificate of Title** and **Appendix C – Site Feature Survey**, as well as **Figure 1** below showing cadastral boundaries and **Figure 2 –Aerial Photo**. See also photos for the site and surrounds in **Plates 1-6**.

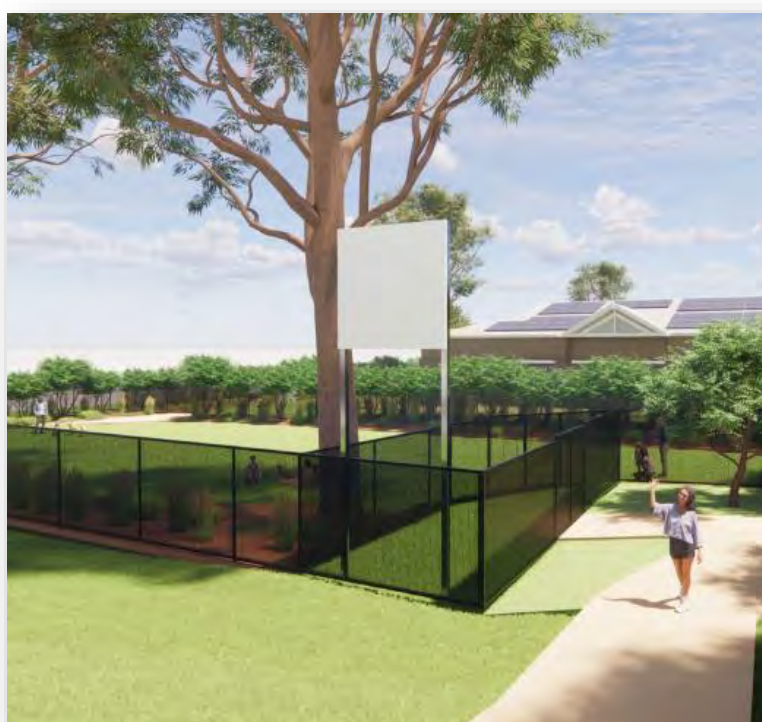
Figure 10 – Pylon Sign on Pinjarra Road

The sign meets the objectives of the LPP – Signs as follows:

- The sign is adequate and effective for business identification needs and is similar or smaller than other pylon signs along Pinjarra Road.
- It minimises visual clutter and rationalises the overall number of signs to one per street frontage.
- The design is of a high standard and presentation and is integrated with and does not dominate built form.
- Ensures that the character and amenity of the Shire is not eroded by excessive or poorly designed or located signs.
- The sign is sympathetic and harmonious with the site and surrounding environment.
- The location and size is not hazardous to cyclists, pedestrians or motorists.

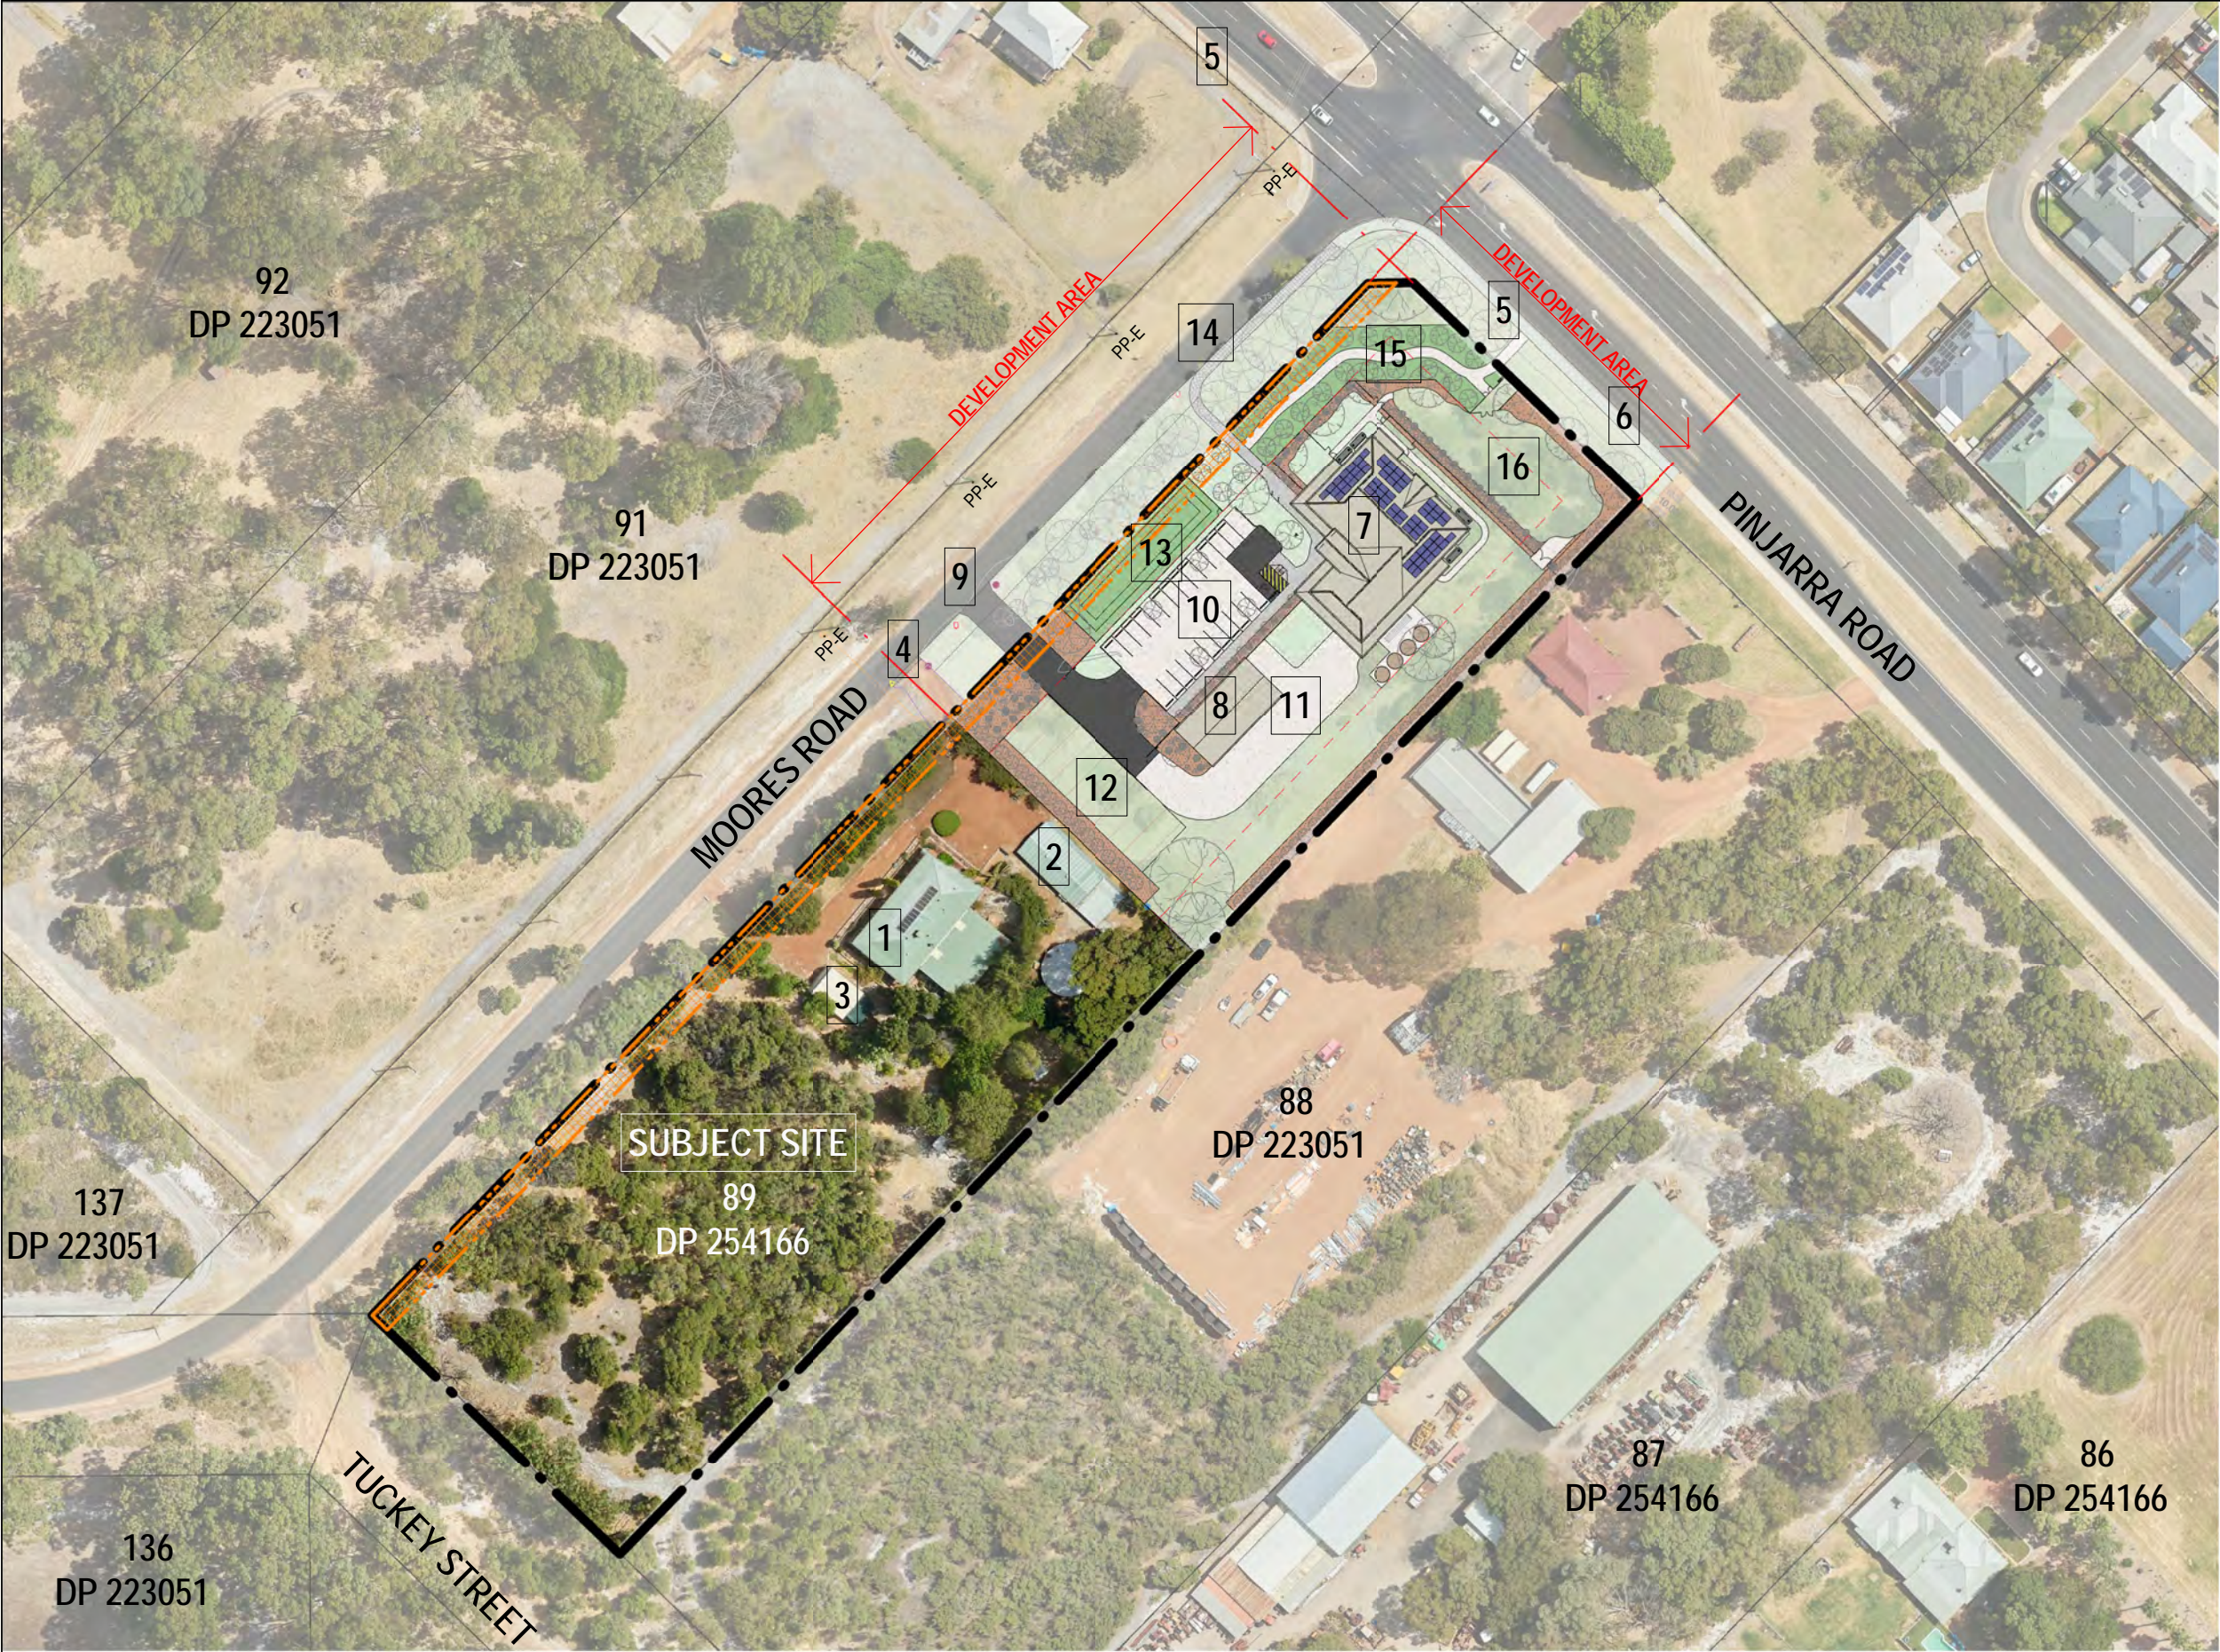
DEVELOPMENT PROPOSAL SUMMARY	
EXISTING CONDITIONS	
SUBJECT SITE ADDRESS: 11 MOORES ROAD, PINJARRA , WA . 6208	
LOT: 89 ON DP254166	SITE AREA: 18,042.16m2
LOCAL AUTHORITY: SHIRE OF MURRAY	
LPS ZONE: RURAL / URBAN DEFERRED	
PROPOSED	
DEVELOPMENT AREA: APPROXIMATELY 7,546m2	
DESCRIPTION: NEW VETERINARY HOSPITAL & MAINTENANCE SHED	
PROPOSED DEVELOPMENT AREA SITE COVERAGE:	
VETERINARY HOSPITAL:	595m2
MAINTENANCE SHED:	147m2

LEGEND:	
1.	EXISTING RESIDENCE
2.	EXISTING SHED 1
3.	EXISTING SHED 2
4.	EXISTING DRIVEWAY CROSSOVER
5.	EXISTING PUBLIC FOOTPATH
6.	EXISTING BUS STOP
7.	VETERINARY HOSPITAL
8.	MAINTENANCE SHED
9.	NEW DEVELOPMENT CROSSOVER
10.	CARPARK
11.	STAFF & SERVICES ACCESS
12.	ON-SITE SEWER MANAGEMENT ZONE (OSSM)
13.	STORMWATER MANAGEMENT RESERVE
14.	PUBLIC FOOTPATH EXTENSION (BY COUNCIL)
15.	PUBLIC ORCHARD
16.	PUBLIC OFF LEASH DOG LAWN

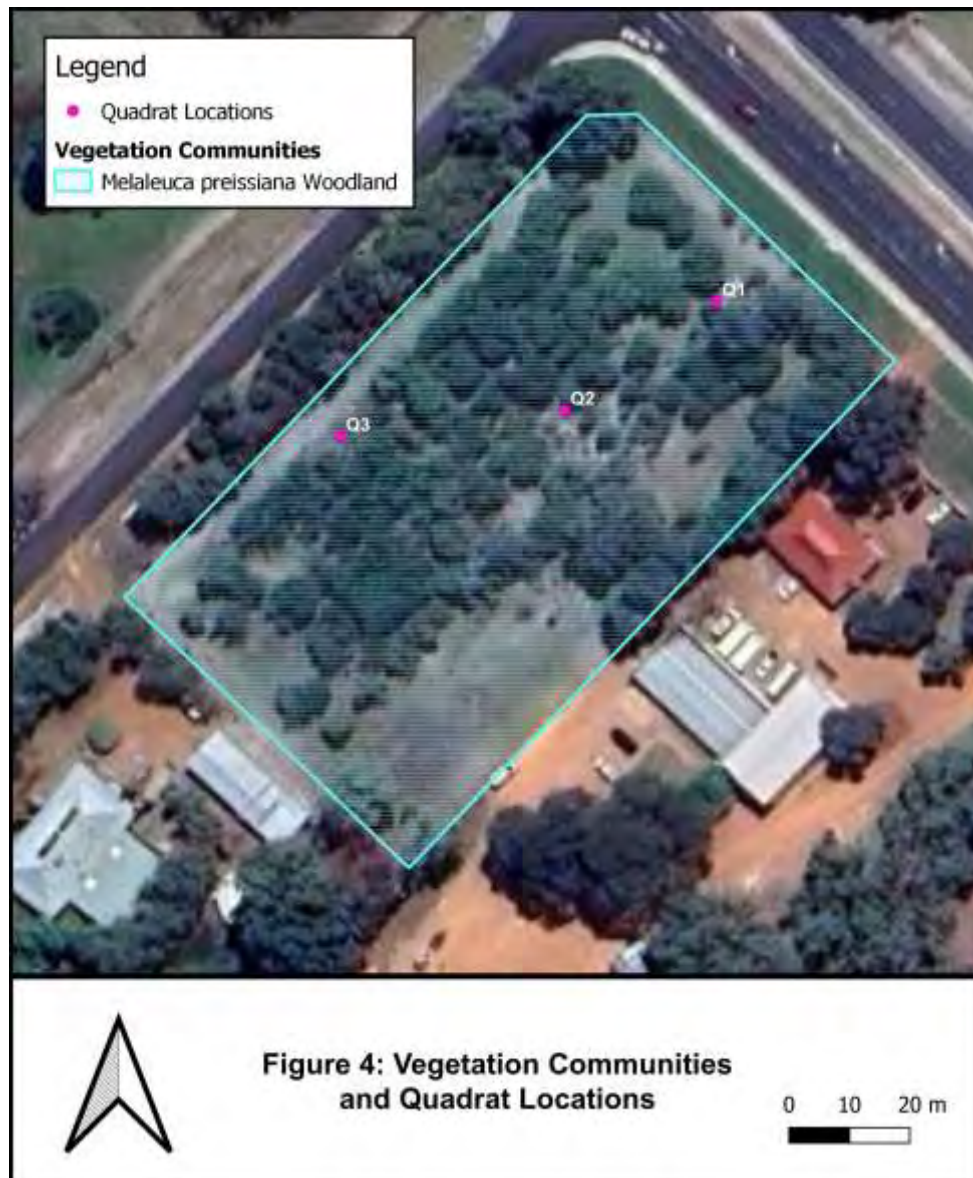
One vegetation community was represented on the site at a local level, which has been described below in **Table 10**. Photographic representations of the vegetation community are shown in the Quadrat data sheets in **Appendix B**. The vegetation community, conditions and quadrat locations are shown on **Figures 4 & 5**.

Community Description
Vegetation Community 1 –<i>Melaleuca preissiana</i> Woodland
Low woodland of <i>Melaleuca preissiana</i> over tall shrubland of <i>Kunzea ericifolia</i> over open sedgeland of <i>Chaetanthus aristatus</i> over very open herbland of <i>*Taraxacum khatoonae</i> and <i>*Hypochaeris glabra</i> .

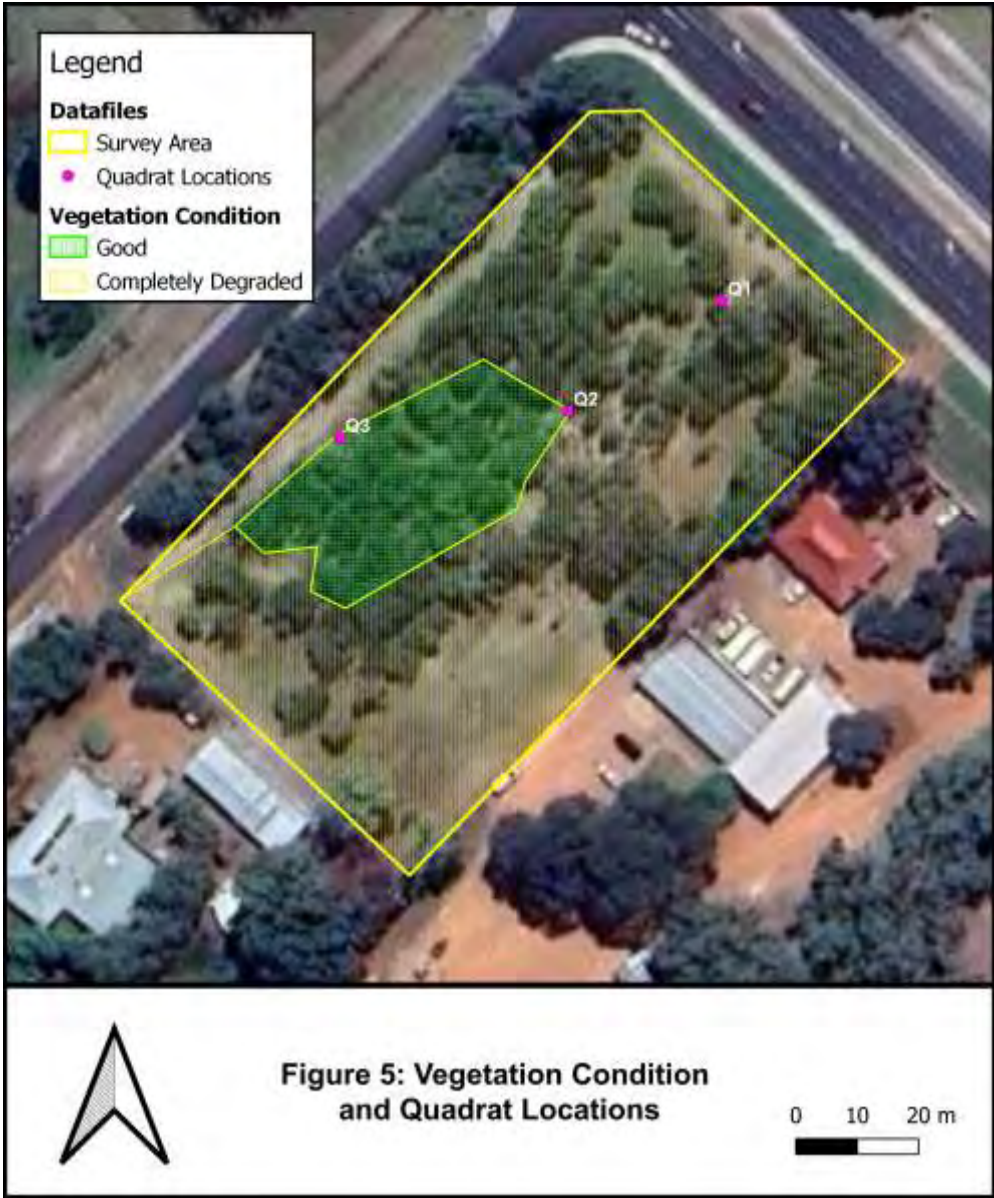
The vegetation condition recorded across the site was “Good” to “Completely Degraded”. Vegetation condition mapping is provided on **Figure 5**.

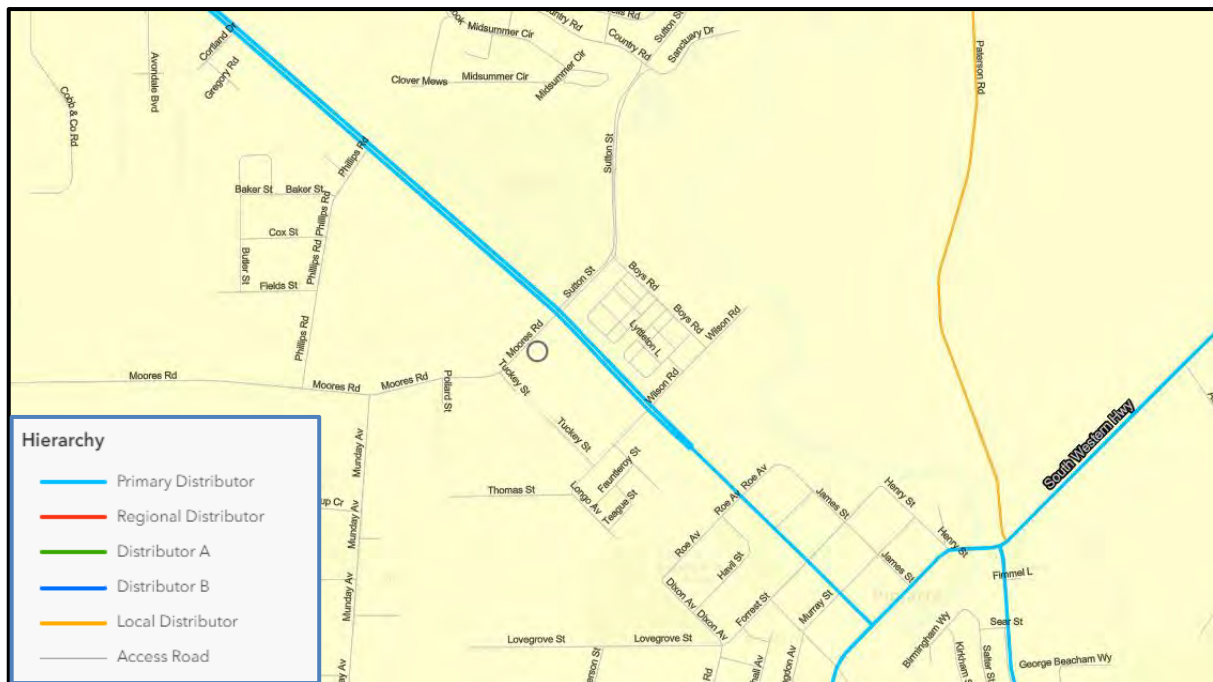
Figure 3 – MRWA Functional Road Hierarchy

Moores Road, which is located along the north-western boundary of the site, is a local road providing direct access to the local industrial precinct to the west of the site as well as access to existing rural residential properties. It has been constructed as a standard width single undivided carriageway with a 6.2m seal. Moores Road has been classified as an *Access Road* under the Main Roads WA *Functional Road Hierarchy* which is defined as a road which “...provides access to abutting properties with amenity, safety and aesthetic aspects having priority over the vehicle movement function. These roads are bicycle and pedestrian friendly and are managed by Local Government.” It operates under a speed limit of 50kph in the vicinity of the site and is owned, operated and maintained by the Shire of Murray.

An extract from the MRWA’s *Functional Road Hierarchy* is shown in **Figure 3**.

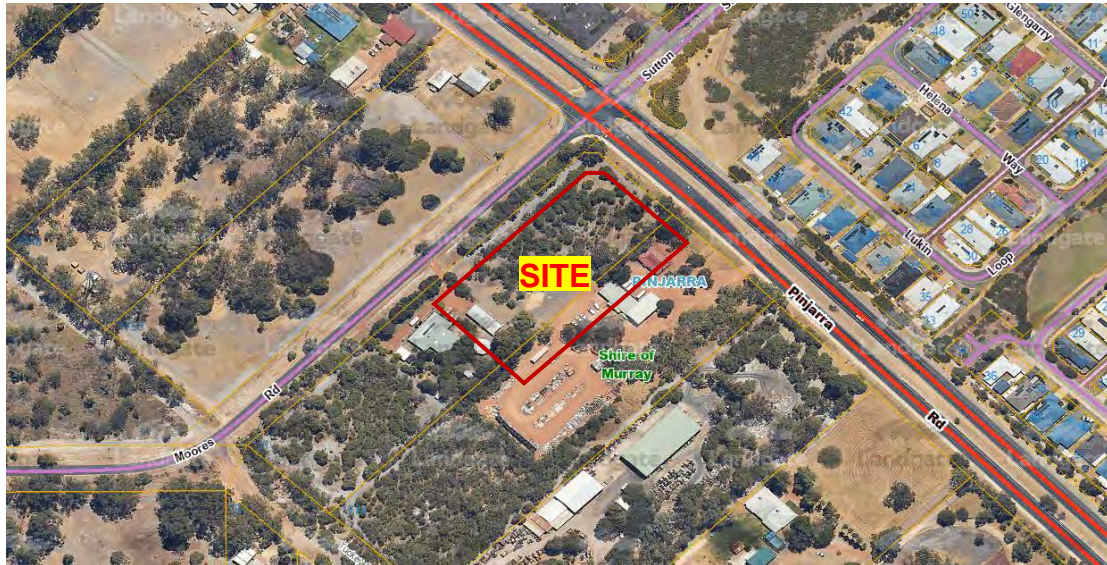
Figure 1. Aerial View of the Site Location (Source: Landgate Map)

Method Planning commissioned Local Geotechnics (LG) to prepare a geotechnical site classification report for 11 Moores Road, Pinjarra WA (the project). The site location is shown in Figure 1.

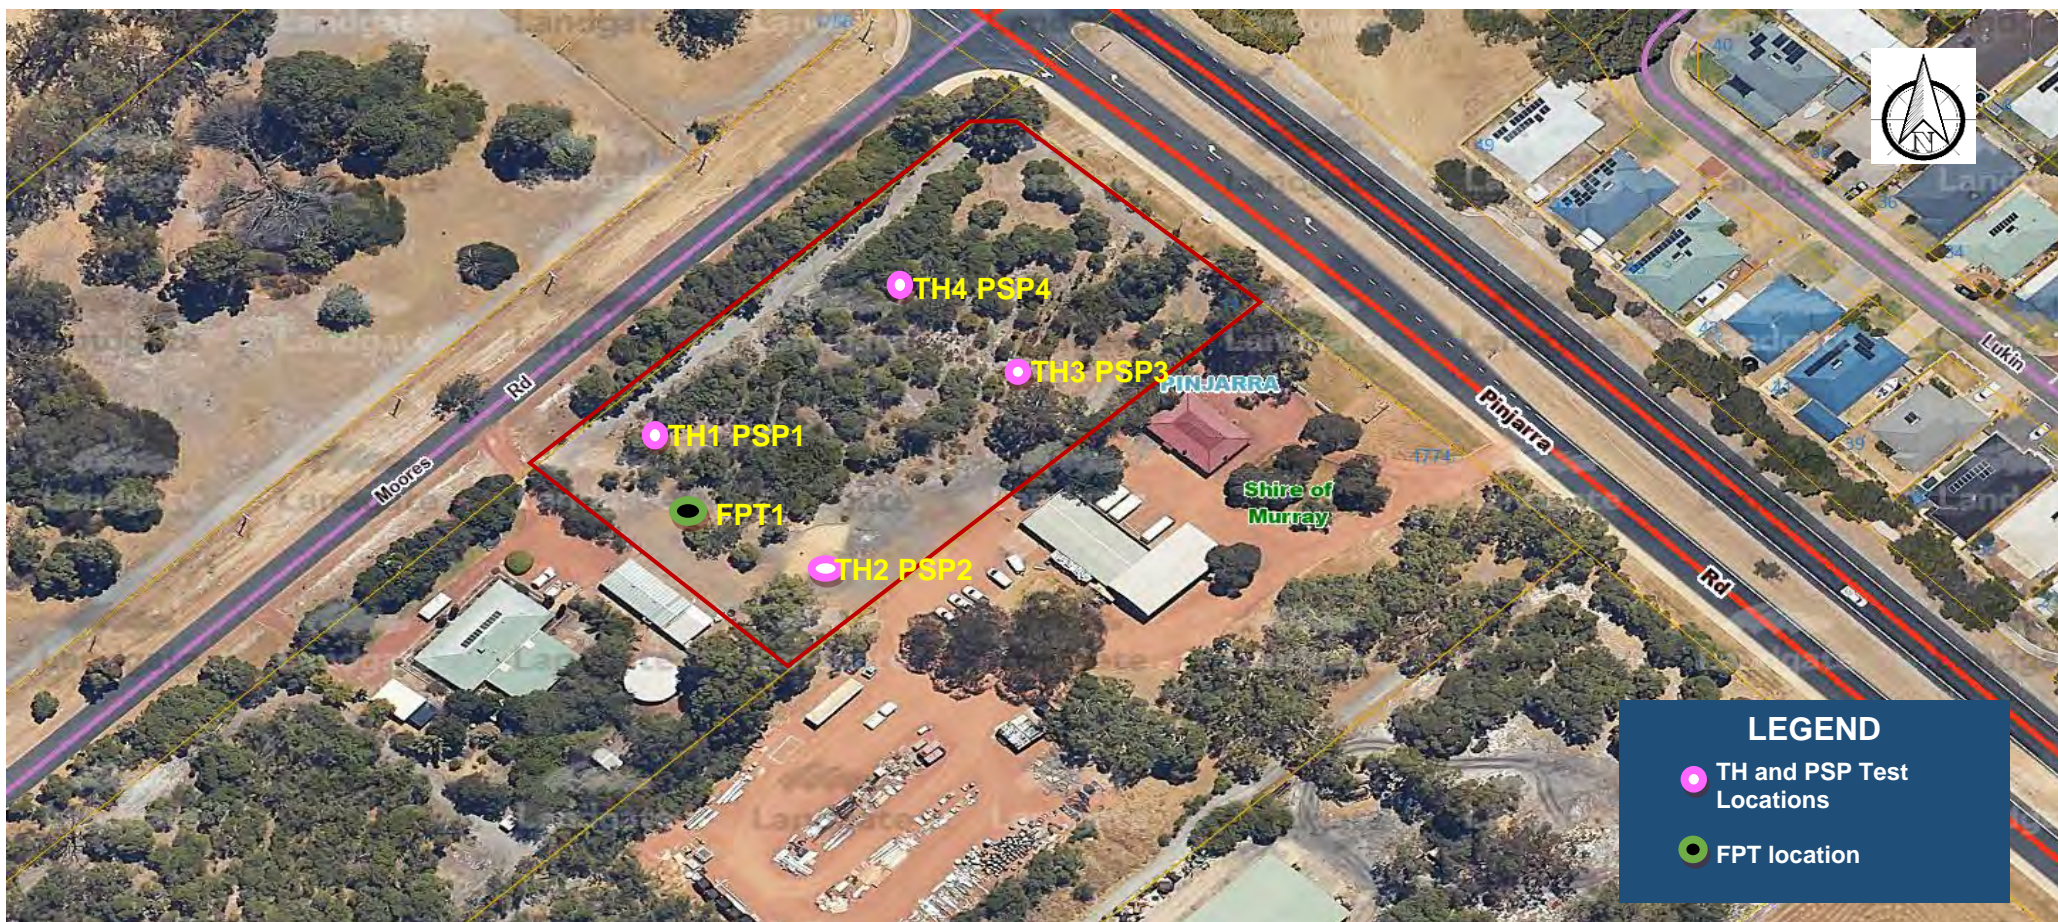
It is observed from the PSP test that the site soil is in loose to dense condition.

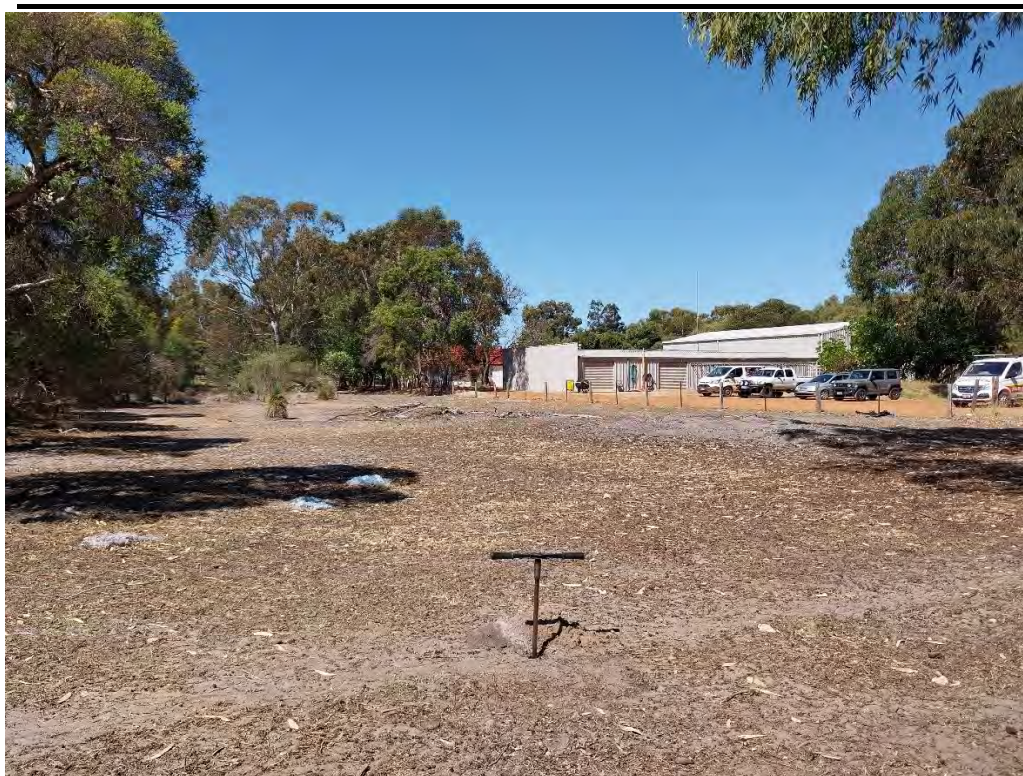
Photo 3. Test Location 02 (TH2), Sub-surface Probing by Using a Hand Auger

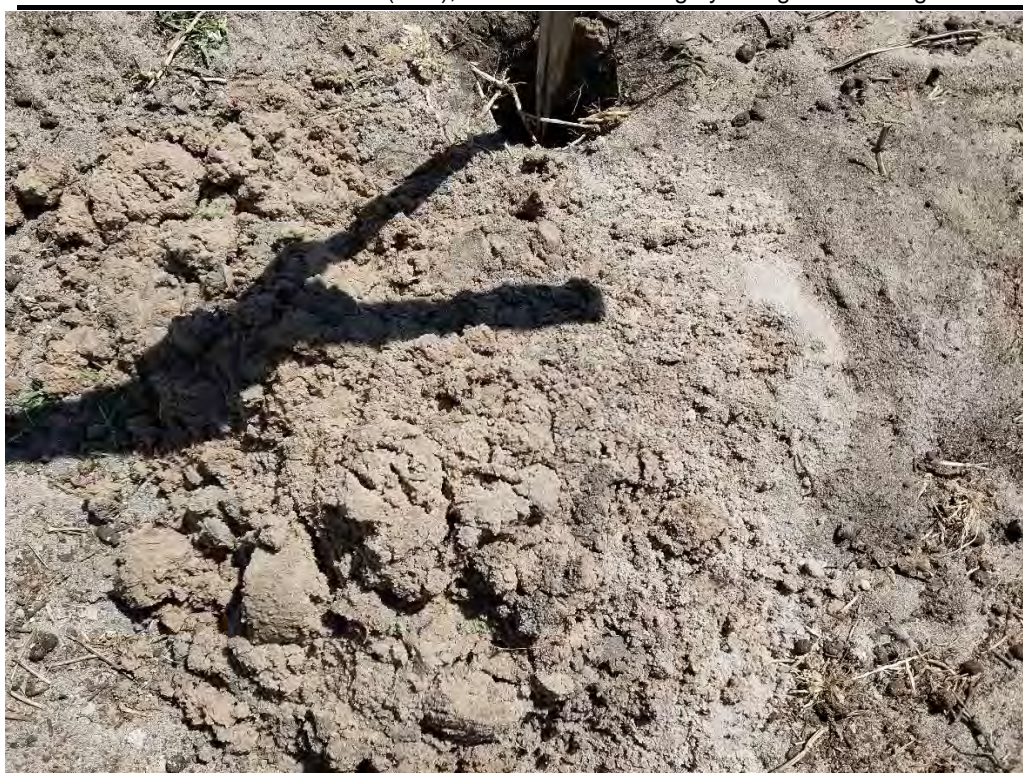
Photo 4. Soil from Test Location 02 (TH2)

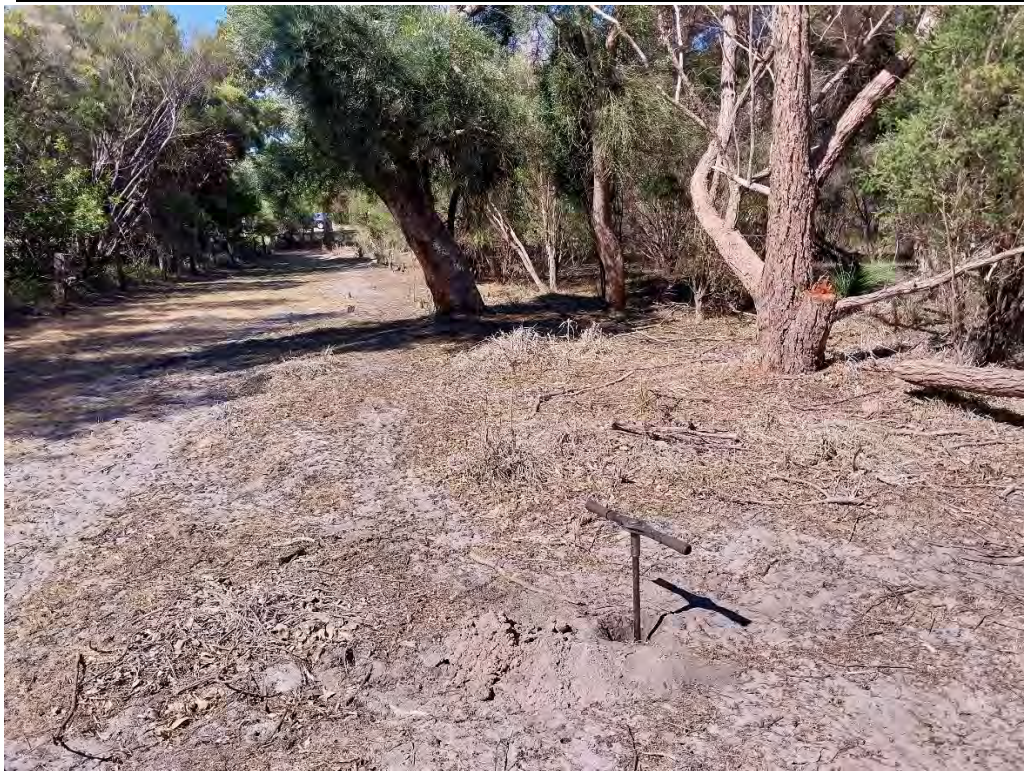
Photo 5. Test Location 04 (TH4), Sub-surface Probing by Using a Hand Auger

Photo 5. Test Location 04 (TH4), Sub-surface Probing by Using a Hand Auger

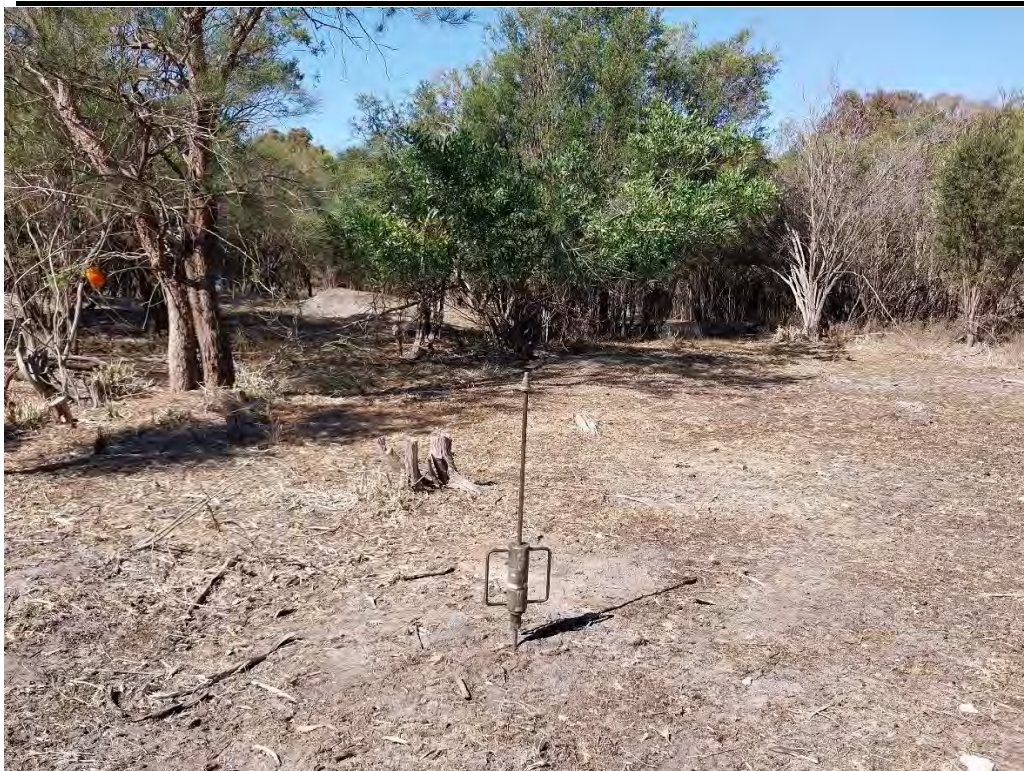
Photo 6. Test Location 04 (PSP4), Testing by Using a Perth Sand Penetrometer

Photo 6. Test Location 04 (PSP4), Testing by Using a Perth Sand Penetrometer

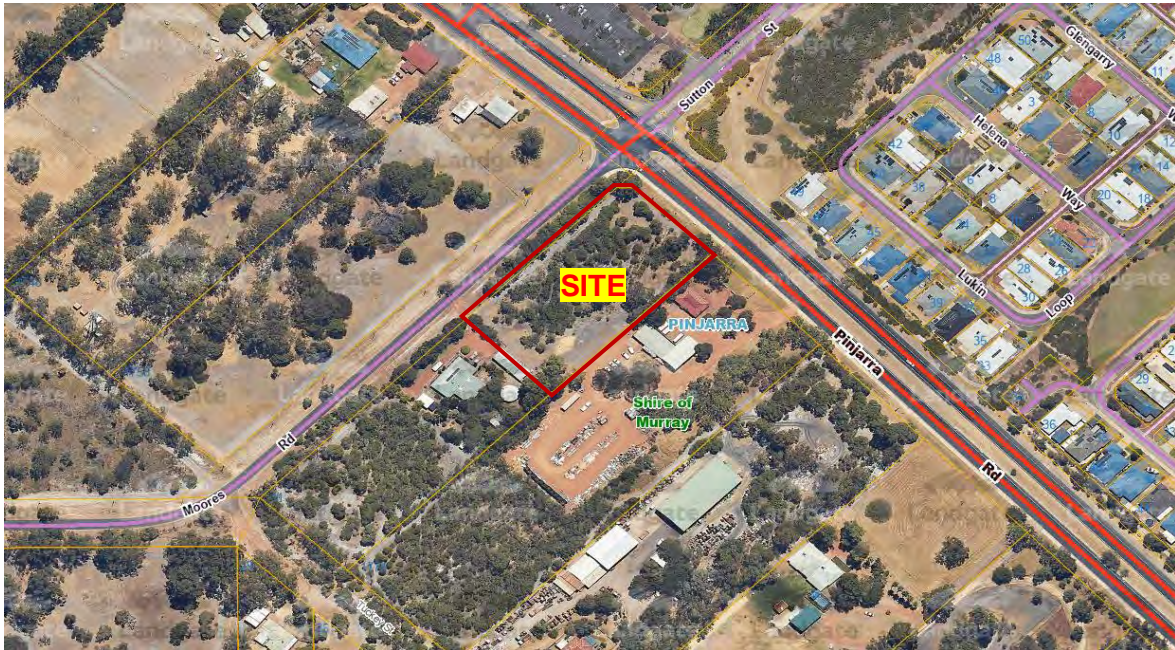
Figure 1. Aerial View of the Site Location (Source: Landgate Map)

Method Planning commissioned Local Geotechnics (LG) to prepare a Site Soil Evaluation report for 11 Moores Road, Pinjarra WA (the project). The site location is shown in Figure 1. The proposed construction will be the Pinjarra Veterinary Hospital, the site plan is attached in Appendix A.

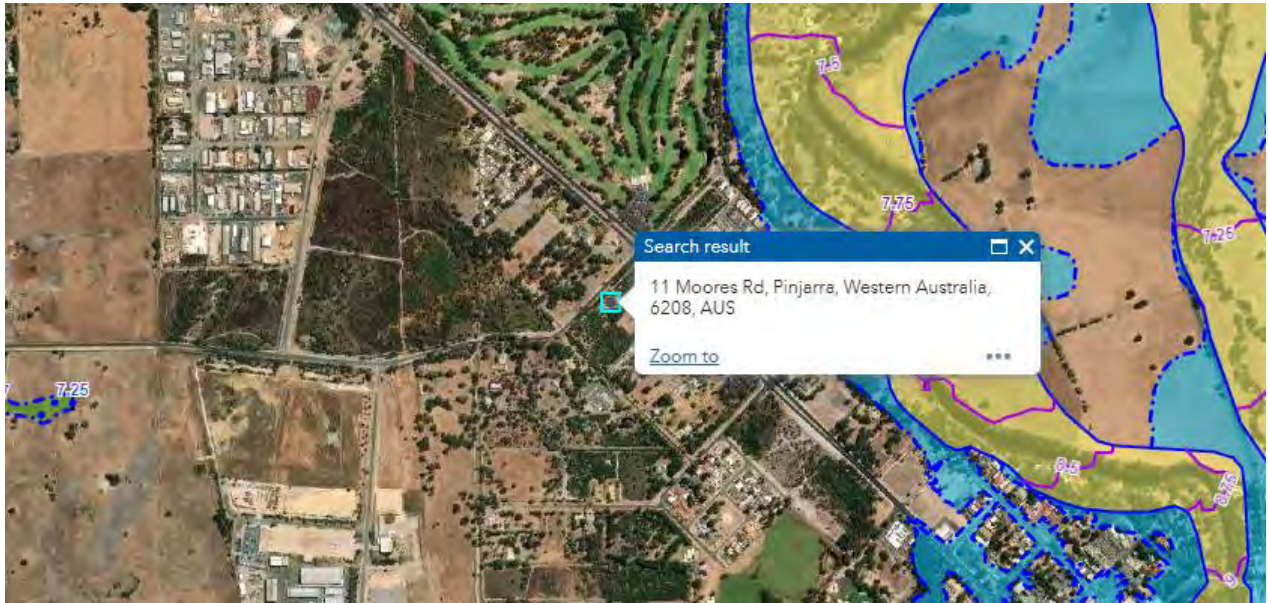
Figure 5. Flood Plain Mapping (Source: Department of Water and Environmental Regulation)

The site is not located within a floodplain according to the Western Australia Flood Plain Mapping database. The Flood Plain Mapping are shown in Figure 5.

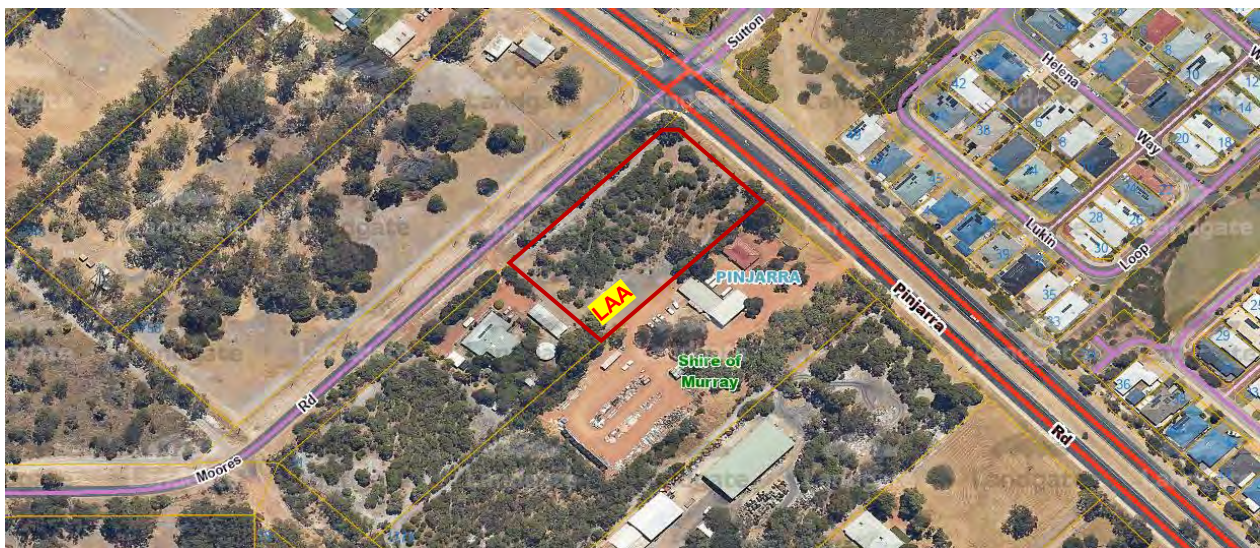
Figure 8. Proposed Land Application Area (LAA)

Hydraulic Load (L/day)*	Soil Category	Conversion factor	LAA (m ²)
Occupancy rate (persons) x design loading rate (L/person/day) = 10 x 70 = 700	2	0.2	140.0
Note: this is a standard calculation and indicative. LAA Area will vary depending on actual number of user.

LAA for this site is **140 m²**. The proposed location of LAA is shown in Figure 8. **The proposed location in Figure 8 is indicative. Location of effluent system remains at the discretion of the future landowner and effluent system designer.**

Location of ATU system at the discretion of the future landowner as long as the setback distance from environmental and structural landmarks should be assessed in accordance with the Government Sewerage Policy (GSP) 2019. Which states that any on-site sewerage system is not to be located within:

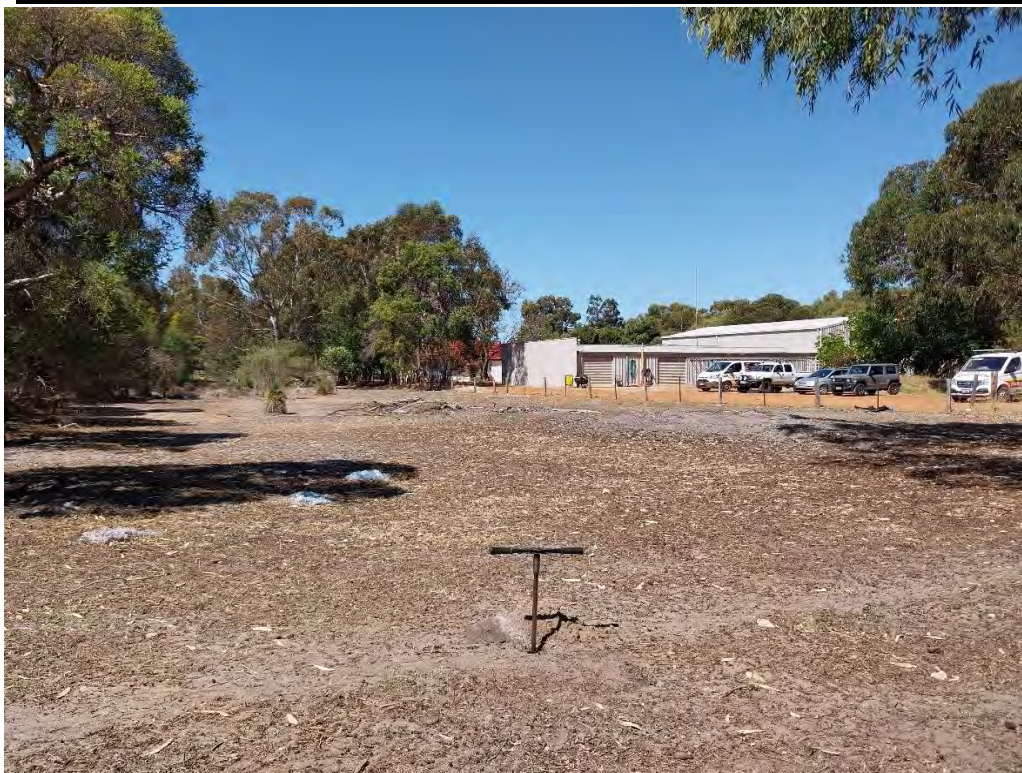
Photo 3. Test Location 02 (TH2), Sub-surface Probing by Using a Hand Auger
