Metro Outer Development Assessment Panel Agenda

Part B – Item 3.1 – LOT NO. 89 (NO. 11) MOORES ROAD, PINJARRA – PROPOSED VETERINARY CENTRE

Form 1 – Responsible Authority Report (Regulation 12)

PINJARRA VETERINARY HOSPITAL
@
11 MOORES ROAD, PINJARRA

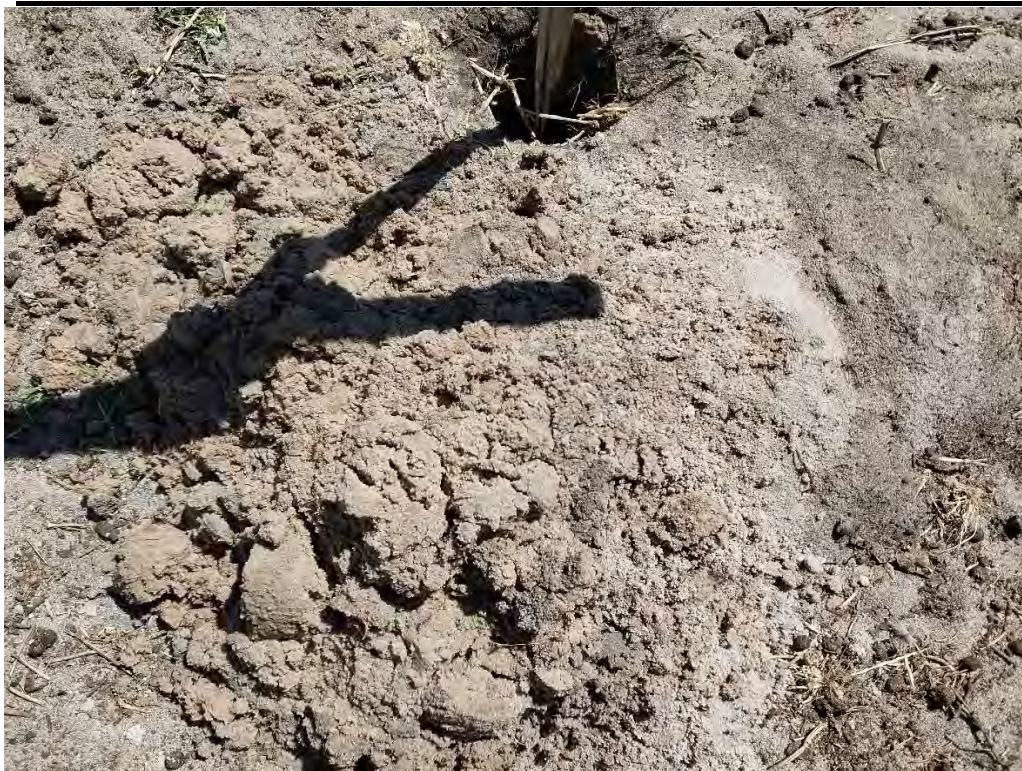
Photo 4. Soil from Test Location 02 (TH2)

- **Topsoil, Silty SAND (SM)** – fine to medium grained, grey, with low plasticity silt, grass and roots, slightly moist, loose to dense, up to a depth of 0.1 m; followed by
- **Silty SAND (SM)** – fine to medium grained, grey, with low plasticity silt, slightly moist, loose to dense, up to a depth of 0.5 m; followed by
- **SAND (SP)** – fine to medium grained, pale grey to pale brown, slightly moist to wet, loose to dense, up to the maximum investigated depth.

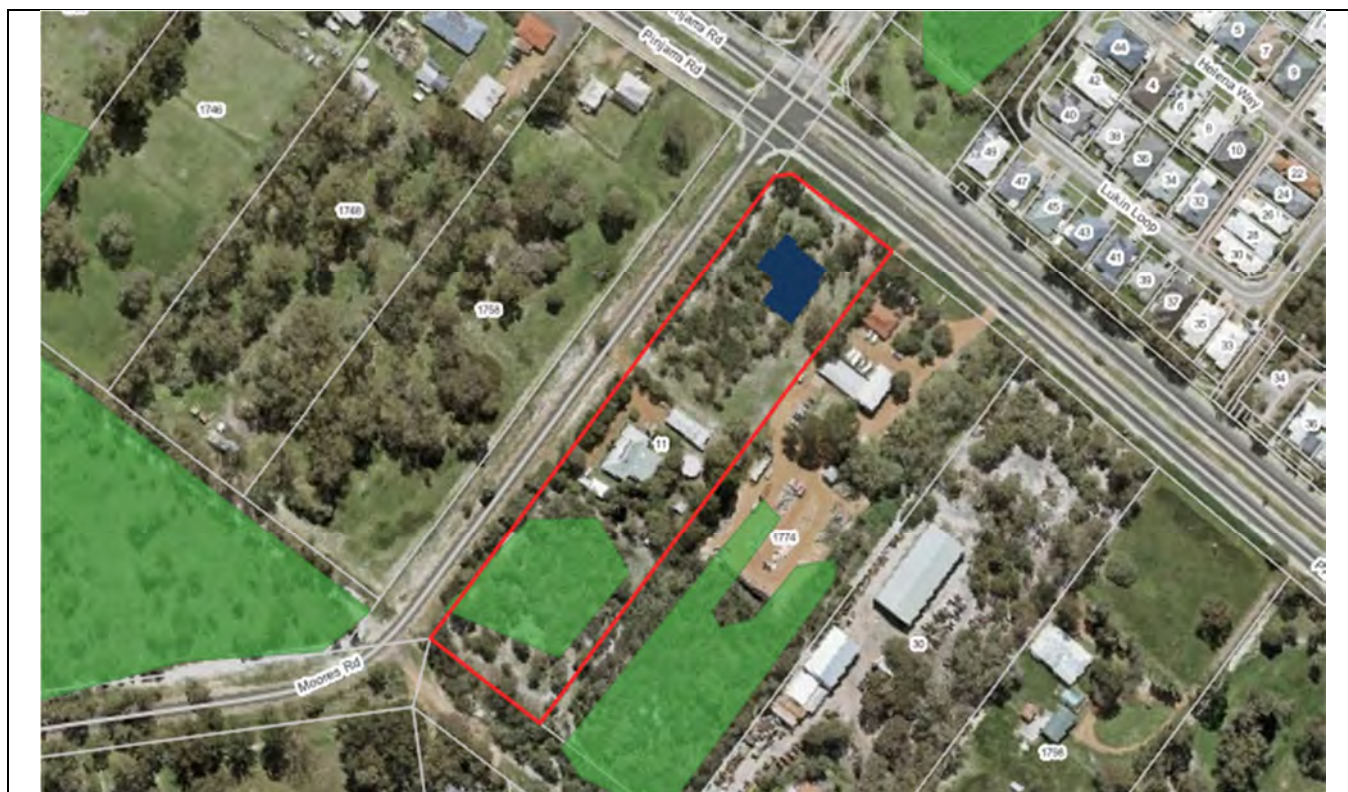
Figure: 4 Map of Native Vegetation Extents for Subject Site

The site has been checked against the Native Vegetation mapping conducted by the Department of Primary Industries and Regional Development (DPIRD-005). This database shows native vegetation on the site, as seen in the image below. However, the asset protection zone, as required in this BMP, will not require the removal of native vegetation.

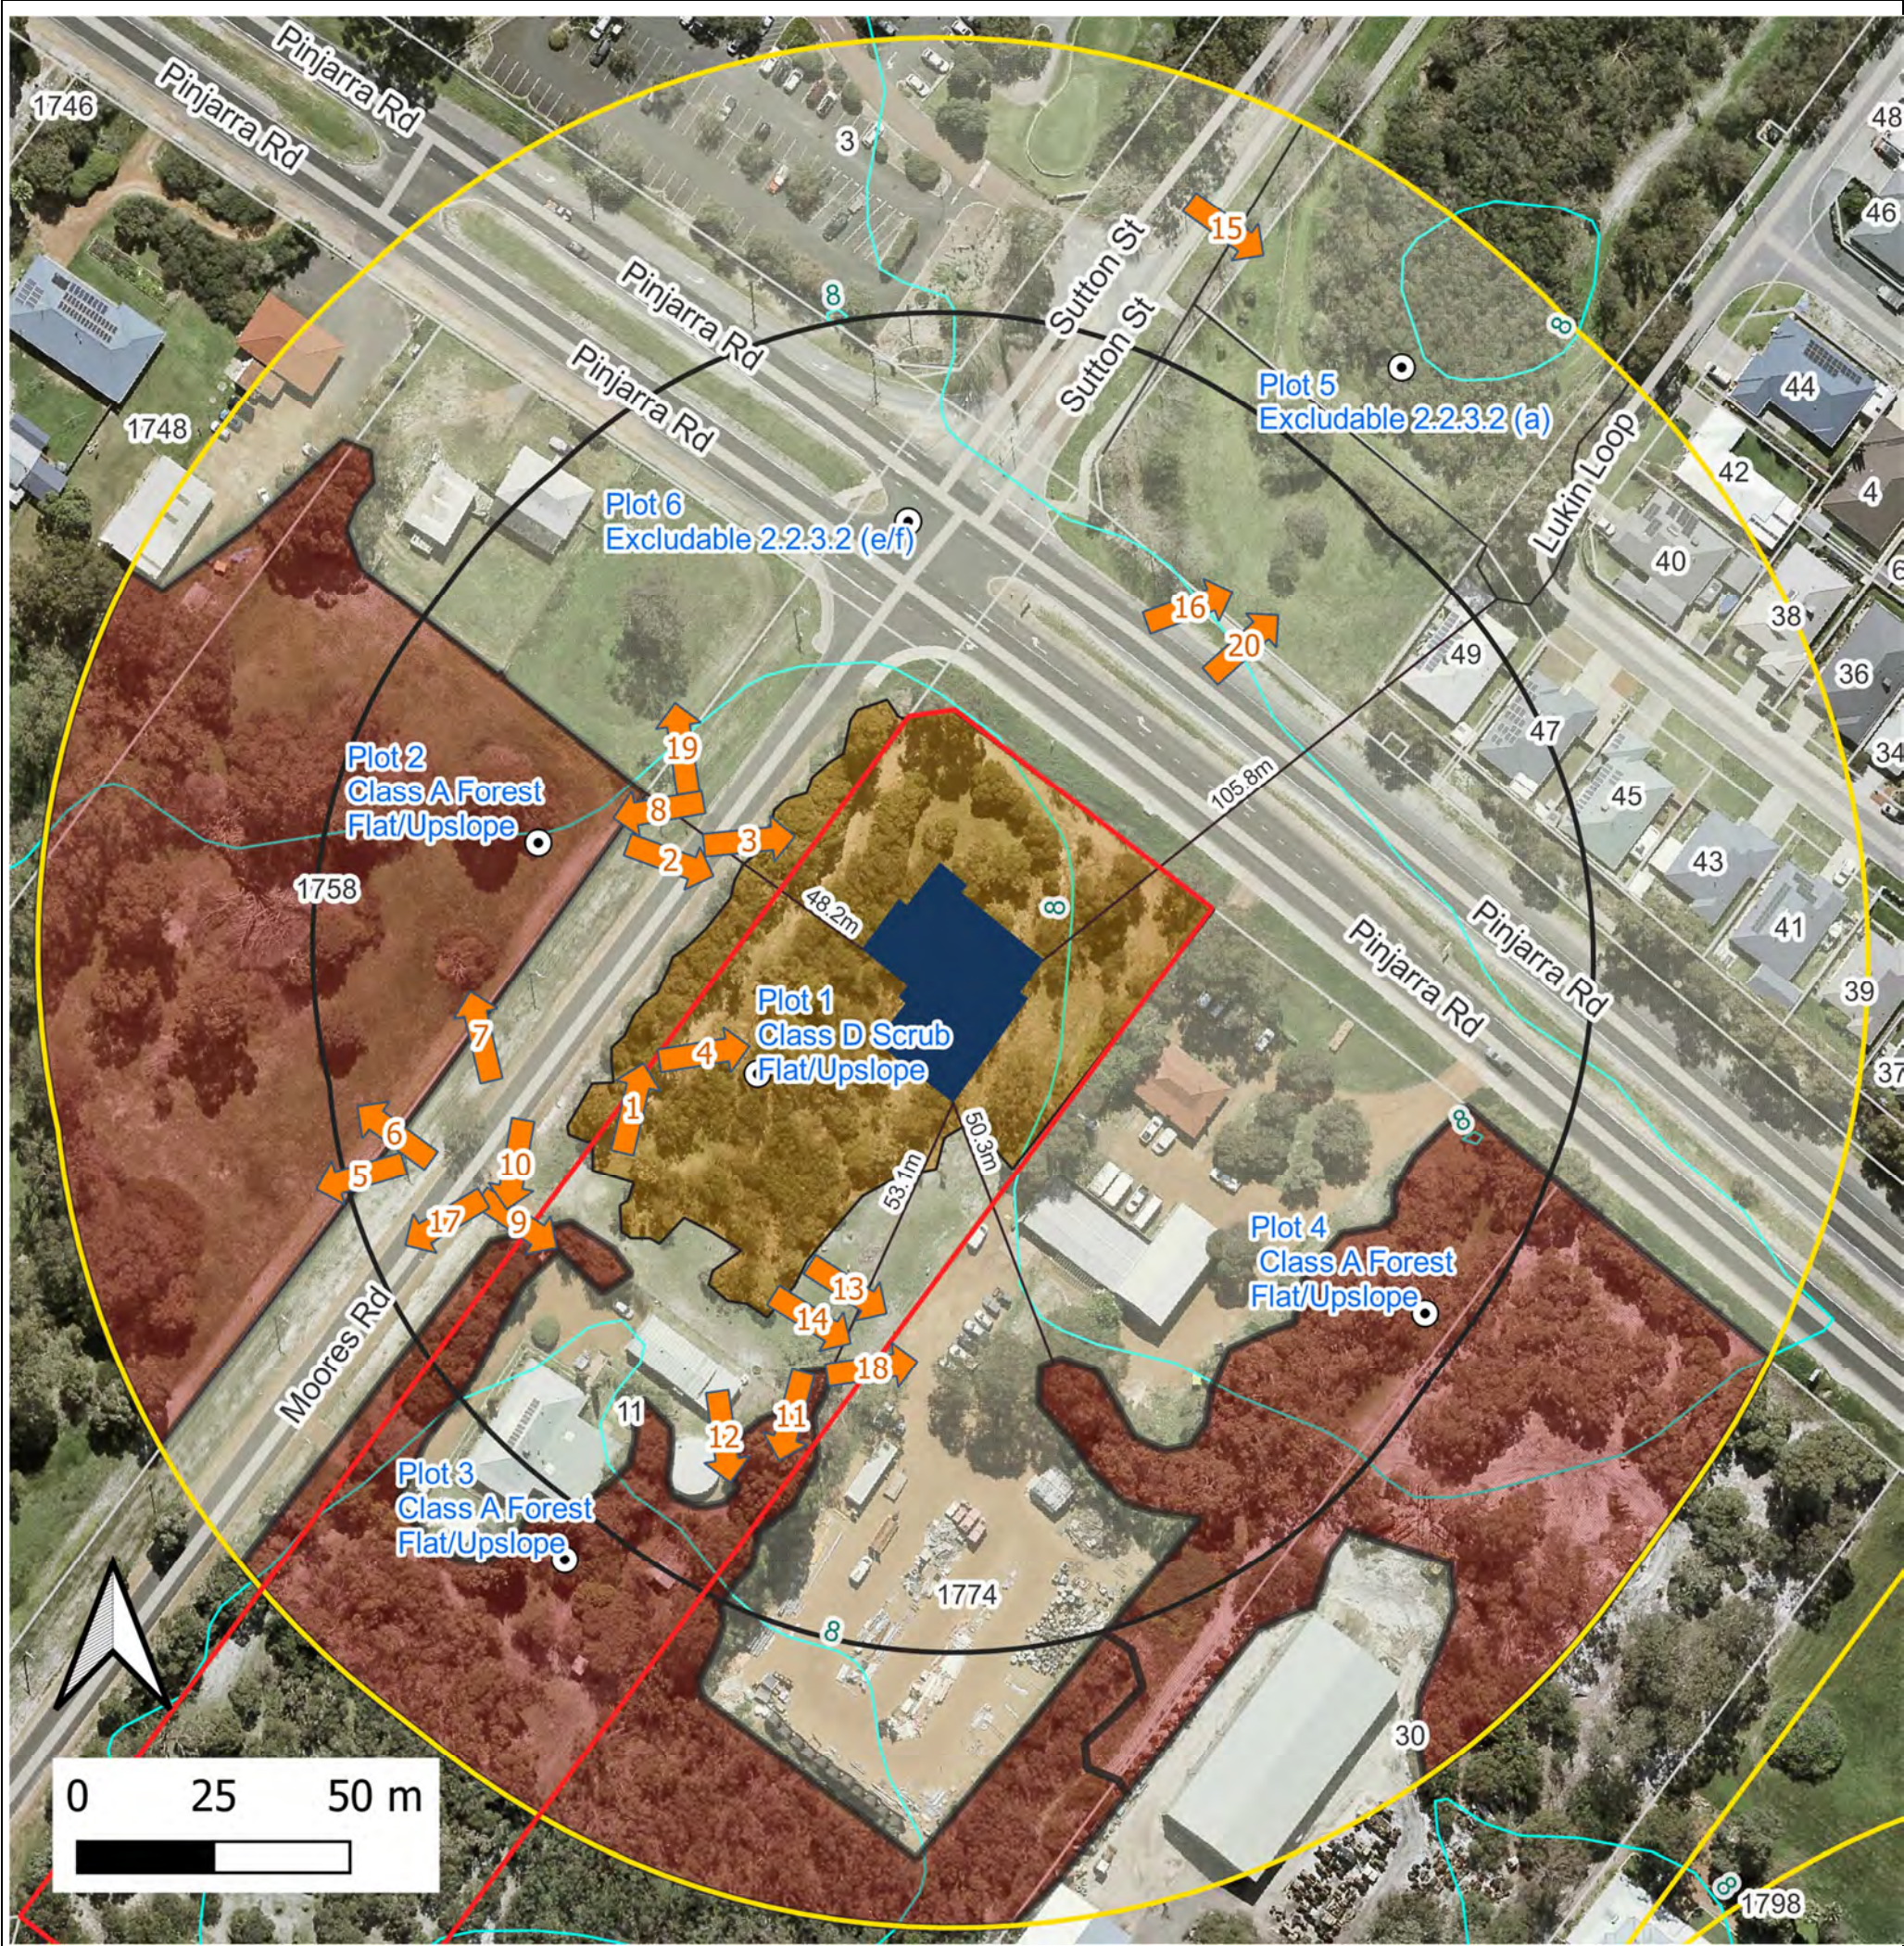
Figure: 5 Vegetation Classification

The assessment of this site/development was undertaken by a BPAD Accredited Practitioner for the purpose of determining the Bushfire Attack Level in accordance with AS 3959-2018 Simplified Procedure (Method 1).

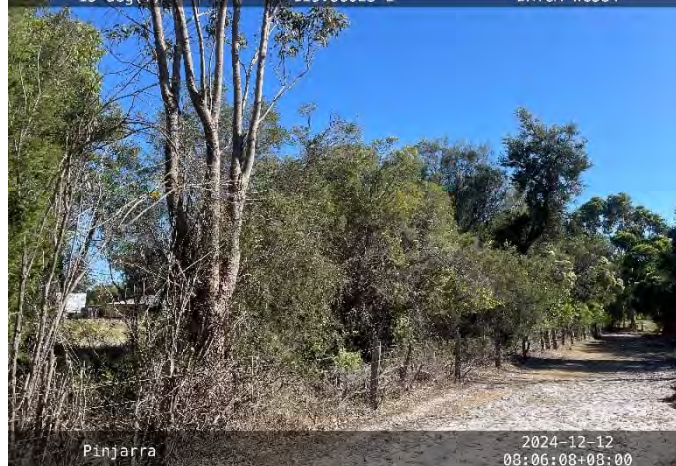
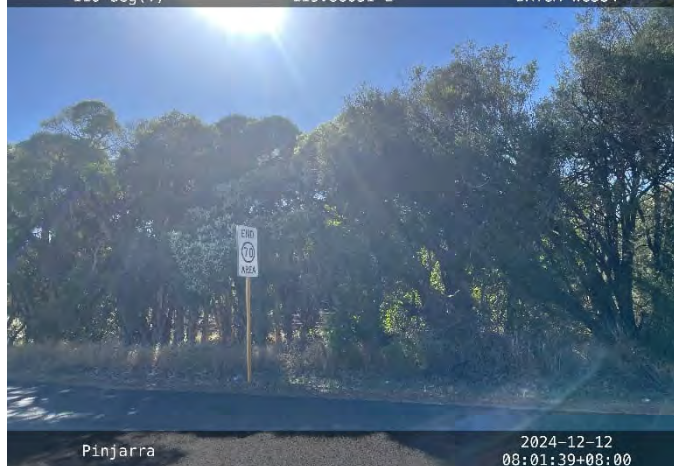
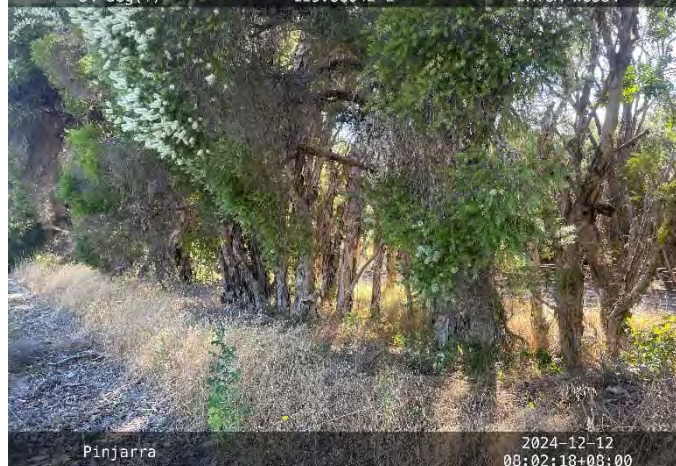
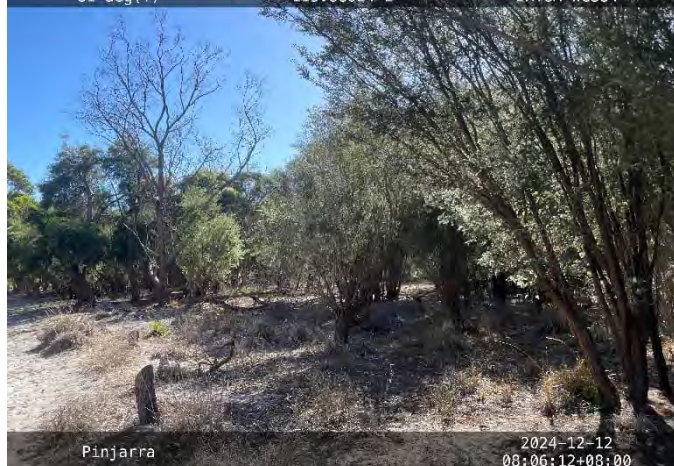
Photo ID: 3			Photo ID: 4

Plot:	1	Effective Slope (°):	Flat/Upslope	Separation Distance (m):	0 m
Vegetation Classification or Exclusion Clause:			Class D Scrub - Closed scrub D-13		
Description / Justification for Classification:					
Tall scrub ~6 m, dominated by Melaleuca species (e.g., Moonah or Modong, and <i>M. systema</i>). Understorey consists of unmanaged grasses, high fine fuel loads, and numerous saplings throughout. Parts are separated by a firebreak, though the same structure persists across the subject lot. Foliage cover exceeds 30%.					
<div>DIRECTION 13 deg(T)</div> <div>32.62010°S 115.86023°E</div> <div>ACCURACY 4 m DATUM WGS84</div>

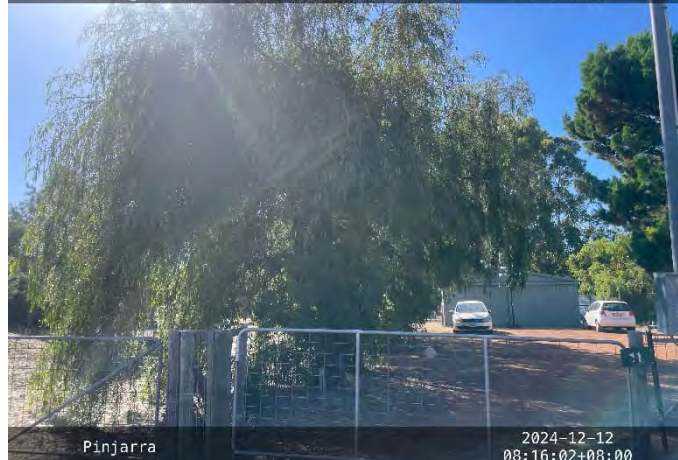
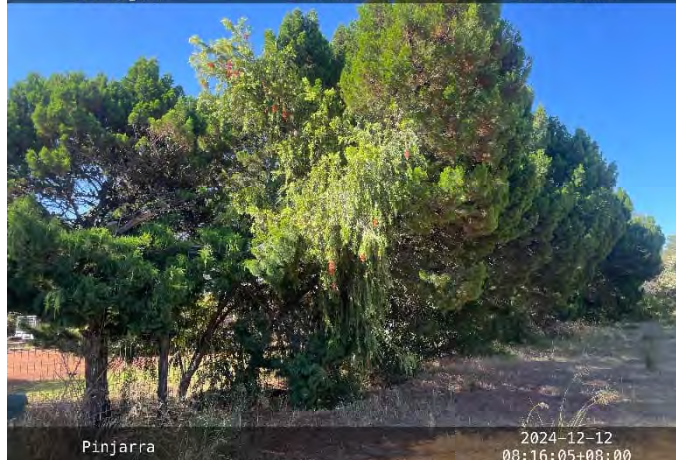
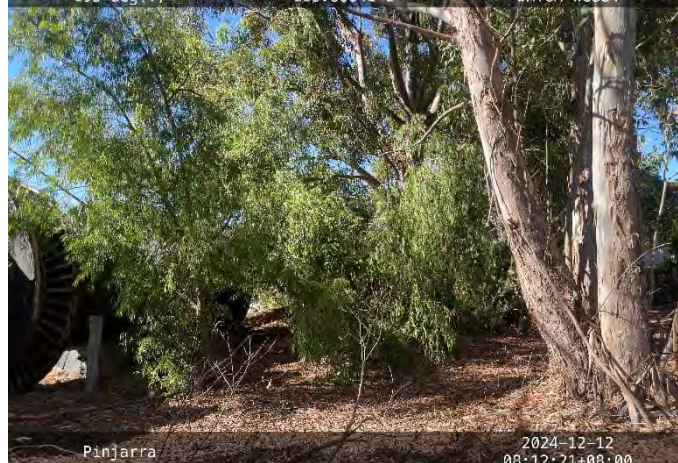
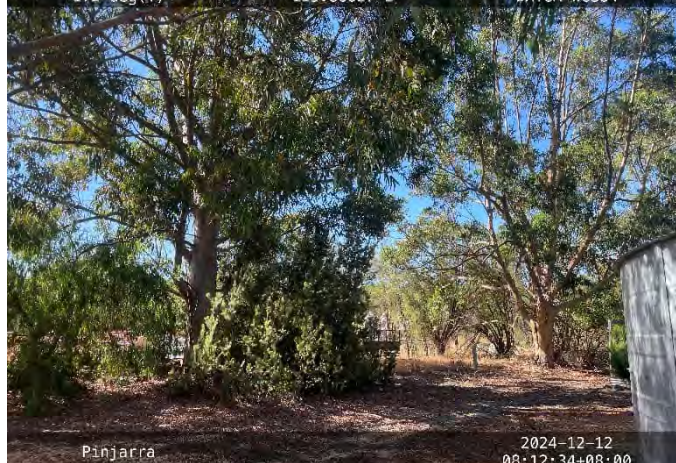
Photo ID: 11			Photo ID: 12

Plot:	3	Effective Slope (°):	Flat/Upslope	Separation Distance (m):	53.1 m
Vegetation Classification or Exclusion Clause:			Class A Forest - Open forest A-03		
Description / Justification for Classification:					
Mixed vegetation consisting of introduced pines (possibly Cypress or Maritime species), ornamentals, and Eucalyptus trees, with an average height of ~17 m. Foliage cover exceeds 30%, with a high fine fuel load present. Some unmanaged grasses and scrub contribute to the midstorey.					
<div>DIRECTION 124 deg(T)</div> <div>32.62029°S 115.85993°E</div> <div>ACCURACY 4 m DATUM WGS84</div>

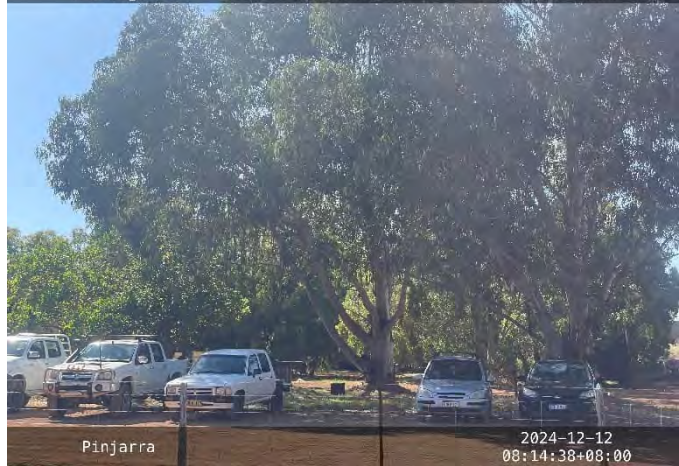
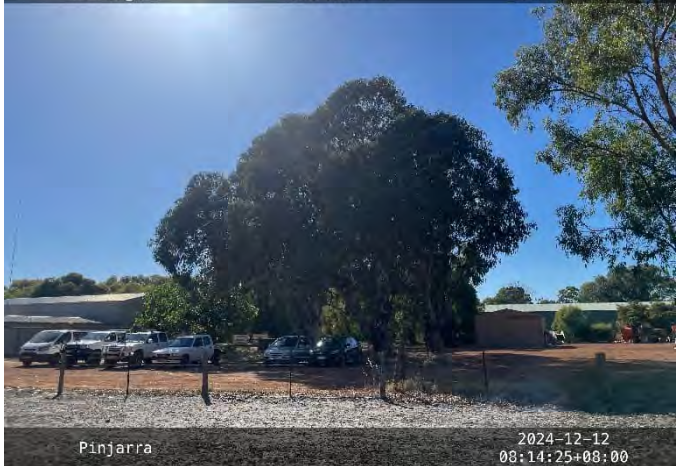
Pinjarra			Pinjarra		
2024-12-12 08:14:38+08:00			2024-12-12 08:14:25+08:00		
Photo ID: 13			Photo ID: 14

Plot:	4	Effective Slope (°):	Flat/Upslope	Separation Distance (m):	50.3 m
Vegetation Classification or Exclusion Clause:			Class A Forest - Open forest A-03		
Description / Justification for Classification:					
Predominantly native forest dominated by Eucalyptus species, with an average height of ~22 m. Aerial imagery indicates a contiguous canopy throughout, with foliage cover exceeding 30%.					
<div>DIRECTION 123 deg(T)</div> <div>32.62046°S 115.86055°E</div> <div>ACCURACY 6 m DATUM WGS84</div>

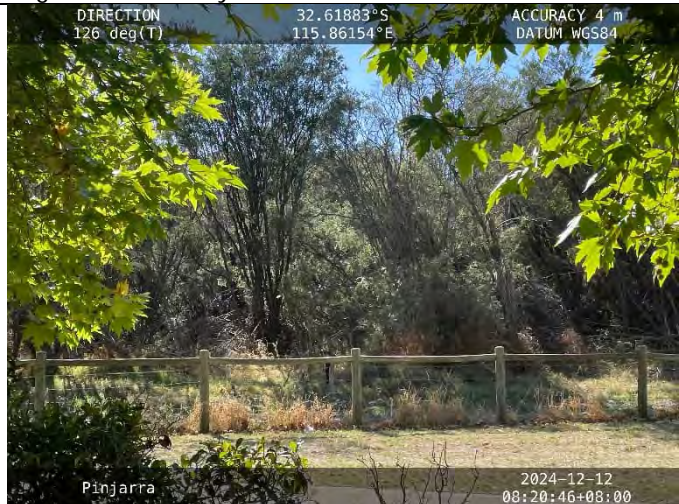
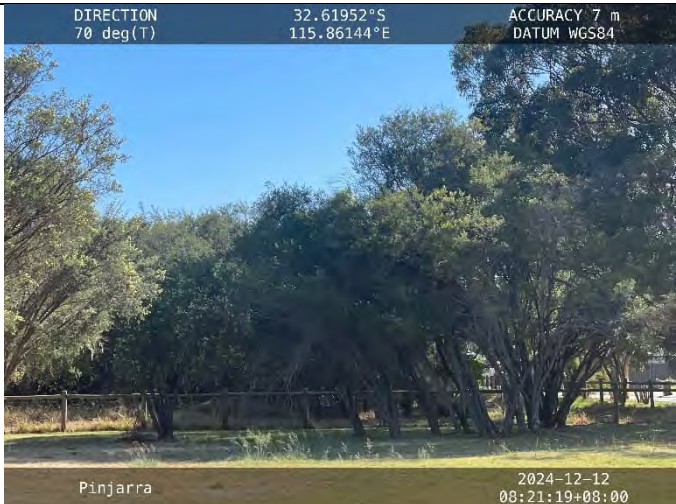
<div>Pinjarra</div> <div>2024-12-12 08:21:19+08:00</div>		
Photo ID: 15			Photo ID: 16

Plot:	5	Effective Slope (°):	N/A	Separation Distance (m):	105.8 m
Vegetation Classification or Exclusion Clause:		Excludable - 2.2.3.2(a) >100m from site			
Description / Justification for Classification:					
Melaleuca scrub approximately 6 m in height, located on fenced land to the north of the subject lot. This vegetation lies beyond the 100 m buffer zone.					
<div><div>DIRECTION 126 deg(T)</div><div>32.61883°S 115.86154°E</div><div>ACCURACY 4 m DATUM WGS84</div></div>

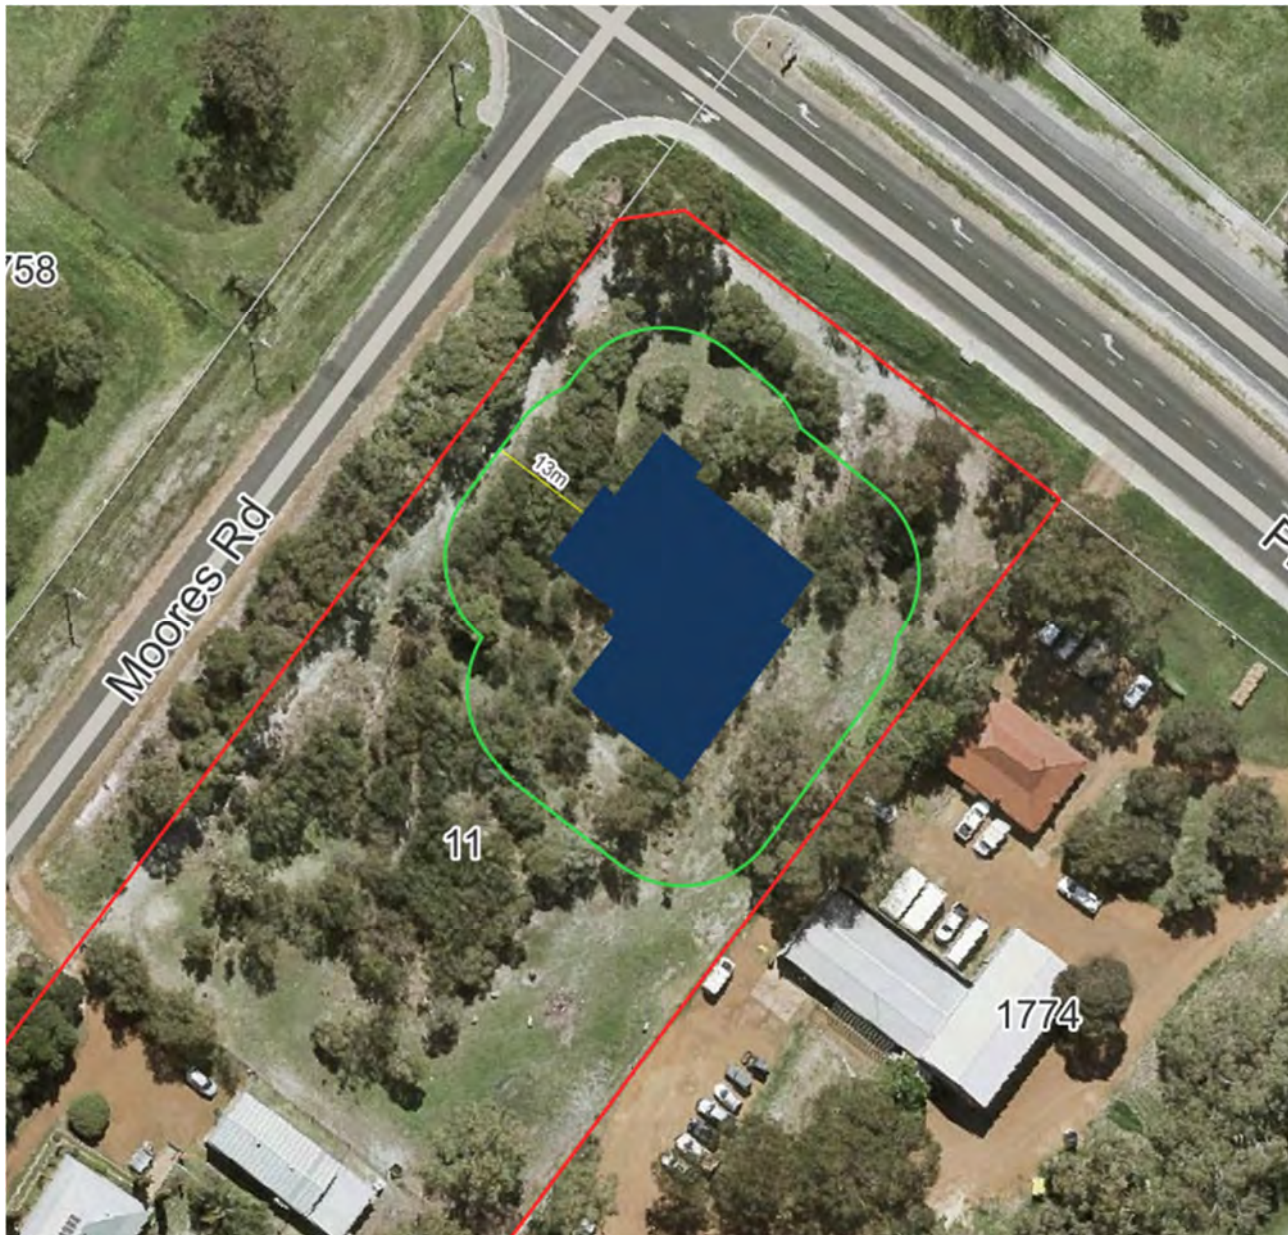
The APZ required for this proposal is detailed in the following table, and visually depicted below.

APZ Requirement from:	Measurement
	(from any external wall or supporting post or column of the proposed building/s)
<i>All directions</i>	13 m

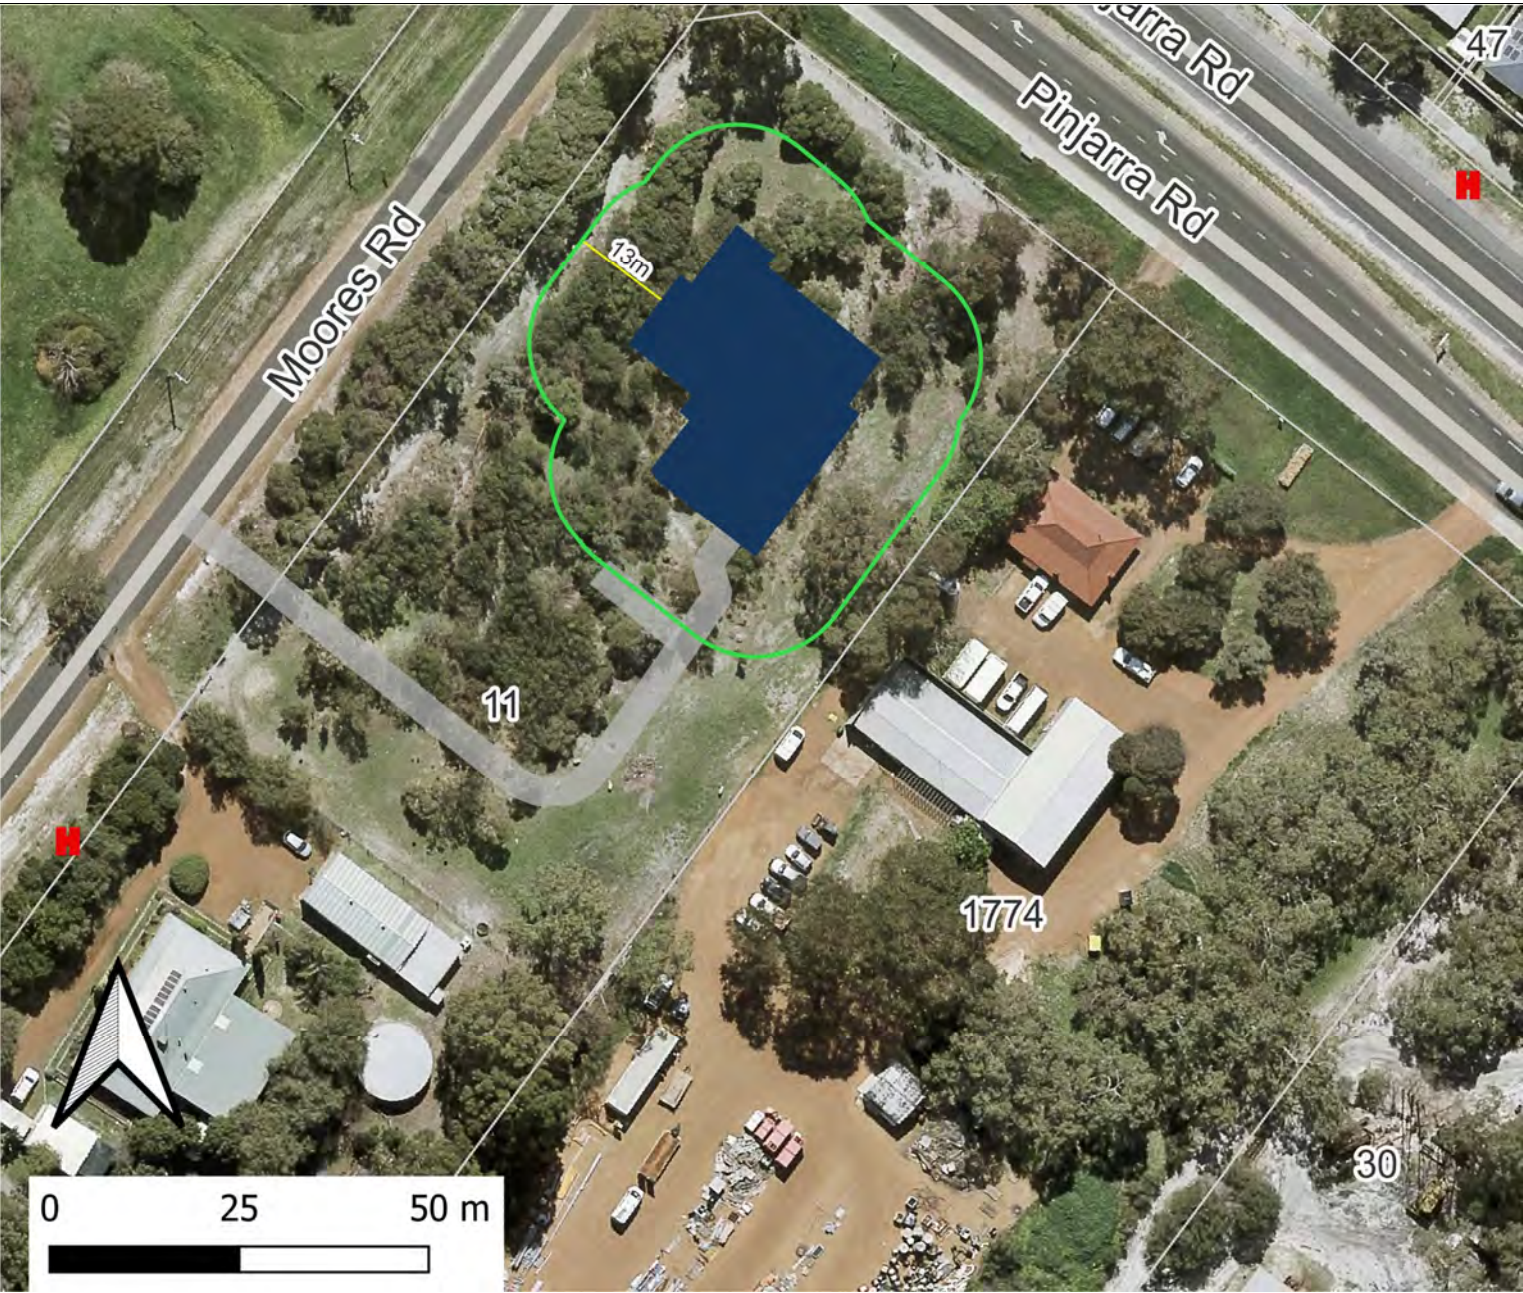
Figure: 6 Spatial Representation of proposed risk management measures

For further information, see Appendix A: Spatial Representation of proposed risk management measures of this report. The APZ is to be managed as per Table 9 of the guidelines, extract shown below.

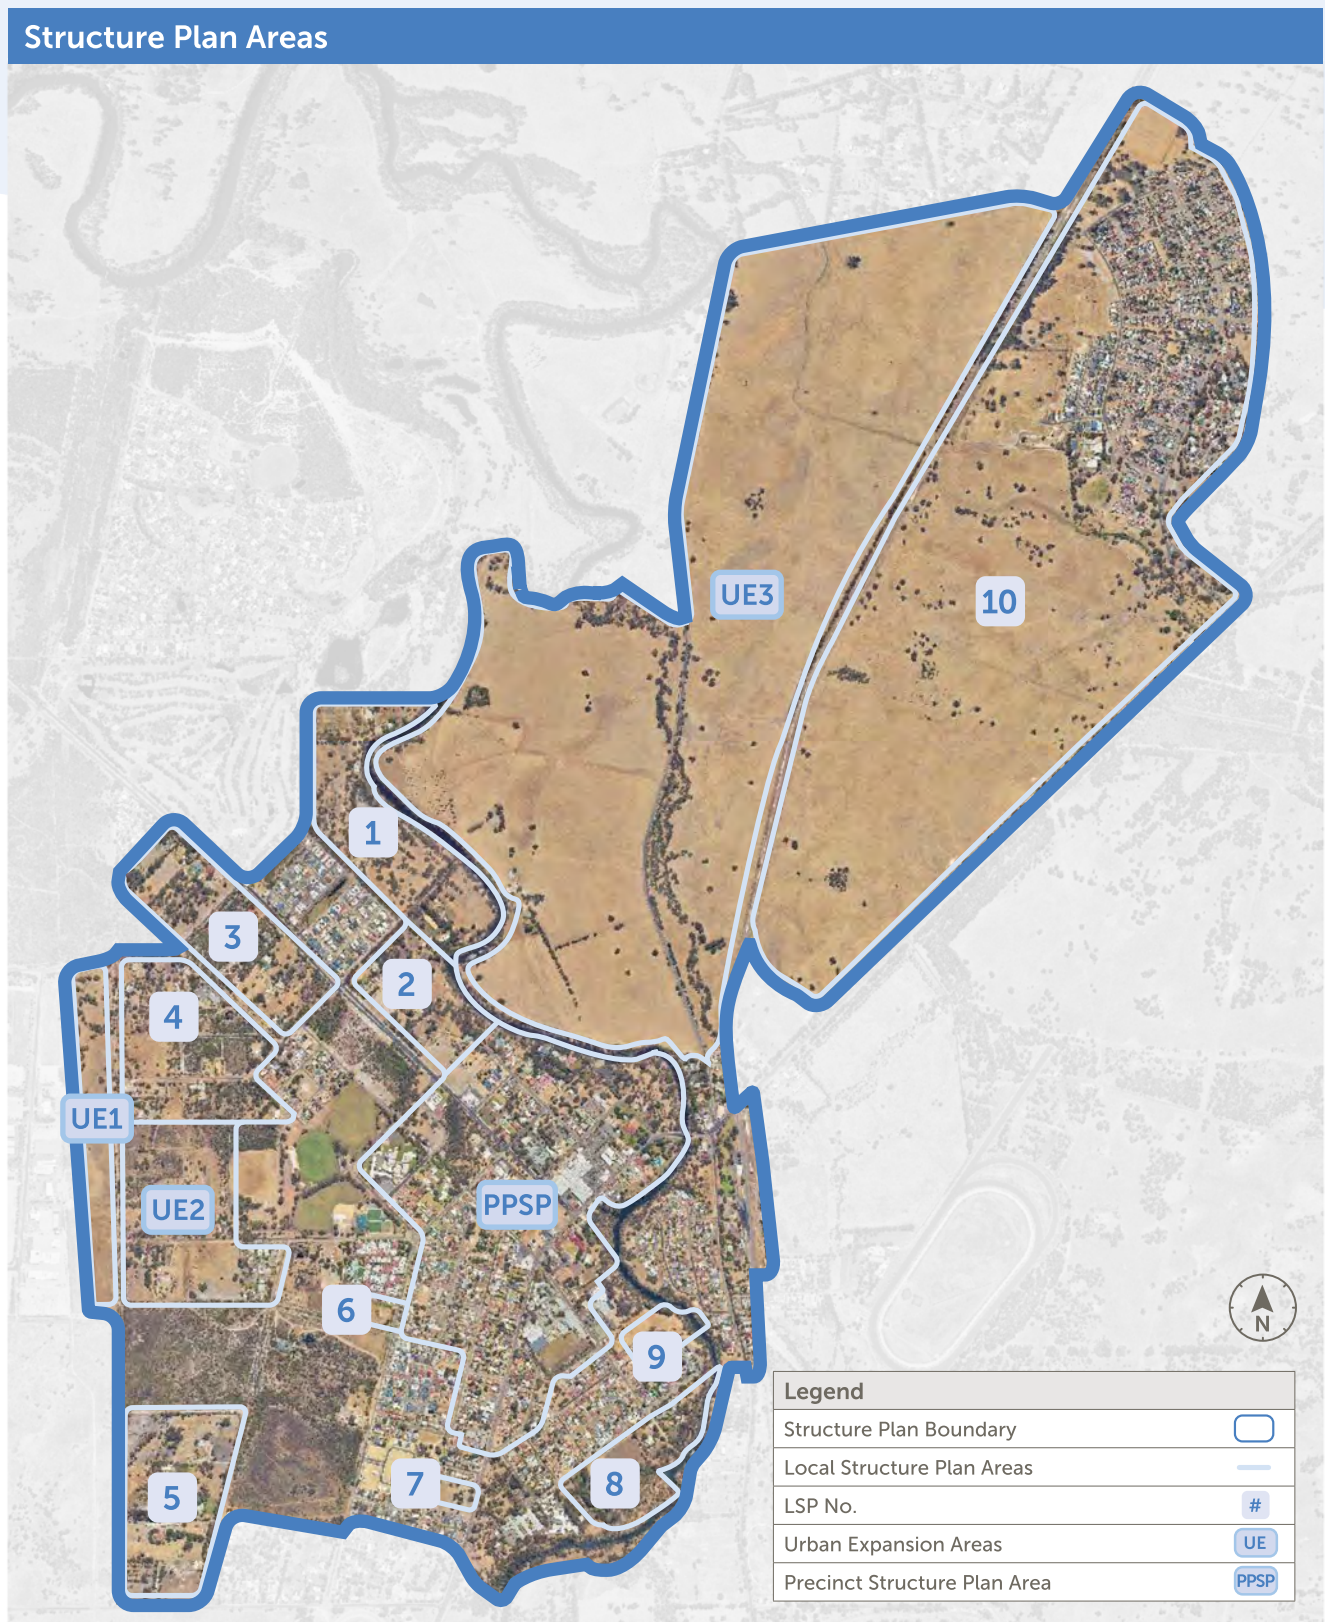
Figure 13: Structure Plan Areas

There are 14 areas, including three Urban Expansion Areas that require either a local structure plan or precinct structure plan prior to applications for subdivision or development being considered. These areas are shown on Figure 13.

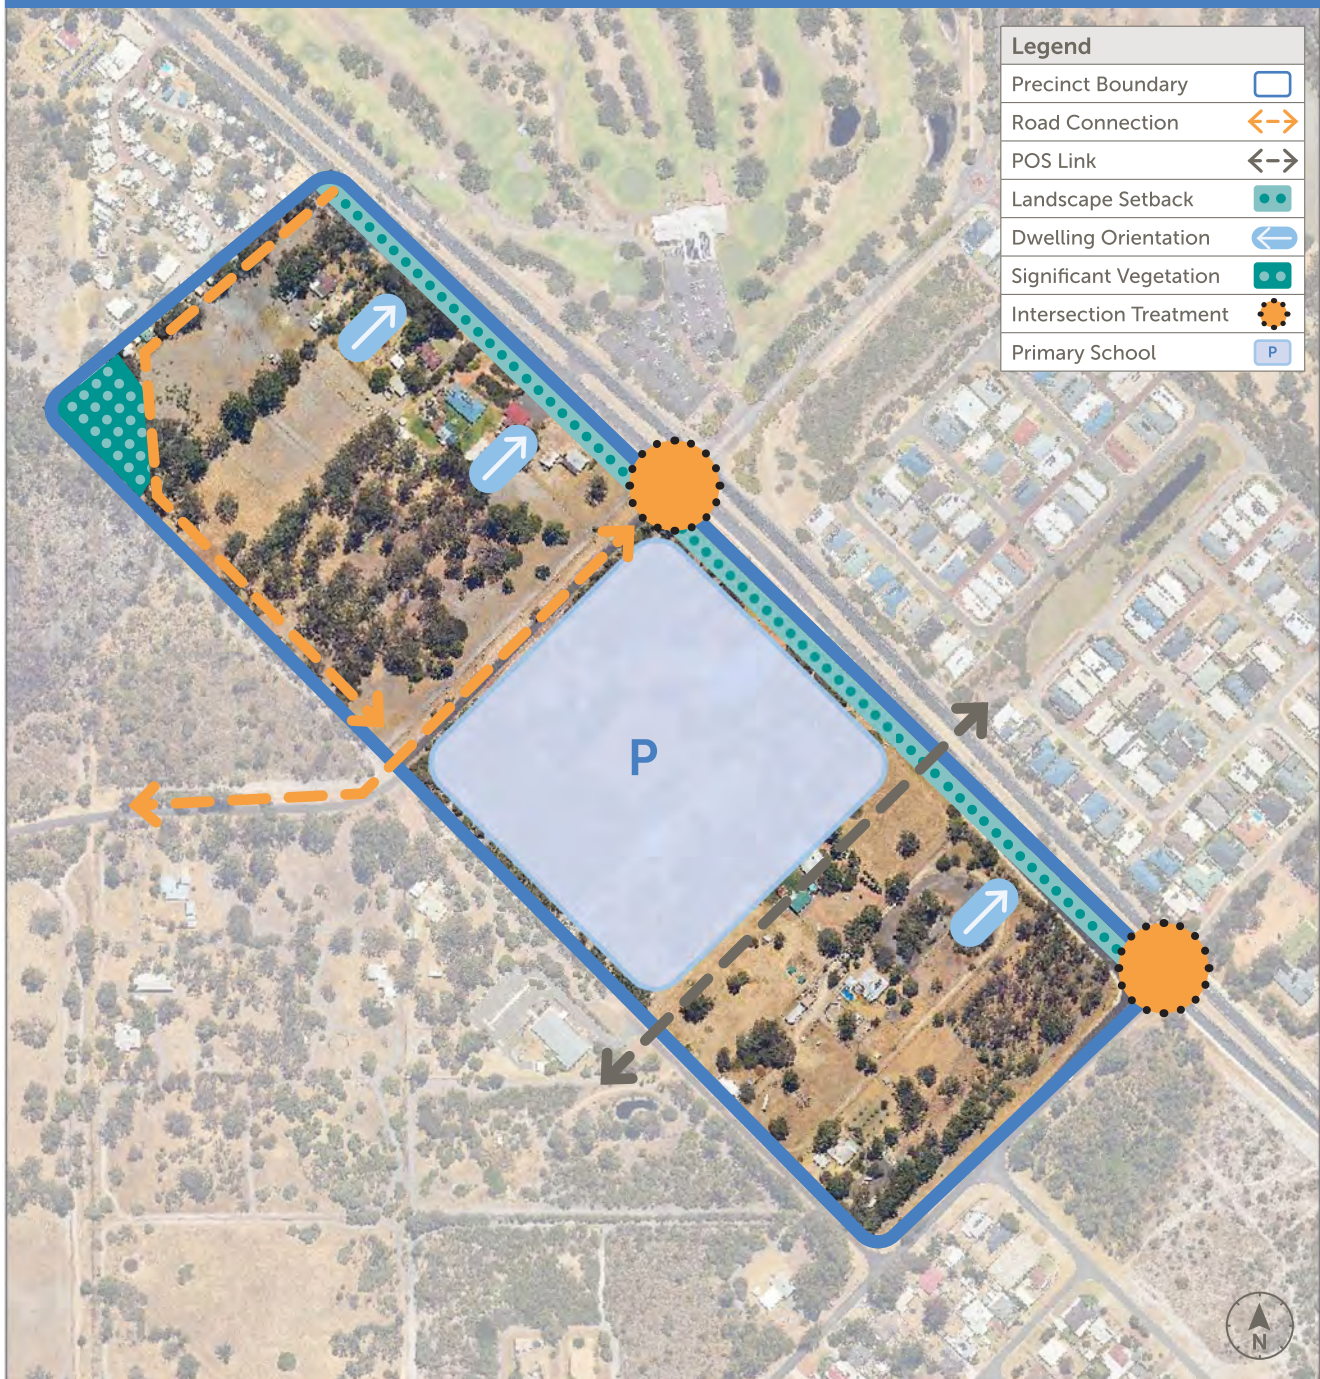
LSP Area 3 - Wilson Road (West) / Pinjarra Road (West)

- › Provide for the widening and upgrade of Moores Road to an Integrator A Town Centre Road with a 38m reserve.
- › Provide for a suitable intersection control treatment at the intersection of Pinjarra Road and Moores Road. Provide for a suitable intersection control treatment at the intersection of Pinjarra Road and Wilson Road.
