# **LOT 889 RODOREDA CRESCENT, RAVENSWOOD**

## **ENGINEERING SERVICING REPORT**

PREPARED FOR THE ASPEN GROUP

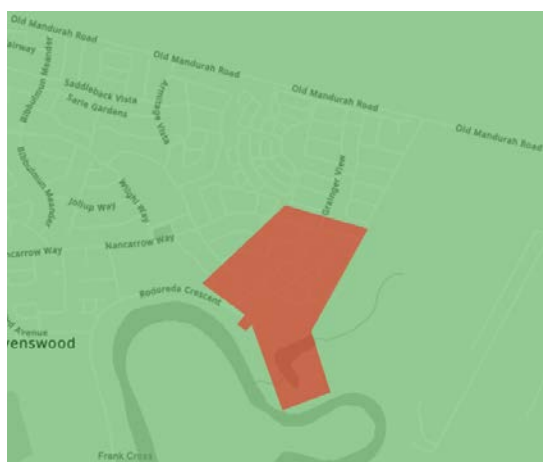
Figure 6a – 4G Coverage

Figures 6a and 6b show Telstra's 4G and 5G network coverage (December 2024).

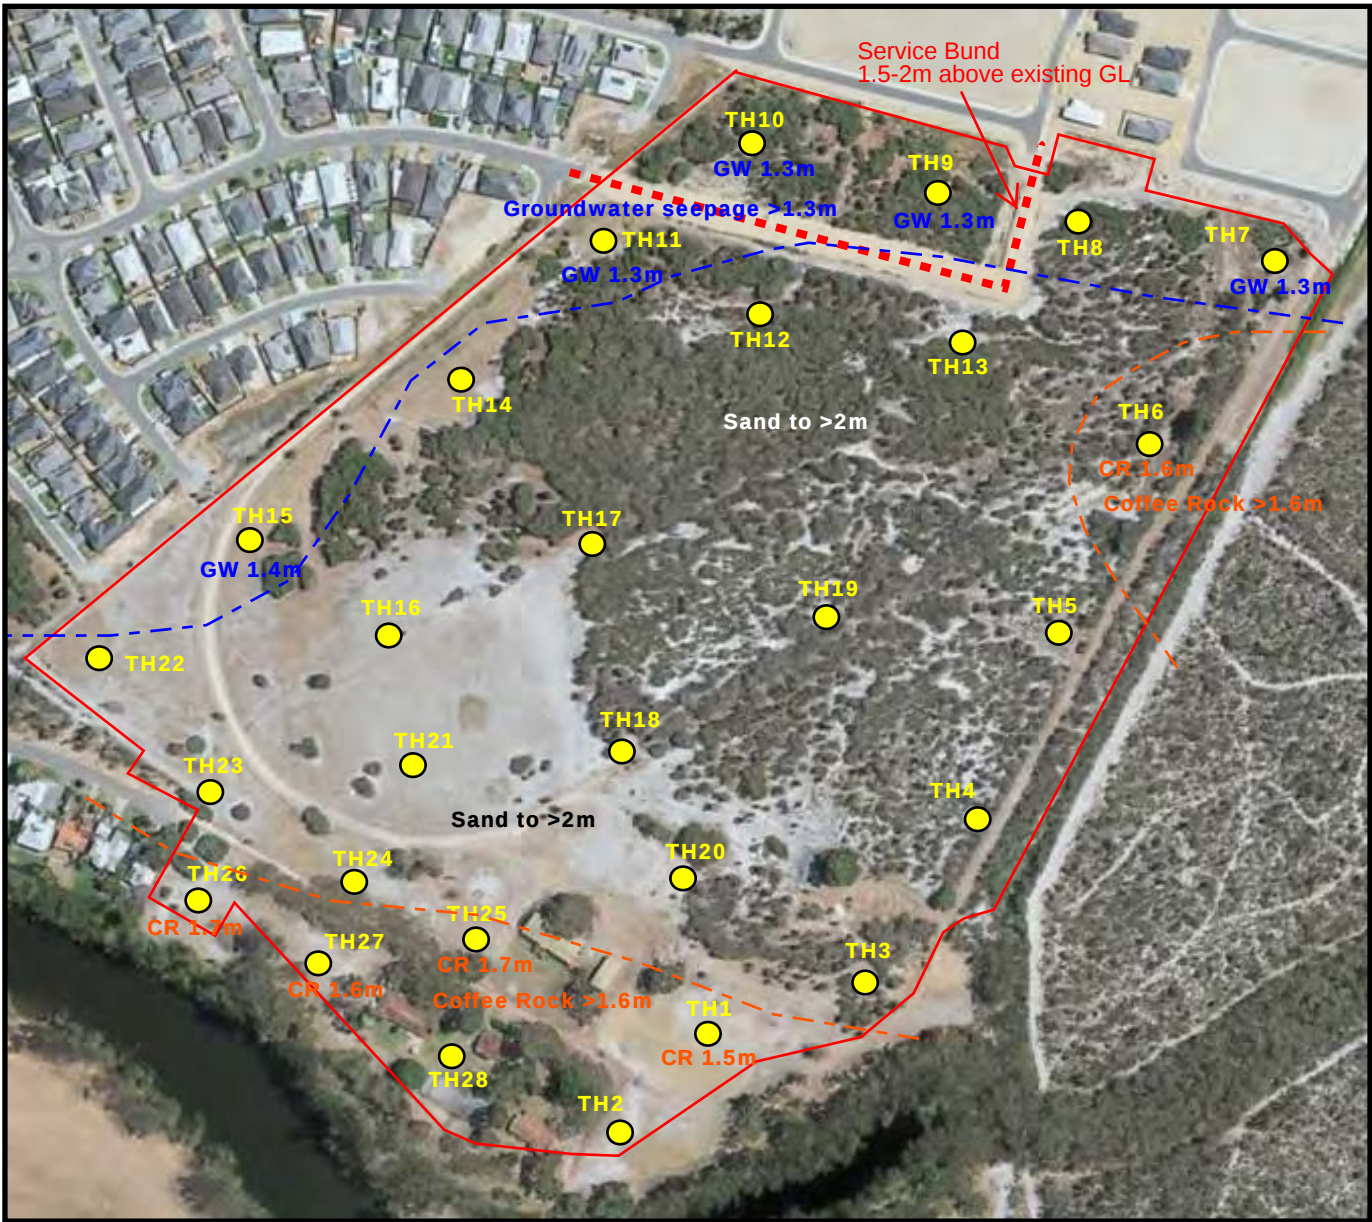
Figure 2 - Subsoil Conditions

GW: Groundwater seepage (m BGL)

CR: Coffee Rock (m BGL)

Coffee rock (very dense, iron cemented sand) was encountered in TH1, TH6 and TH25-27 at approx. 1.6m, as shown on Figure 2. The material could not be excavated with the 5 tonne excavator, though tests holes often collapsed before the thickness of the layer could be determined. The coffee rock was predominantly confined to the southern boundary.

No high flow groundwater was encountered in test holes, however slight seepage and moist soils were encountered at approx. 1.3m in TH7-11 and TH15 (refer Figure 2). The DoW Perth Groundwater Map does not currently cover this area, however experience working in the vicinity of the site suggests groundwater to be close to the existing ground surface during the winter rainfall period.

The drainage characteristics of the sand on site are good. Soakwells will be suitable for stormwater runoff assuming sufficient height above the maximum groundwater levels. In some areas of the site coffee rock occurs to within 1.6m of the surface (refer Figure 2). If the land surface is cut down during earthworks, the coffee rock layer may impede vertical drainage and should be broken out below soakwells to improve drainage.
