Retaining Wall Inspection

Client: IQ CONSTRUCTION
Address: LOT 977 NANCARROW WAY, RAVENSWOOD
Job Reference: 25-2340
Inspection Date: 10-2-2026

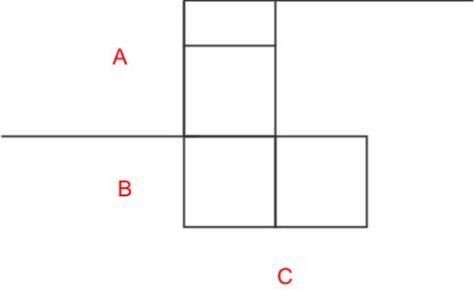
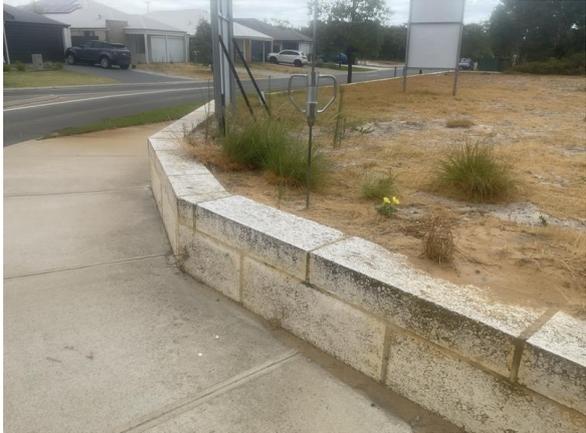
Wall Profile – Location 1

Mark A: Height of Retaining	500 mm
Mark B: Embedment	350 mm
Mark C: Width at base	700 mm
Construction Material: 350 x 350 Reconstituted Limestone Block	
Condition: Fair

Depth / Location	150 - 450	450 - 750	750 - 1050
Low Side	Unable to test		
High Side	9	VH

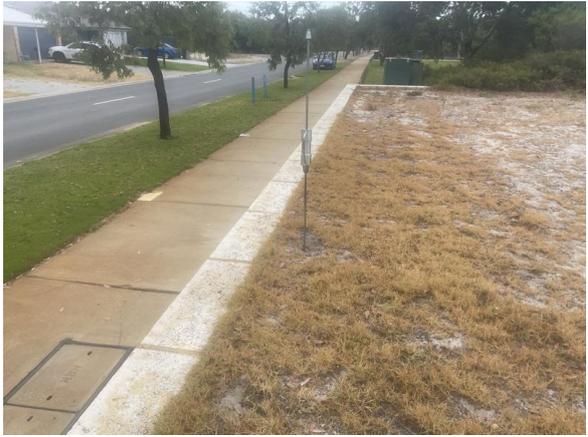
Wall Profile – Location 2

Mark A: Height of Retaining	500 mm
Mark B: Embedment	350 mm
Mark C: Width at base	700 mm
Construction Material: 350 x 350 Reconstituted Limestone Block	
Condition: Fair

Depth / Location	150 - 450	450 - 750	750 - 1050
Low Side	Unable to test		
High Side	11	VH

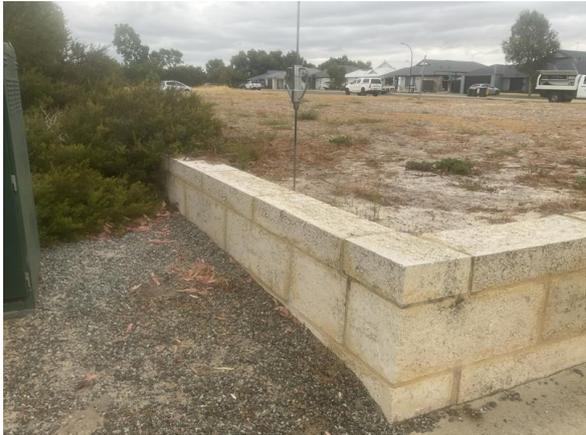
Wall Profile – Location 3

Mark A: Height of Retaining	500 mm
Mark B: Embedment	350 mm
Mark C: Width at base	700 mm
Construction Material: 350 x 350 Reconstituted Limestone Block	
Condition: Fair

Depth / Location	150 - 450	450 - 750	750 - 1050
Low Side	Unable to test		
High Side	9	VH

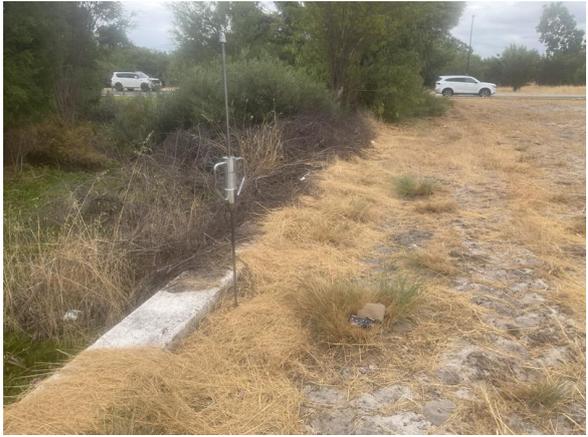
Wall Profile – Location 4

Mark A: Height of Retaining	500 mm
Mark B: Embedment	350 mm
Mark C: Width at base	700 mm
Construction Material: 350 x 350 Reconstituted Limestone Block	
Condition: Fair

Depth / Location	150 - 450	450 - 750	750 - 1050
Low Side	Unable to test		
High Side	9	VH

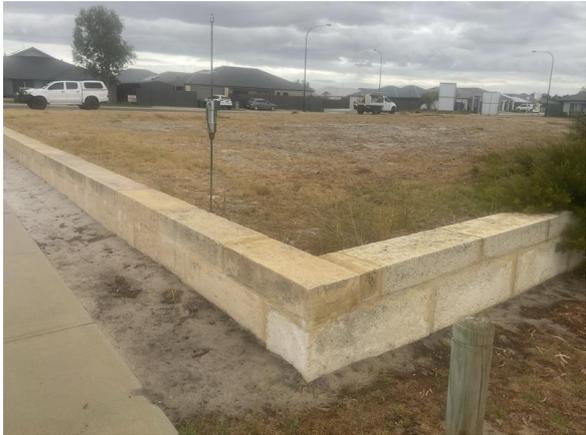
Wall Profile – Location 5

Mark A: Height of Retaining	500 mm
Mark B: Embedment	350 mm
Mark C: Width at base	700 mm
Construction Material: 350 x 350 Reconstituted Limestone Block	
Condition: Fair

Depth / Location	150 - 450	450 - 750	750 - 1050
Low Side	Unable to test		
High Side	9	VH
