**Report on**  
**Geotechnical Site Classification**  
**11 Moores Road, Pinjarra WA**

Project:  
**LGK0372024SC**  
**Rev\_0**

**RE:** Geotechnical Site Classification for 11 Moores Road, Pinjarra WA.

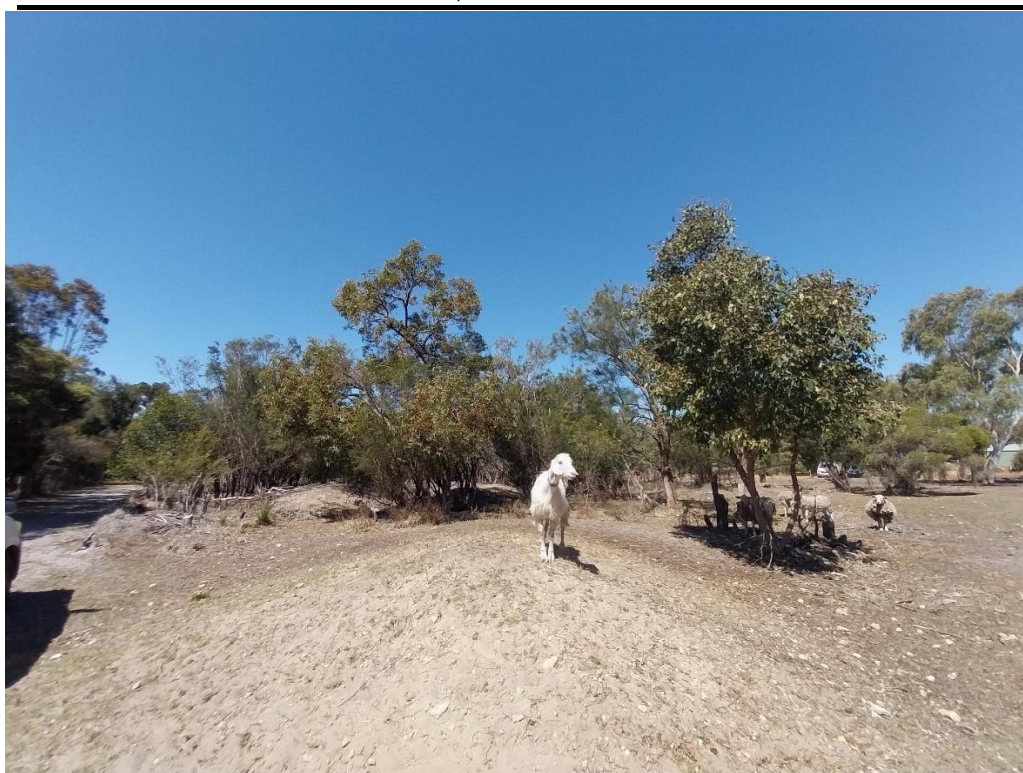
Photo 2. General Site Condition

The surface condition and the overall topography of the site are generally flat. There are medium to large sized trees can be observed at the time of investigation. The site boundaries are enclosed with fences. There are surrounding houses adjacent to the property.

- Clear any unsuitable material from the topsoil of the site. Unsuitable materials generally includes: organics, grass roots, uncontrolled fill of building rubbles, bricks, stone blocks, concrete, wood, asphalt, bore well, different types of waste etc.

- There is a bore at the site. Fill the bore in layers and compact to dense condition.
- Remove all the trees with roots from the site and backfill with clean sand.

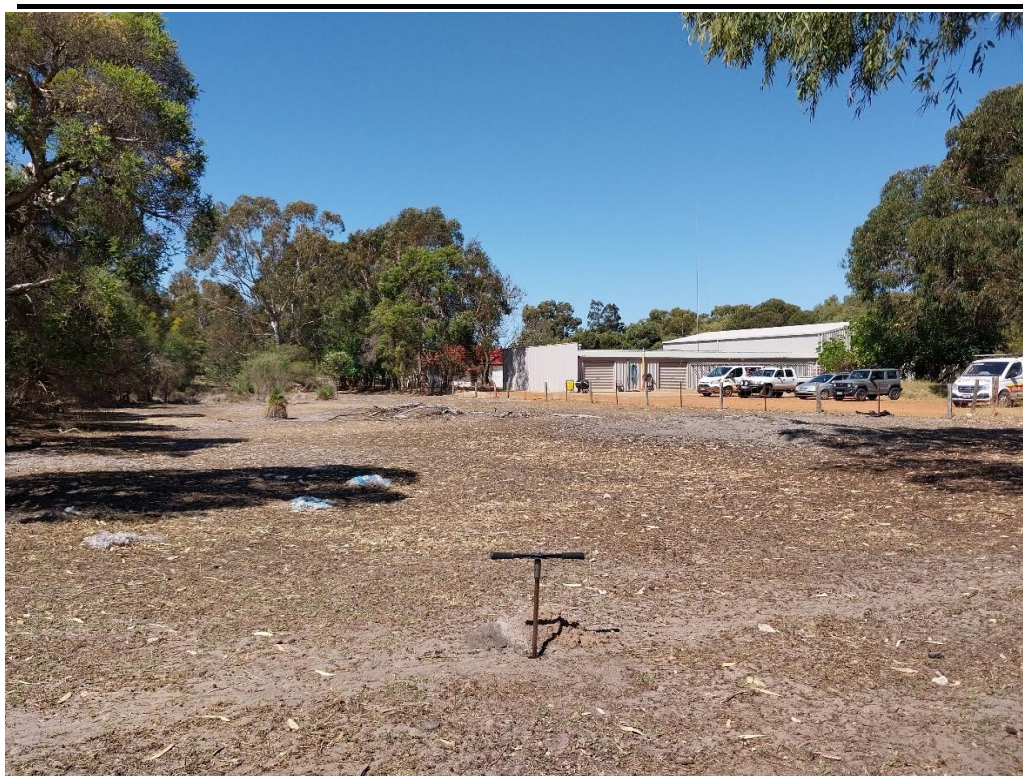
Photo 3. Test Location 02 (TH2), Sub-surface Probing by Using a Hand Auger

Test holes TH1 – TH4 consist of similar soil profile as described below:

- **Topsoil, Silty SAND (SM)** – fine to medium grained, grey, with low plasticity silt, grass and roots, slightly moist, loose to dense, up to a depth of 0.1 m; followed by
- **Silty SAND (SM)** – fine to medium grained, grey, with low plasticity silt, slightly moist, loose to dense, up to a depth of 0.5 m; followed by
- **SAND (SP)** – fine to medium grained, pale grey to pale brown, slightly moist to wet, loose to dense, up to the maximum investigated depth.

TH1, TH2, TH3 and TH4 were terminated at depths of 1.7 m, 1.5 m, 1.8 m and 1.5 m respectively due to hole collapsed. Ground water table was encountered at depths of 1.3 m, 1.0 m, 1.0 m and 0.6 m at TH1, TH2, TH3 and TH4 during the time of investigation. Test hole logs are attached in Appendix B.

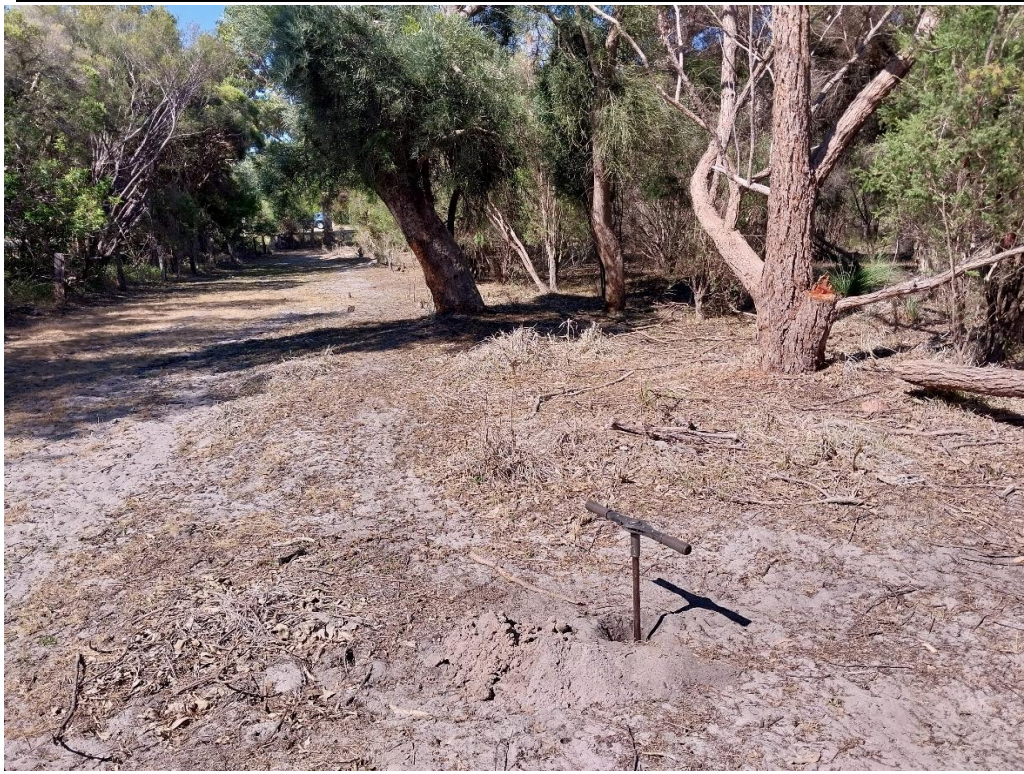
Photo 5. Test Location 04 (TH4), Sub-surface Probing by Using a Hand Auger

Depth (m)	RL (m)	Method	Penetration resistance	Sampling Type	Graphic Log	Classification Symbol	Description of Soil Strata	Additional observations	Perth Sand Penetrometer Test (Blows/300mm)
0.0						SM	<b>Topsoil, Silty SAND</b> - fine to medium grained, grey, with low plasticity silt, grass and roots, slightly moist, dense		0
0.1						SM	<b>Silty SAND</b> - fine to medium grained, grey, with low plasticity silt, slightly moist, dense		5
0.2						SP	<b>SAND</b> - fine to medium grained, pale grey, slightly moist, dense		10
0.5							colour changes to pale brown		15
0.6							water table encountered		20
1.0									25
1.5							Terminated at a depth of 1.5 m due to hole collapsed		
2.0									
2.5

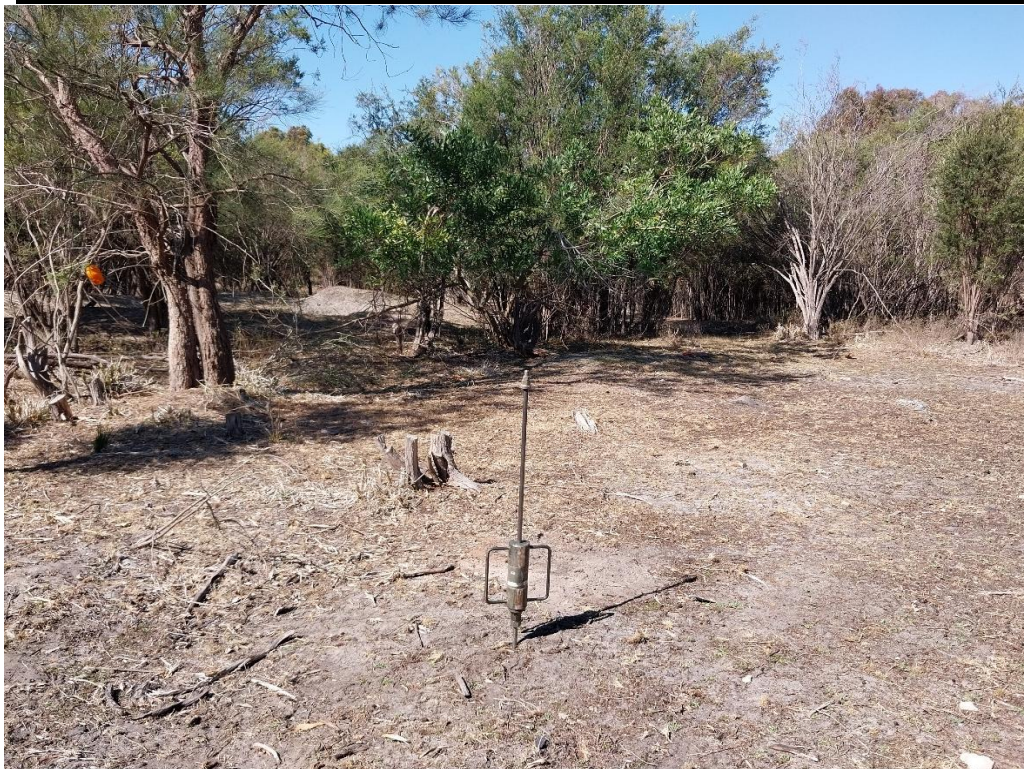
Photo 6. Test Location 04 (PSP4), Testing by Using a Perth Sand Penetrometer

PSP tests (PSP1 to PSP4) were conducted alongside the test holes. PSP tests indicate the soil density of the site as per Standard Australia HB 160-2006, Table 6.4.6.2. PSP data are presented in Table 1 and PSP test certificates are attached in Appendix B.

PSP Location	PSP1		PSP2		PSP3		PSP4	
Depth (mm)	No. of Blows/300mm (Density Classification)							
0 – 150	Seating		Seating		Seating		Seating	
150 – 450	4	L	5	L	5	L	10	D
450 – 750	6	MD	6	MD	5	L	11	D
750 – 1050	6	MD	6	MD	5	L	11	D
Note: Density Classification is obtained based on Number of blows required for 300 mm penetration of PSP Very Loose (VL) < 2; Loose (L) 2 – 6; Medium Dense (MD) 6 – 8; Dense (D) 8 – 15; Very Dense (VD) > 15

It is observed from the PSP test that the site soil is in loose to dense condition.

- Before laying a foundation, compact the site up to 1050 mm depth to a dense condition as per AS 3798-2007. We recommend, PSP seating for 0-150 mm, 8 PSP blows for 150-450 mm, 9 PSP blows for 450-750 mm and 10 PSP blows for 750-1050 mm and 10 PSP blows for every 300 mm of penetration.
