**1818 LAKES RD NORTH DANDALUP**  
**DETERMINATION OF FORESHORE SETBACK**

Report No. J25003  
7 August 2025

**BAYLEY ENVIRONMENTAL SERVICES**  
30 Thomas Street  
SOUTH FREMANTLE WA 6162

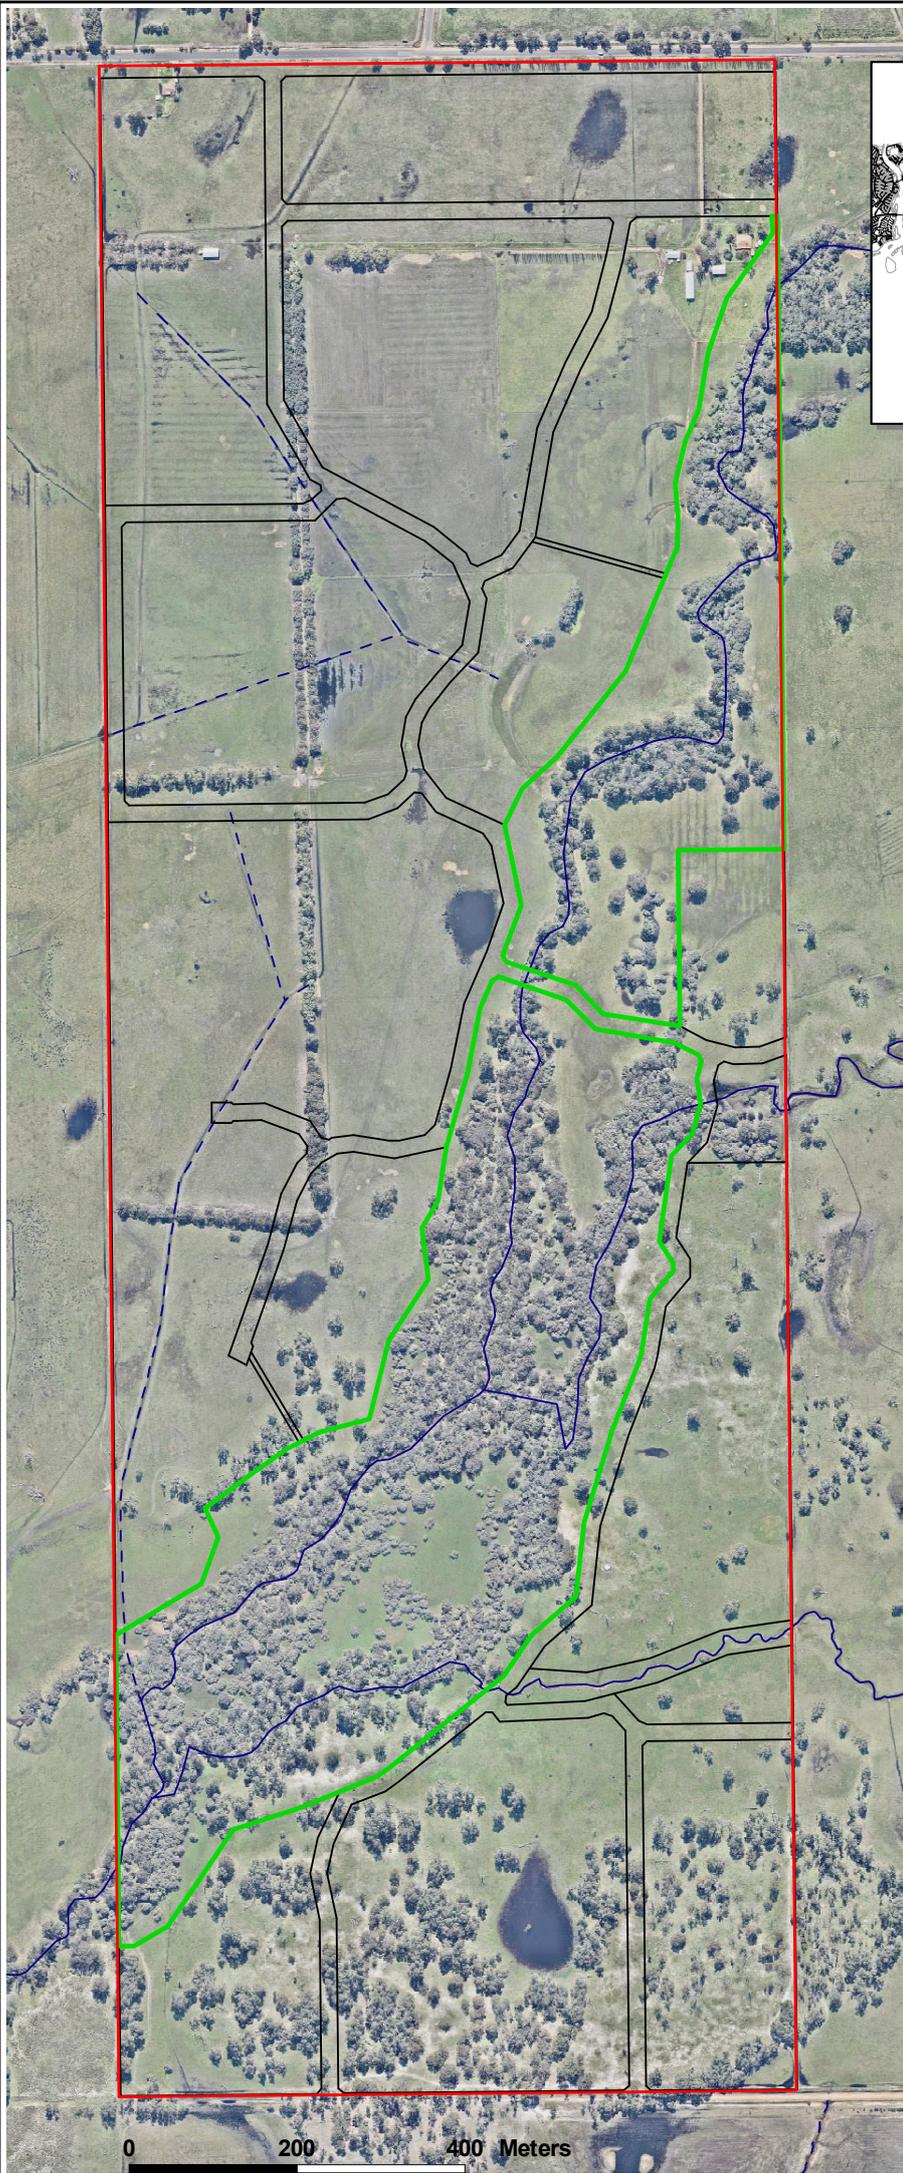
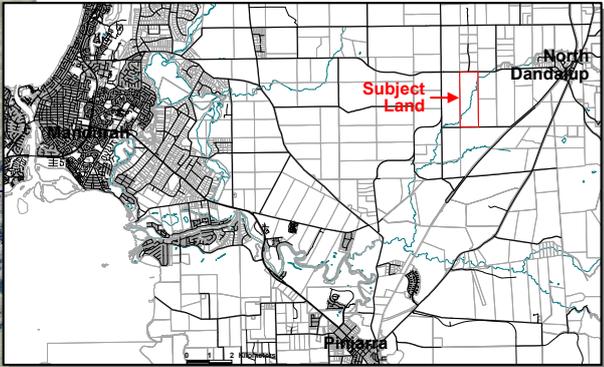
- Subject land boundary
- Conceptual road alignment
- Watercourse
- - - Paddock drain
- Proposed foreshore reserve

LOCATION AND LAYOUT

Valley Holdings WA Pty Ltd proposes to rezone Lot A39 (No. 1818) Lakes Road, North Dandalup (the subject land) for rural-residential use. The rezoning is intended to facilitate the future subdivision of the 194.7ha property into approximately 120 lots with a minimum size of 1ha. Figure 1 shows the location of the subject land. Figure 2 shows an aerial photograph of the site and surroundings.

Figure 1 shows the proposed boundary of the foreshore reserve.

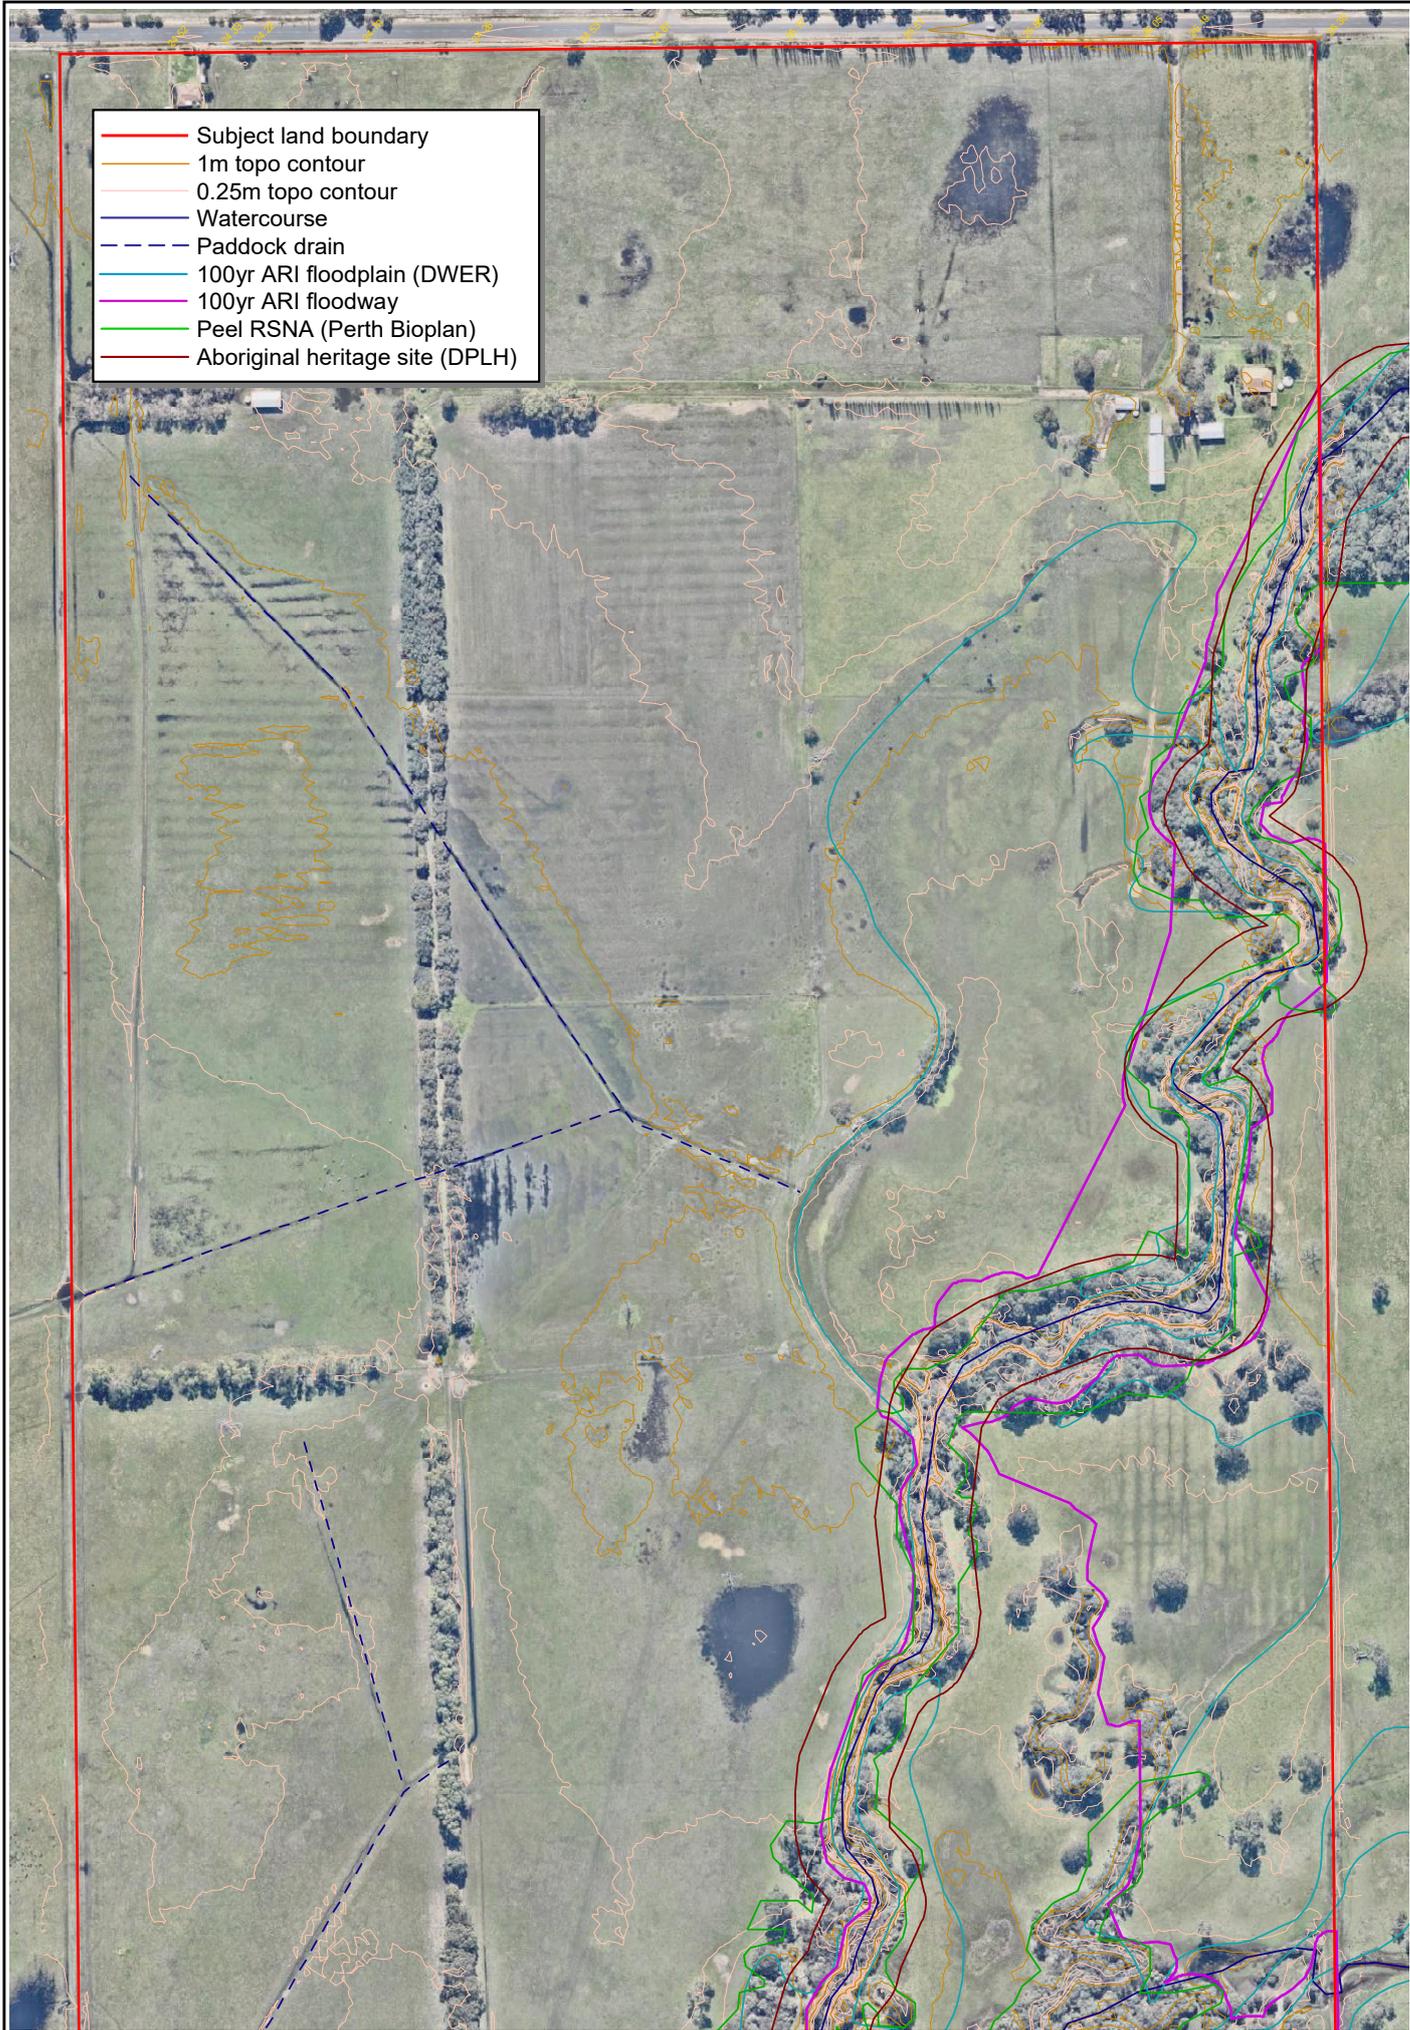
Figure 3a

- Subject land boundary
- 1m topo contour
- 0.25m topo contour
- Watercourse
- - - Paddock drain
- 100yr ARI floodplain (DWER)
- 100yr ARI floodway
- Peel RSNA (Perth Bioplan)
- Aboriginal heritage site (DPLH)

ENVIRONMENTAL FEATURES

These features are shown on Figure 3.

The Department of Water (DoW) mapped the 100-year floodplain of the North Dandalup River in 2011 as part of the Murray DWMP. Figure 3 shows the DoW floodplain mapping. The DoW study did not differentiate the floodway from the flood fringe. The DoW modelling predicted that the 100-year ARI flood level would be 26.25m AHD at Lakes Road, 25m AHD at the eastern boundary of the subject land and 19.5m AHD at the south-western boundary.

Figure 3 shows the boundaries of the floodway resulting from the Pentium (2025) modelling.

The junctions of these tributaries are complex, with multiple channels and overflows. Other minor paddock drains flow into the river from the north-west. Figure 3 shows the tributaries.

The watercourse of the North Dandalup River is listed on the DPLH Aboriginal Heritage Database as registered Aboriginal heritage site No. 27937: Mythological. The mapped site extends 30m each side of the centreline of the watercourse and is associated with the Waugyl mythology. Figure 3 shows the mapped boundaries of the Aboriginal site.

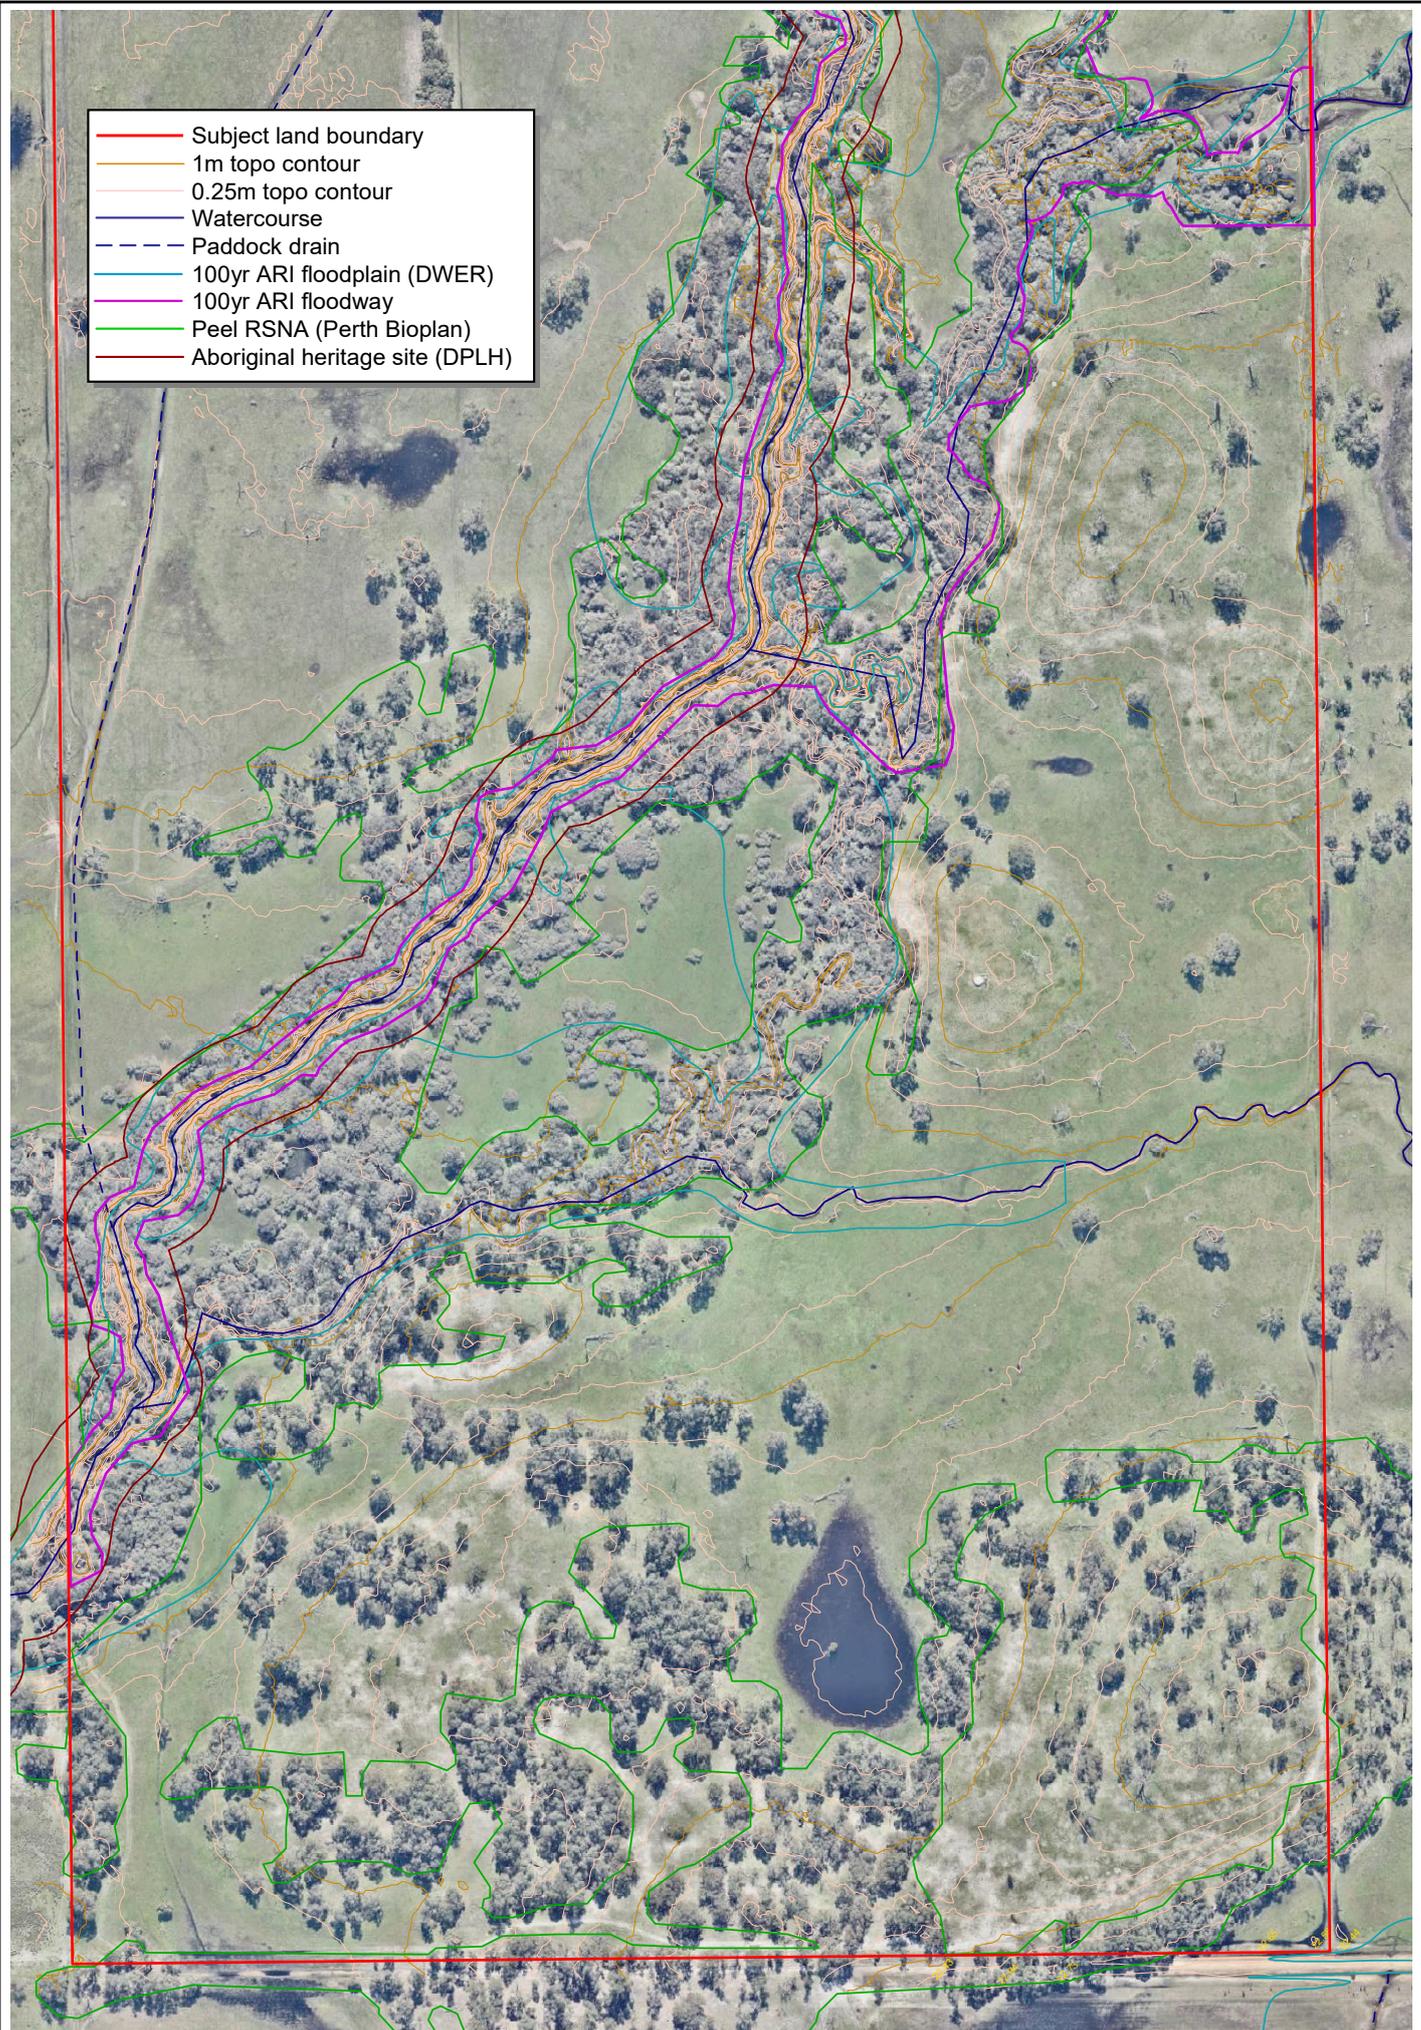
Figure 3b

- Subject land boundary
- 1m topo contour
- 0.25m topo contour
- Watercourse
- Paddock drain
- 100yr ARI floodplain (DWER)
- 100yr ARI floodway
- Peel RSNA (Perth Bioplan)
- Aboriginal heritage site (DPLH)

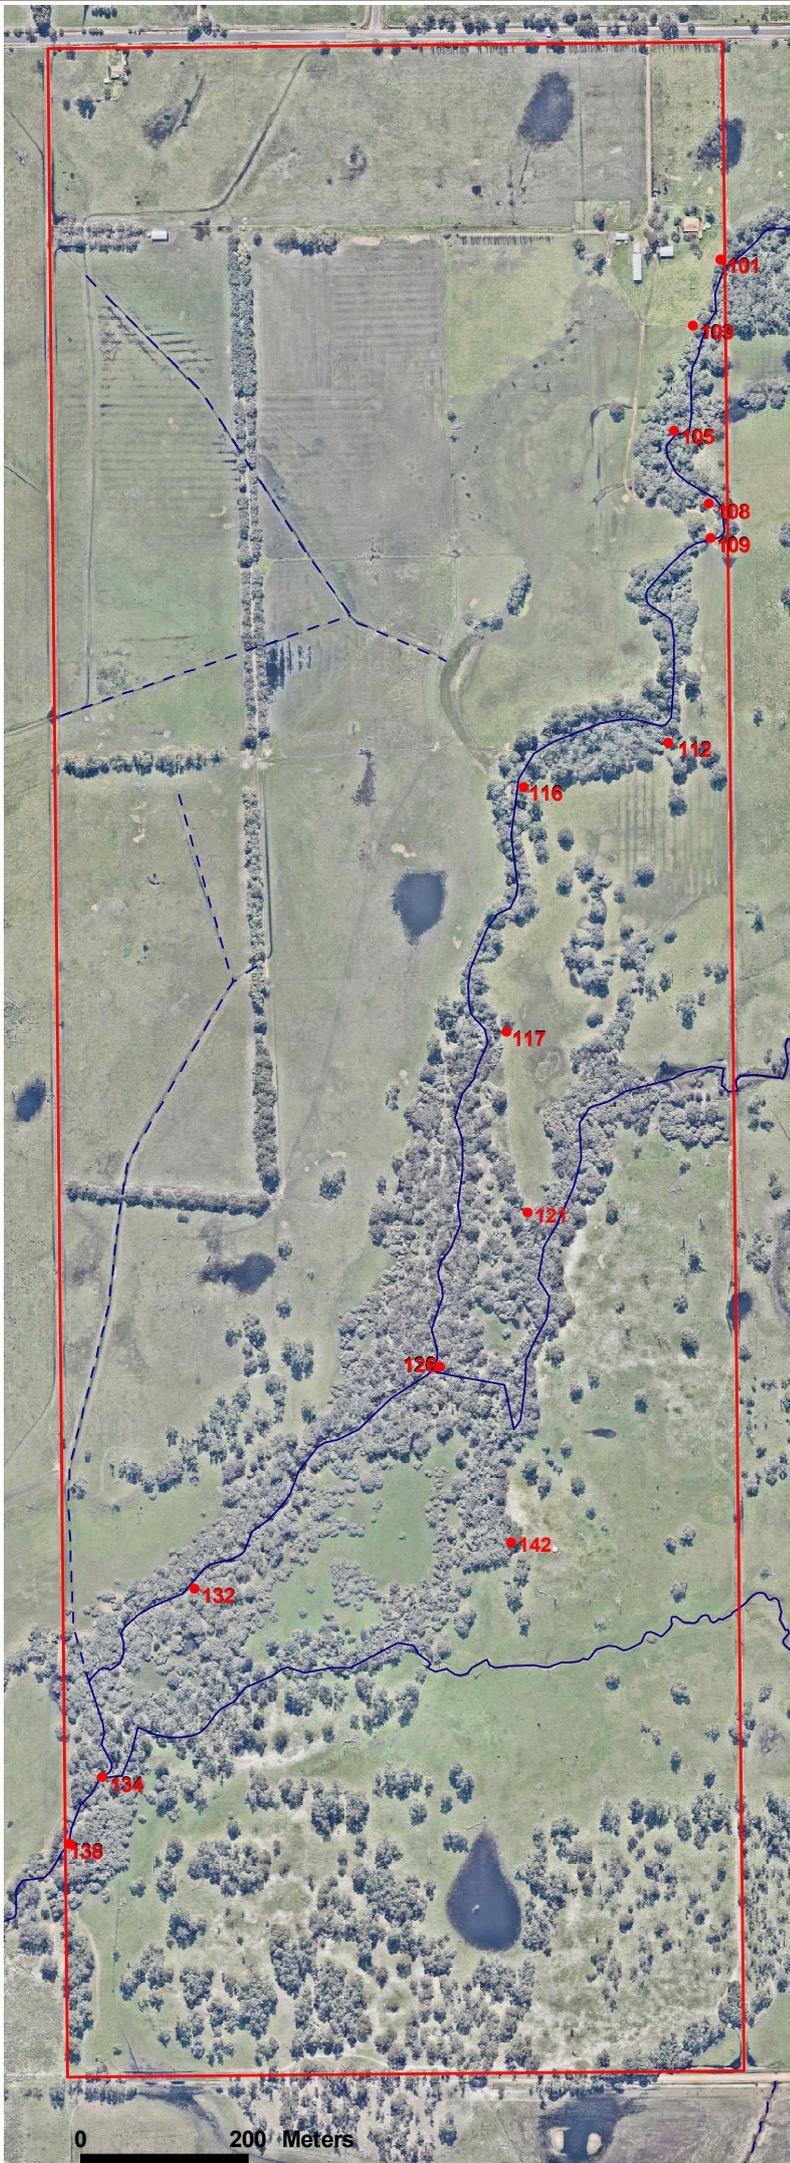
Figure 4c

- Subject land boundary
- Photo point (see Figures 4a & 4b)
